Final Technical Memorandum

Lake Stevens Outlet Study

Indicator Engineering PLLC

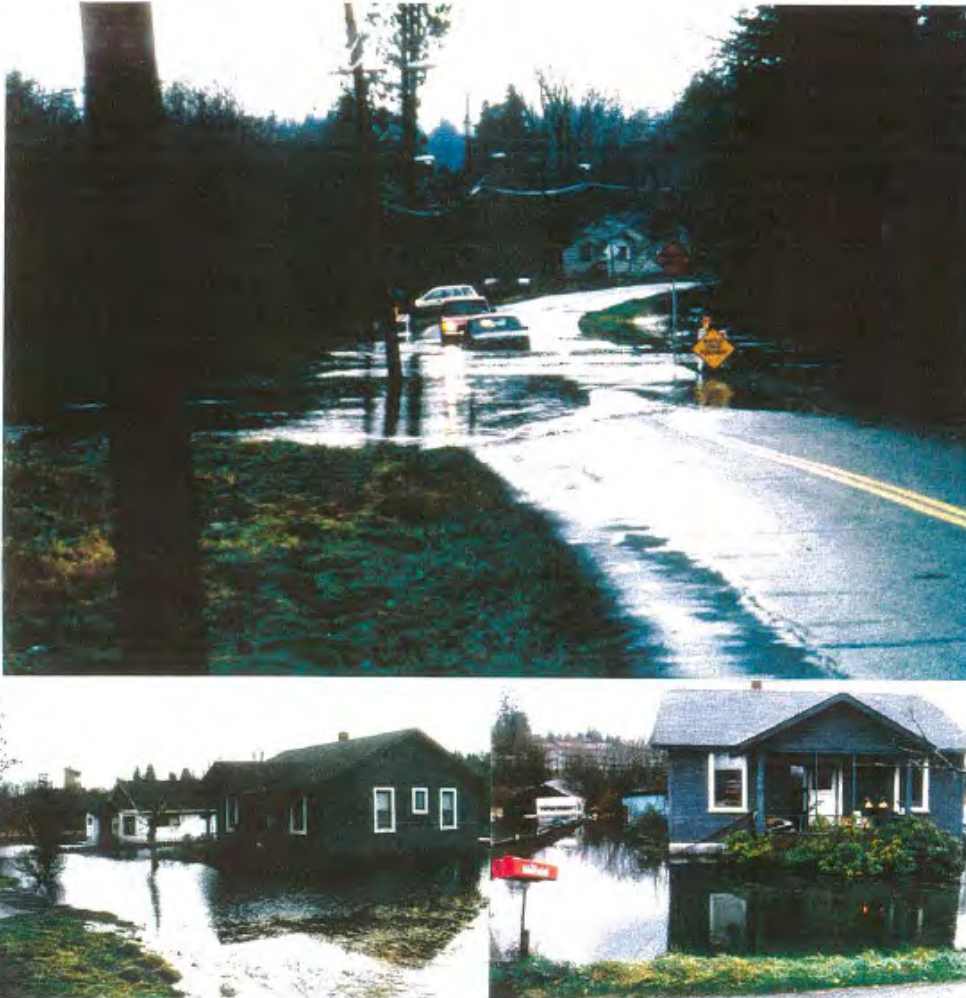
Figure 4-2

Significant flooding has occurred in the watershed in three locations, including Stevens Creek (outside this Study area), the north side of Hartford Drive opposite the outlet channel in a wetland area, and in the downtown business loop of Lake Stevens. Figure 5 shows flooding in 1997 on Hartford Drive.

Flood Conditions along Hartford Road
January, 1997

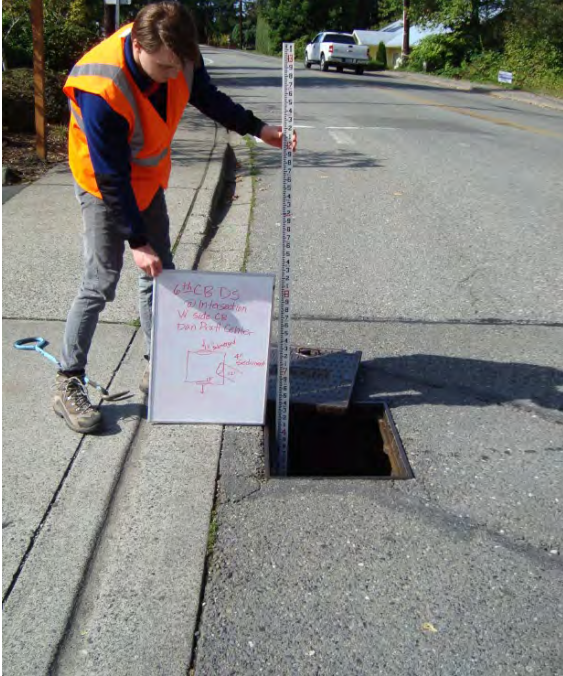
Drainage pipes conveying stormwater runoff from 16th Avenue west of the intersection of Main Street and 16th Avenue NE route meets with runoff draining 16th Avenue NE from the east just east of the intersection at a low point. The pipes and catch basins in this location had significant deposits of sediment and/or were submerged under water. The parking lot of the Boys and Girls Club to the south is also connected to the drainage system at this location. One of the catch basins was equipped with a new bypass pipe that appeared to be installed to alleviate flooding at this location (Photo 1). The most downstream catch basin is not submerged (Photo 2), whereas upstream catch basins are (such as in Photo 1) indicating there is either a blockage in the pipes, a sag in the line, or the grades are not aligned properly for positive flow.

Photo 1. Upstream Catch Basin in Vicinity of Intersection of Main Street and 16th Avenue NE on September 25, 2019.

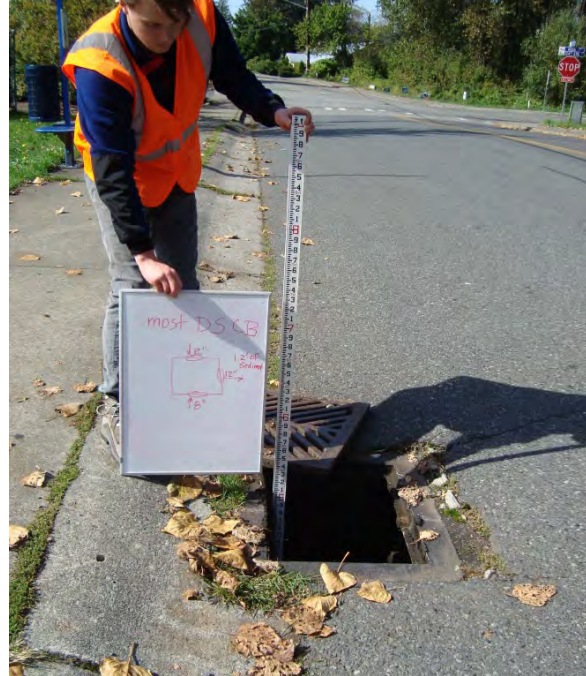
Photo 2. Most Downstream Catch Basin in Vicinity of Intersection of Main Street and 16th Avenue NE on September 25, 2019.

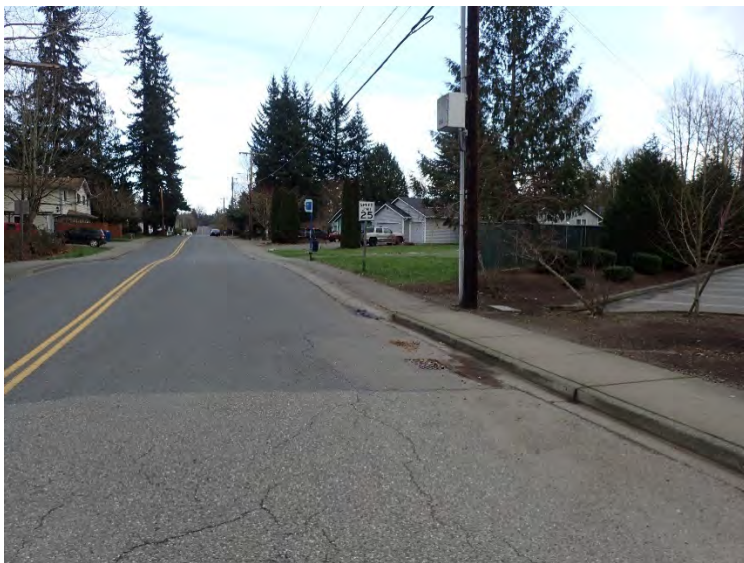
According to residents, 16th Avenue NE did not overtop during the February 2020 flood event, and there was no evidence of such during the February 11, 2020 site visit (Photo 3).

Photo 3. 16th Avenue NE on February 11, 2020 looking East. near Boys and Girls Club.

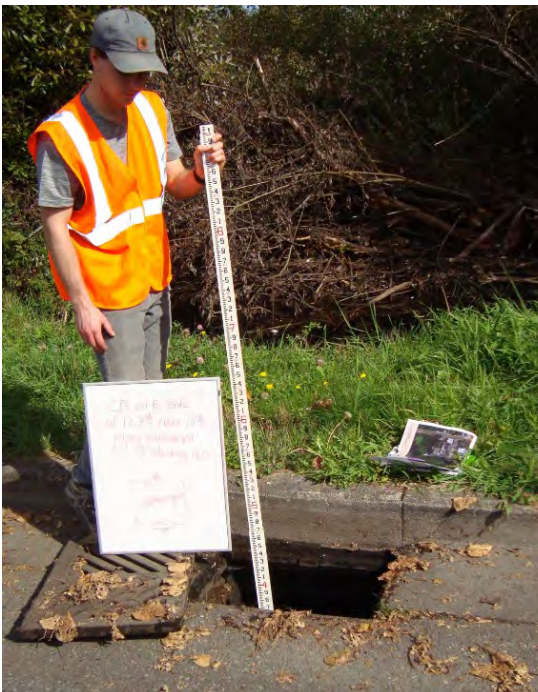
complex that runs in the north-south direction parallel to NE 125th Street. During our field investigation, conveyance ditches were full of water and adjacent catch basins and pipe systems conveying stormwater runoff to the conveyance ditches were submerged. Photo 4 shows the catch basin closest to the conveyance ditch on the east side of 125th Avenue NE and the ditch in the background on September 25, 2019. Within the catch basin in photo 4, the pipe is submerged and the ditch is full of water. Positive flow away from the roadways and upland would be challenging in this situation during heavy or sustained precipitation because of the low lying, saturated conditions of the surrounding area. Photo 5 shows this same location on February 11, 2020, after the intersection was likely flooded in the previous five days. Photos 6 and 7 show the culvert crossing at 18th Avenue NE on September 25, 2019. The culvert is nearly submerged. Additionally, beaver activity in the wetland backs water up into the conveyance ditches on occasion. City personnel remove dams and beavers, as required to maintain positive flow.

Photo 4. Catch Basin on NE 125th Street on East Side of Street nearest intersection with 18th Avenue NE on September 25, 2019.

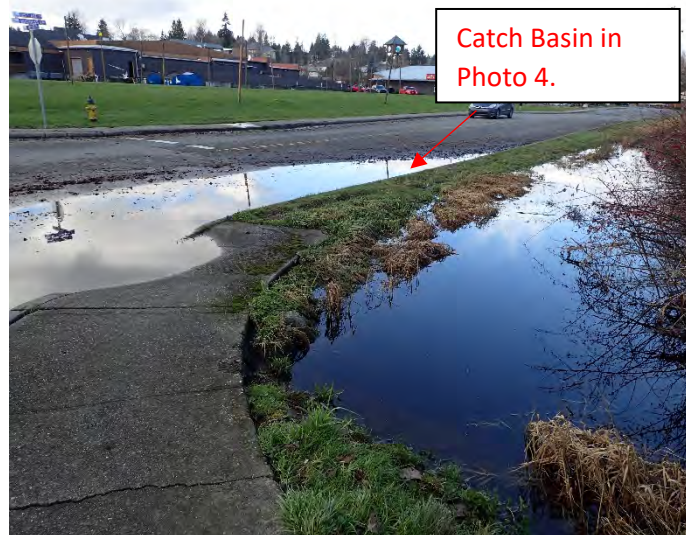
Photo 5. Intersection of NE 125th Street and 18th Avenue NE looking North on February 11, 2020. Intersection was flooded during February 2020 event.

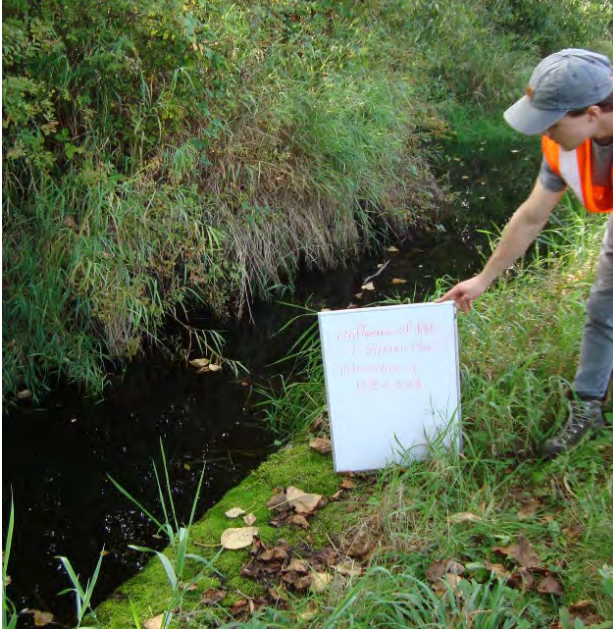
Photo 6. Upstream side of 18th Avenue NE Culvert on September 25, 2019.

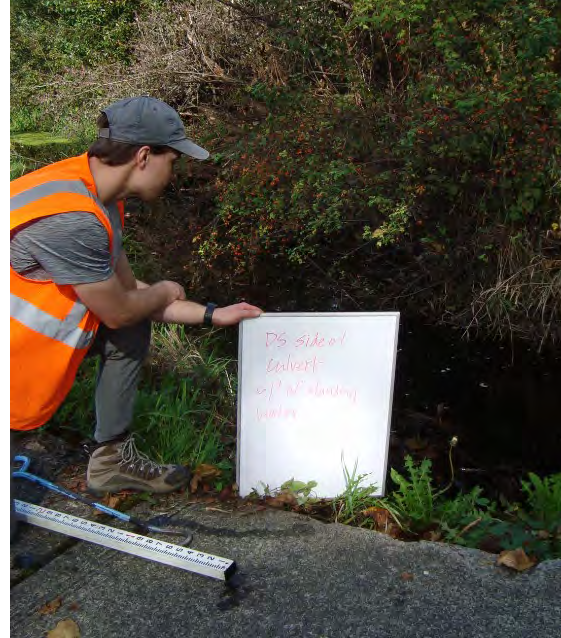
Photo 7. Downstream side of 18th Avenue NE Culvert on September 25, 2019.

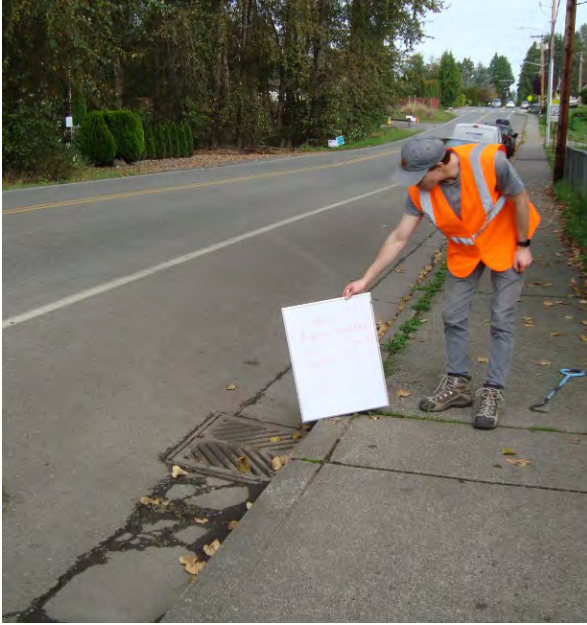
Staff report that flooding occurs at the intersection of 20th Avenue NE and 125th Street two to three times a year. This intersection is at the low point of 20th Avenue NE and crosses the same large wetland complex that runs in the north-south direction parallel to NE 125th Street. However, this area has been developed on the south side of 20th Avenue NE with apartment buildings, confining flow to the ditch between developed multi-family residential properties and the roadway on NE 125th Street and 20th Avenue NE. During our field investigation, the conveyance ditch was full of water (within 0.5 feet of the sidewalk elevation), adjacent catch basins and pipe systems and the 20th Avenue NE culvert were submerged. Photos 8 and 9 show the location of a submerged catch basin on 20th Avenue NE near the low point in the road in the location of frequent flooding on September 25, 2019 and February 11, 2020. The catch basin was full of water at the time of our September site visit and submerged in February 2020 from the previous week's flooding. Photo 10 shows the catch basin upstream of the low point on 20th Avenue NE, which was also submerged during the September 25, 2019 field visit. Photo 11 shows the conveyance ditch south (upstream) of 20th Avenue NE near the culvert crossing and that the water elevation is within 0.5 feet of the sidewalk. Photo 12 shows the downstream side of the culvert. The water elevation is approximately 2 feet below the road. The culverts appear to be a constriction to flow in this location, either due to a physical blockage or culvert sizes, as indicated by water backing up on the upstream end of the culvert. Photo 13 shows flooded conditions on 20th Avenue NE at the low point on February 6, 2020.

Photo 8. Catch Basin at low point on 20th Avenue NE near culvert crossing.

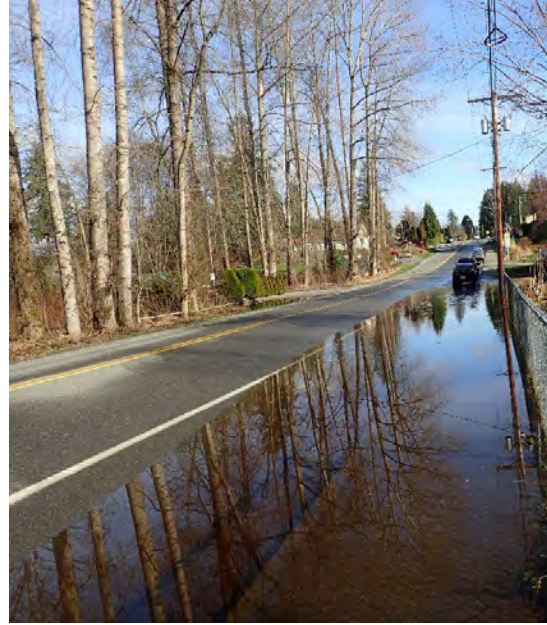
Photo 9. Approximate location of Photo 8 on February 11, 2020.

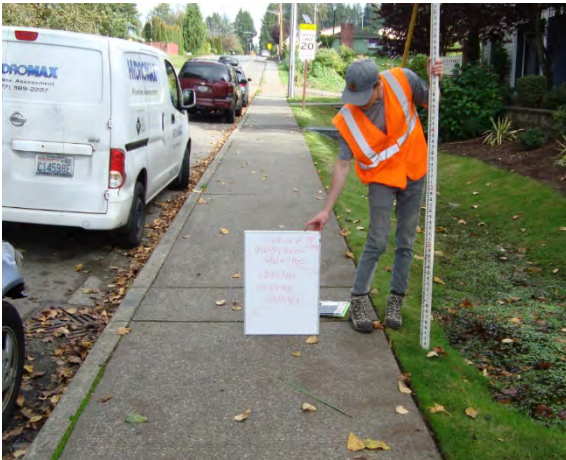
Photo 10. Catch Basin on 20th Avenue NE upstream of low point to the west.

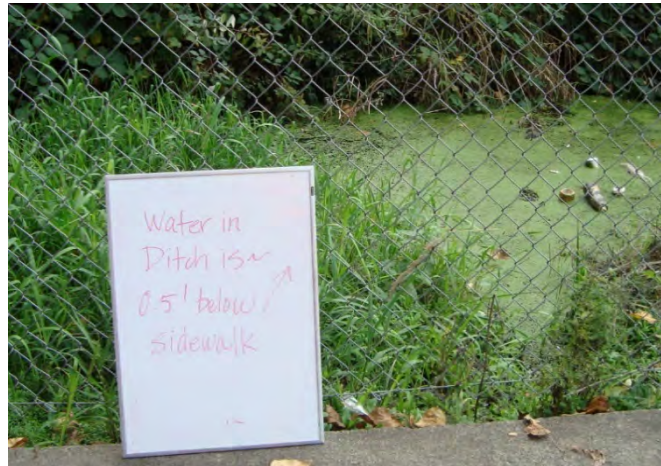
Photo 11. Water in conveyance ditch south of 20th Avenue NE upstream of culvert crossing.

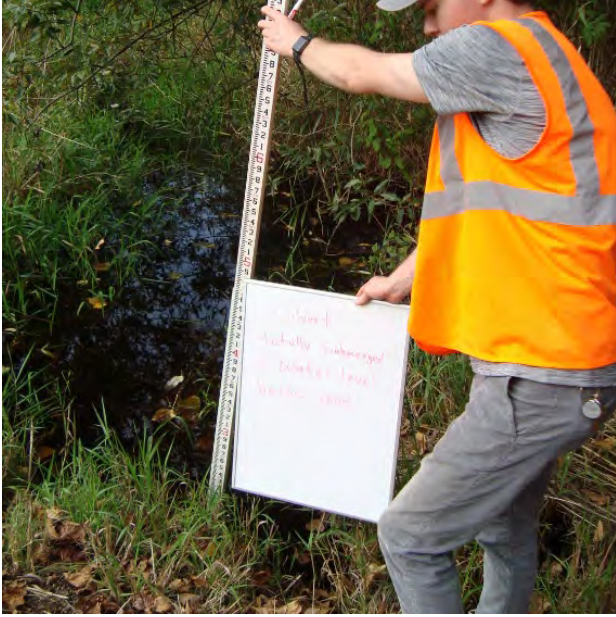
Photo 12. Conveyance ditch downstream of culvert crossing on north side of 20th Avenue NE.

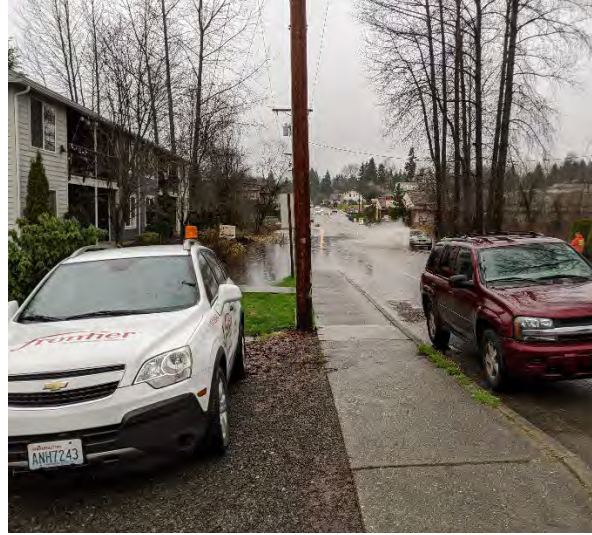
Photo 13. Flooding on 20th Avenue NE on February 6, 2020, looking west.

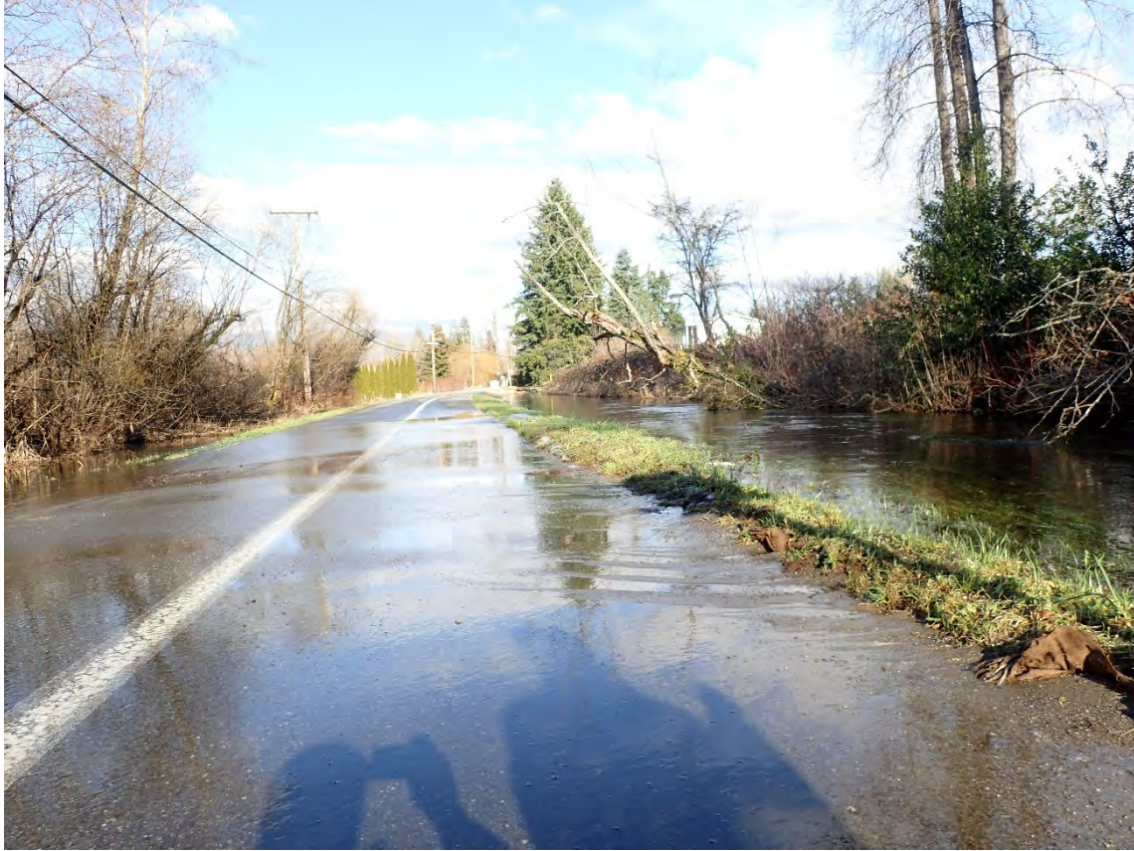
Flooding is reported to occur at the confluence of the outlet channel and the conveyance ditch/wetland complex at Hartford Drive. As shown in Figure 5, photographs from flooding in 1997 show water over the roadway in this location. Again in February 2020, water crested the roadway in this location and was still present during our site visit on February 11, 2020. Photo 14 shows conditions in February after flooding, before the water had completely receded. A review of modeling results indicates that backwater from the confluence of Catherine Creek and wetland complex on the north side of Hartford Dr. combine with high flows from upstream to create high water in both upstream and downstream directions during heavy precipitation events. The outlet channel in the vicinity of the confluence is shallow with low banks relative to upstream and downstream conditions, which could also contribute to flooding in this vicinity. Geomorphic conditions are described in Section 7.

Photo 14. Hartford Drive in the vicinity of historic outlet channel on February 11, 2020. Hartford Drive was closed due to water over the roadway (approximately 1.5 inches deep on 2/11/2020).

Geomorphic evaluation of the stream channel included observations of channel planform, dimensions, and substrate during a field visit on October 3, 2019. The outlet channel was walked to observe physical and biological characteristics (biological conditions are described in Section 8) and photographic documentation is provided in Attachment B. As described in Historical Documentation Section 3, the outlet channel is not natural and was created around 1908 in association with the Rucker Lumber Mill located on the northeast side of Lake Stevens, near the current City Hall. The channel has consistent dimensions from upstream at the lake outlet to downstream at the confluence of Catherine Creek, ranging from 12 to 18 feet in width, and banks of 4.5 to 8 feet high. The channel length is approximately 3,160 feet (0.6 miles). The LiDAR image in Figure 10 illustrates the channel depth relative to the surrounding landscape. The shallow location is near the confluence of the historic channel. At this location the bank height is only 4.5 feet compared to an average bank height of 7.5 for the remainder of the channel. Water depth ranged from 0.3 to 1.2 feet on the day of our site visit. Because the channel is artificial, it has an artificial planform as well. It is relatively straight and ditch-like, confined to the south side of Hartford Drive for most of its length with no floodplain connection except in the location of the confluence where banks are low and the road overtops and floods during heavy precipitation (see Photo 14).

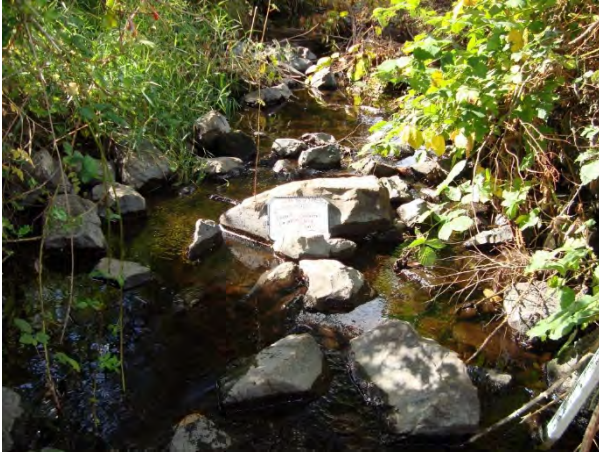
third private bridges upstream of the confluence with Catherine Creek the channel consists of large angular riprap that has been placed or fallen into the channel for bank or streambed protection (Photo 10). A large gravel bar was present in the vicinity of the Main Street bridge during our site visit (Photo 11).

Photo 15. Angular riprap in channel near private bridges 2 and 3.

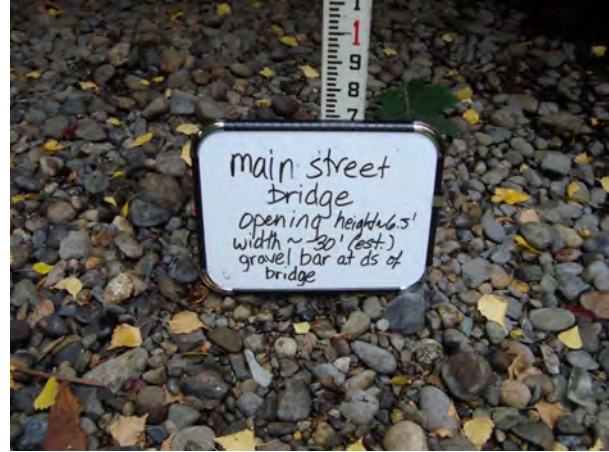
Photo 16. Gravel bar in the vicinity of Main Street bridge.

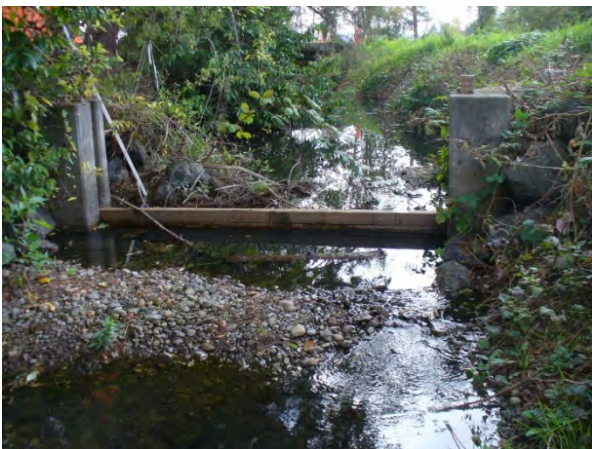
Photo 17. Existing lake outlet control weir is manually-operated. It does not regulate low flows well due to leakage and may be an upstream fish passage barrier during low flow periods as well. 10/3/19

A preliminary evaluation of the lake elevation and existing weir indicates that the weir might not be operating as intended. This needs to be confirmed. Preliminary modeling shows that the weir could be actively managed between February and October to continually release 1 or 2 cfs which would be sufficient to provide minimum flows for aquatic species. This would result in slightly higher lake levels (green lines in Figure 16) than currently modeled with the existing outlet (red line in Figure 16). The observed lake levels (blue line in Figure 16) indicate that the weir is not providing the intended function, since it does not match the red line.

Replace lake outlet weir and upper channel modifications. Weir will provide lake level and stream channel control for both high and low lake levels and the channel will be modified to improve habitat and channel capacity.

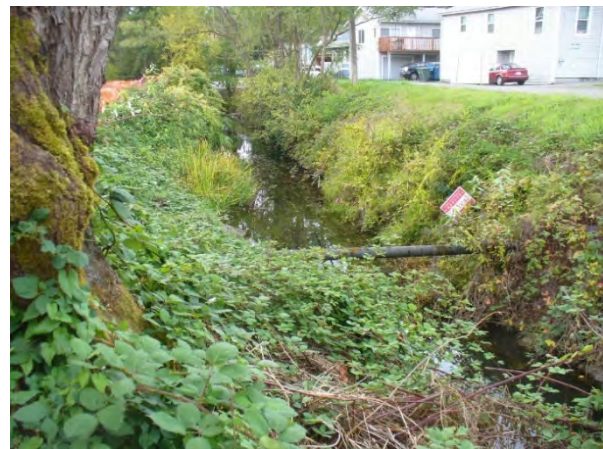
Photo 18. Facing upstream, channel section along N. Lakeshore Dr. Note elevated sanitary sewer crossing and invasive vegetation. Extensive bank armoring is obscured by shrubby vegetation. 10/3/19

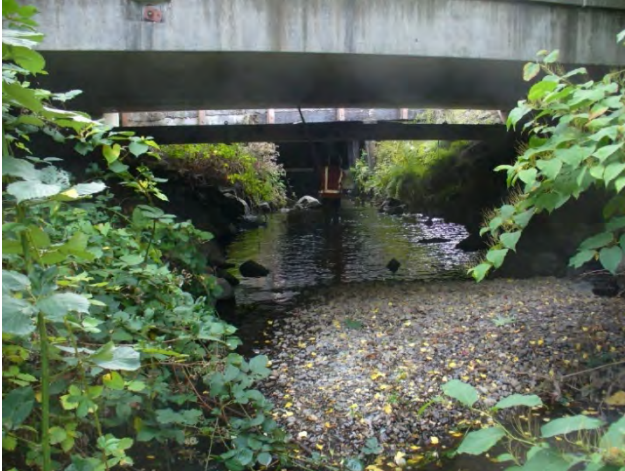
Photo 19. Main Street crossing from the downstream side. 10/3/19

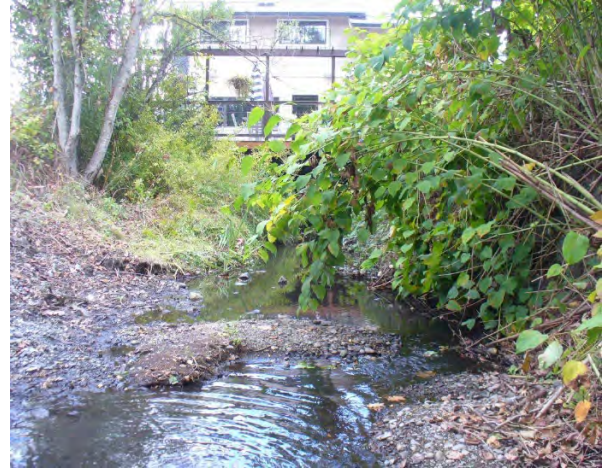
Photo 20. Facing downstream between the 20th Street NE and Main Street crossings. Note the increased stream slope and associated gravel substrate. Knotweed is overhanging the channel. 10/3/19

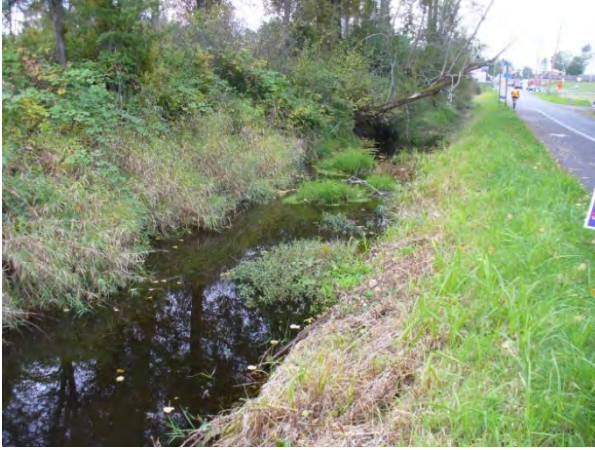
As shown in Photos 21 through 26 below, the lowermost channel sections flow at a low gradient such that most of the length is glide habitat with slow-moving, medium-depth water with neither well-formed pools nor riffles. The substrate consists mostly of fines in the lowermost section (sand and very small gravel) with some areas of medium gravel proceeding upstream. Emergent wetland vegetation is present along the channel. The south bank (right bank facing downstream), is fairly well vegetated with shrubs and immature trees, though invasive vegetation including Himalayan blackberry, reed canarygrass, and Japanese knotweed is also present. However, the effective buffer width along the right bank is fairly narrow bordering residential development. The left bank, along Hartford Drive, is mowed to the water's edge resulting in little or no effective buffer width. Very little wood, almost none, is present along the lower channel.

Photo 21. Approaching downtown Lake Stevens in the background, upstream.

Creek is low-gradient with standing water (glides or standing pools). Aquatic emergent vegetation in channel, diversely vegetated wetland to the left (south), though it includes invasive Himalayan blackberry and reed canarygrass. 10/3/19

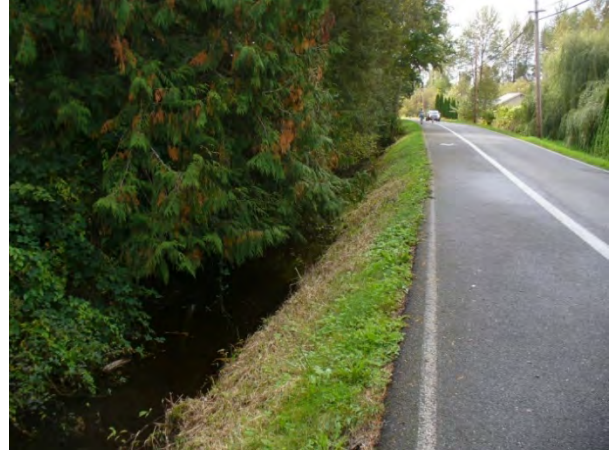
Photo 22. Section of improved overhanging vegetation, but only on the bank to the left in the photo.

Hartford Drive shown on right in photo. 10/3/19

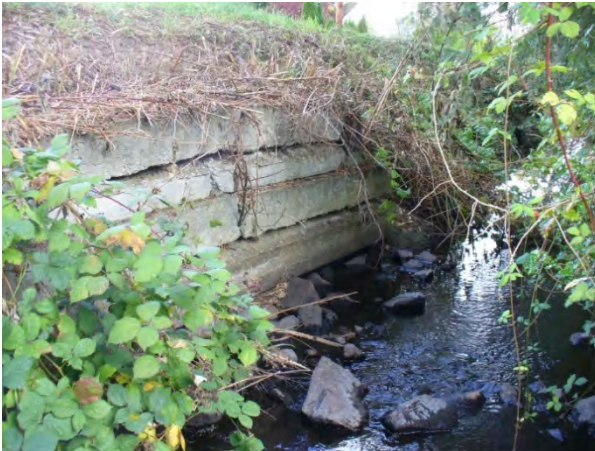
Photo 23. Remnant bed and bank armoring. 10/3/19

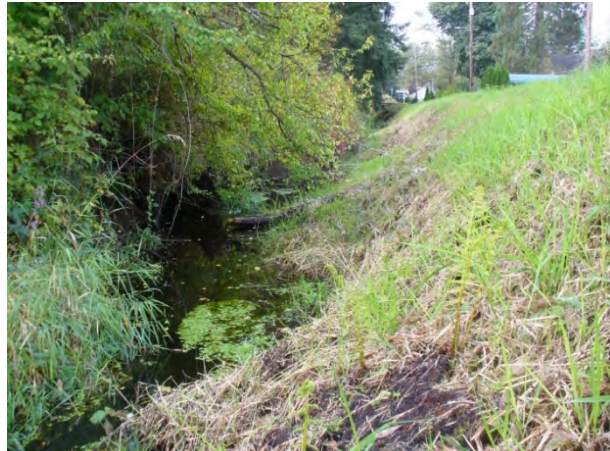
Photo 24. Typical lowermost channel section with low-gradient quiet-water, little wood, some vegetation on the left, but a mowed roadway embankment on the right. 10/3/19

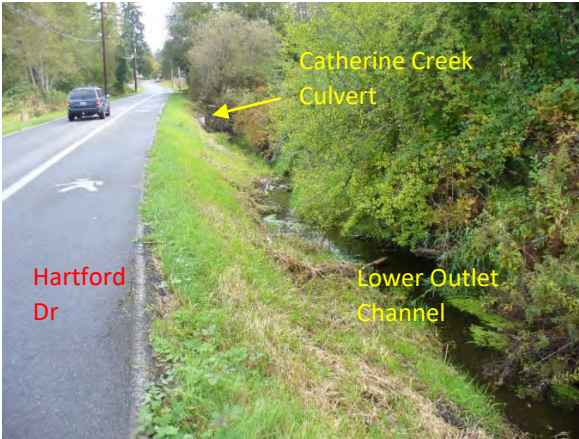
Photo 25. Facing downstream towards the Catherine Creek confluence. 10/3/19

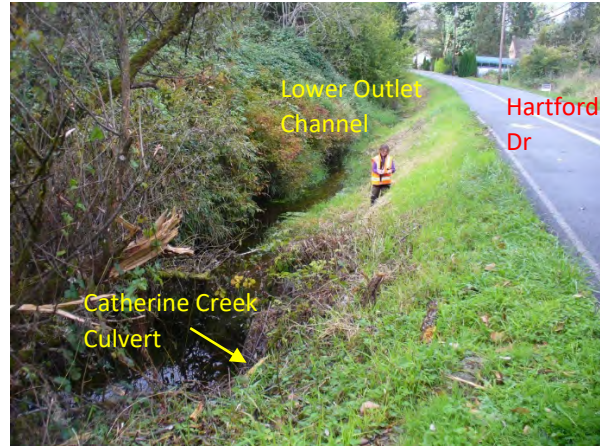
Photo 26. Facing upstream from the Catherine Creek confluence. 10/3/19
