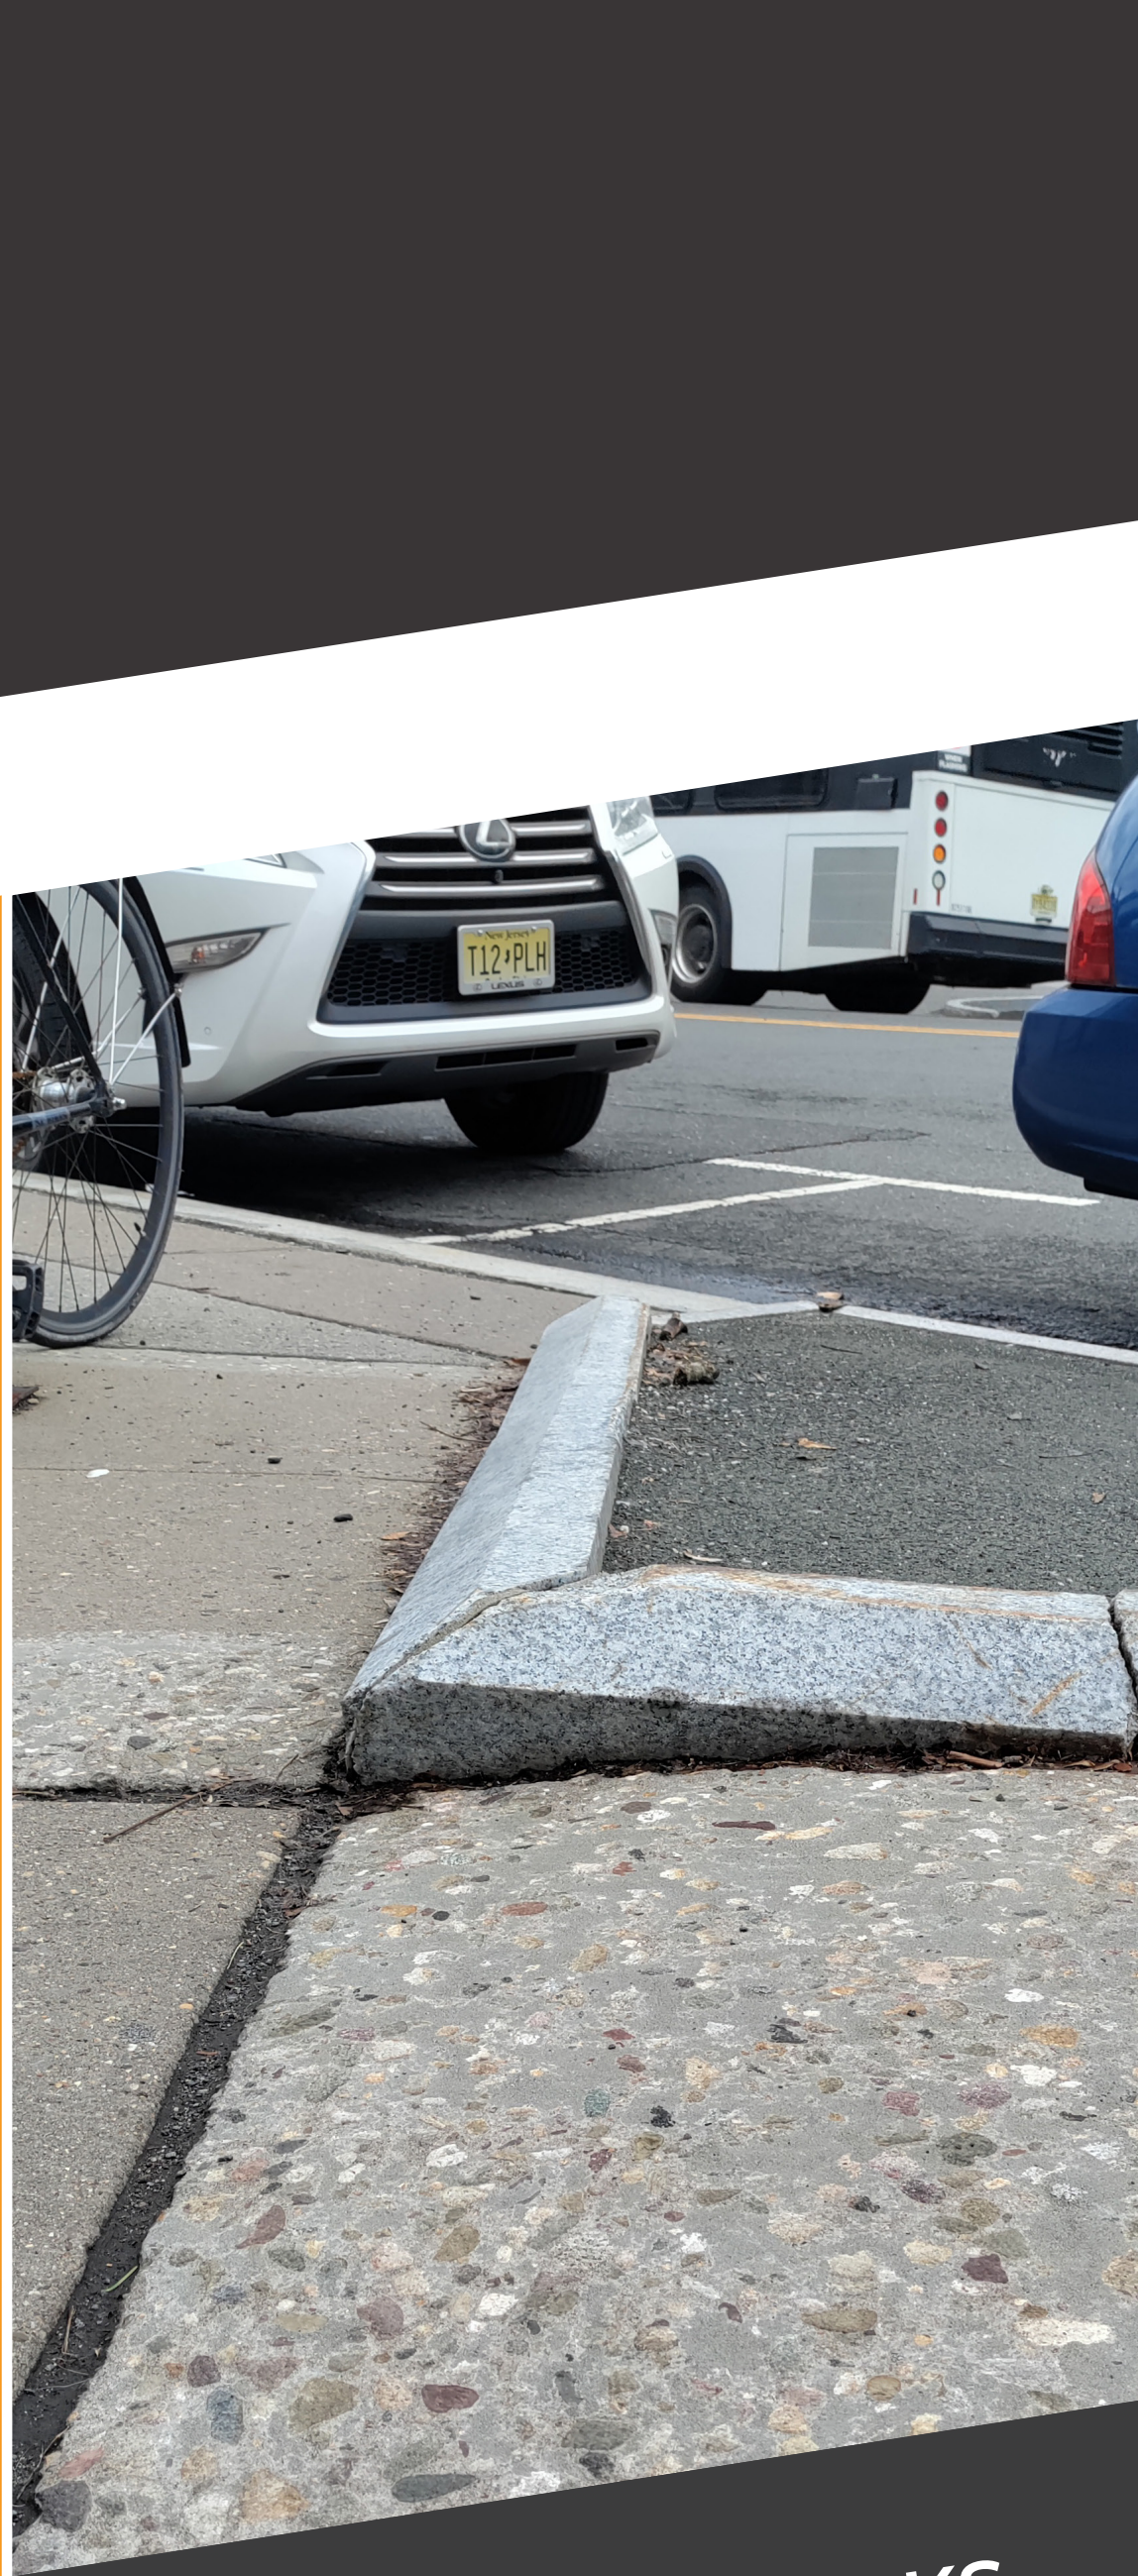
HEAVING SIDEWALKS

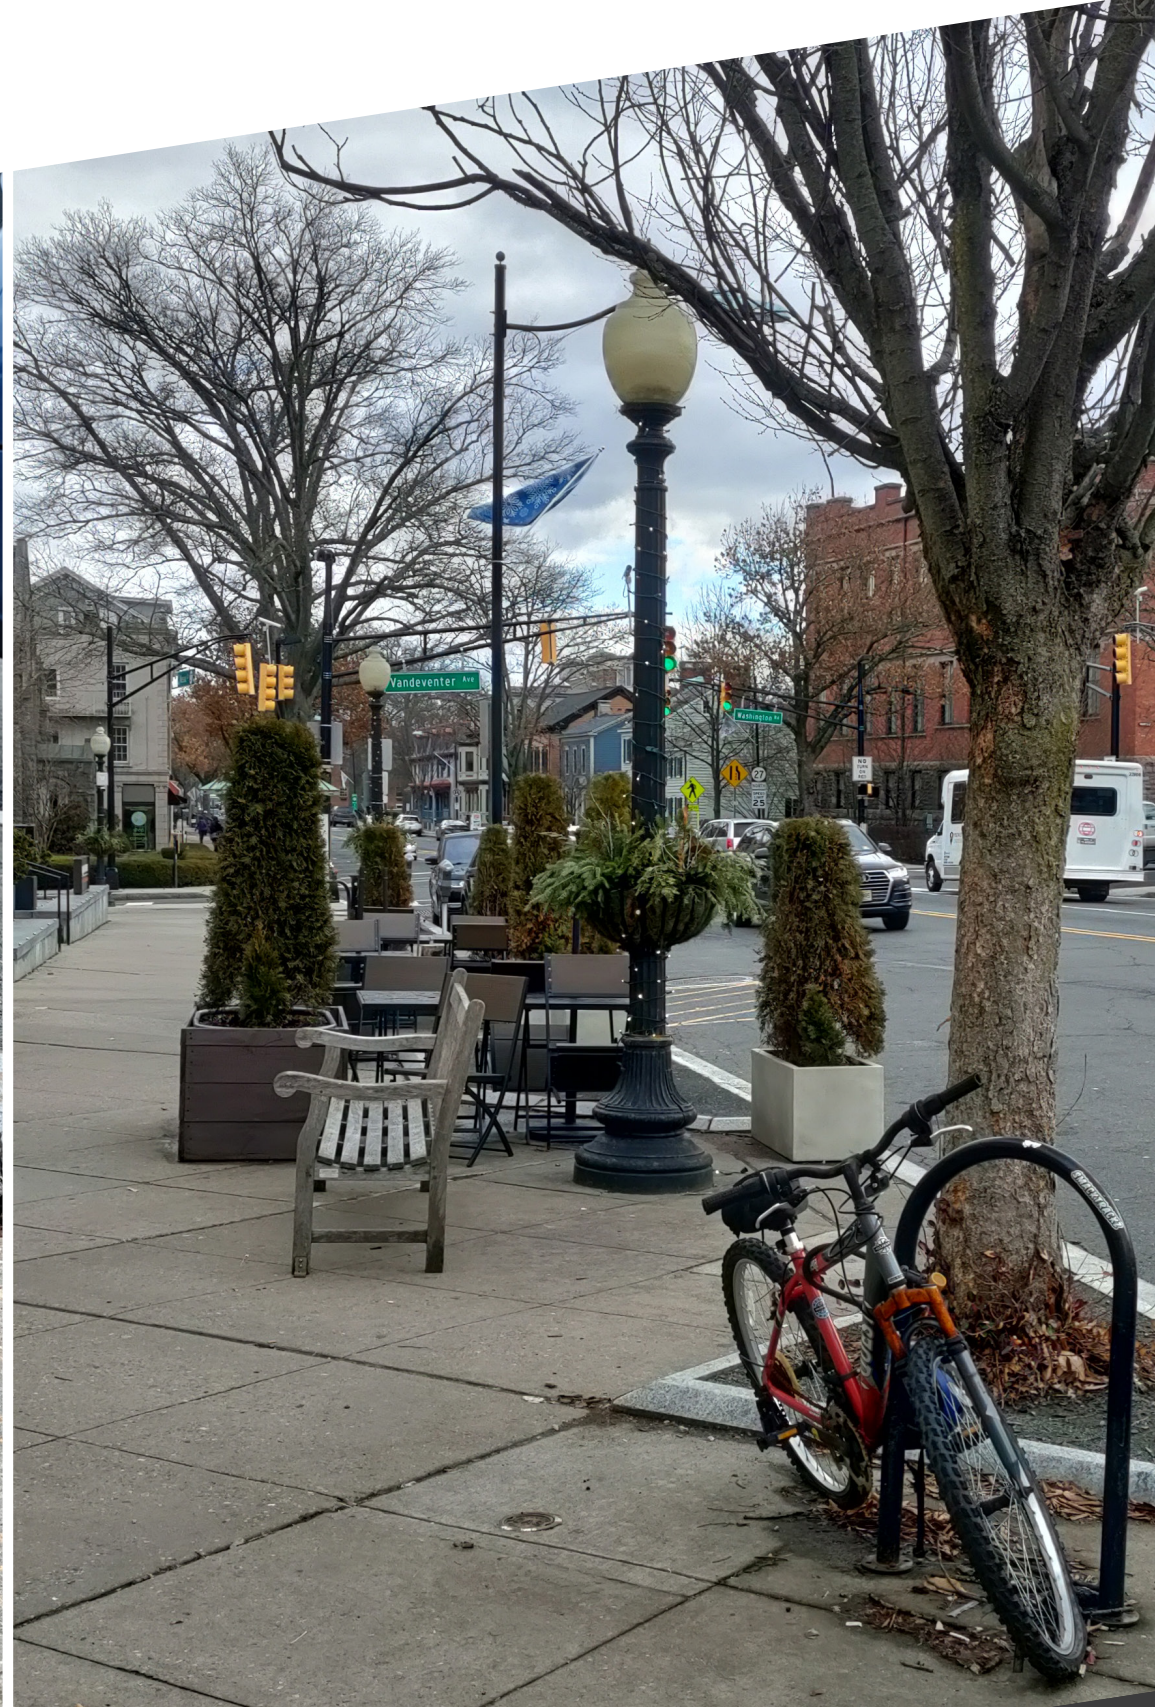
LACK OF COHESIVE FURNITURE PALETTE

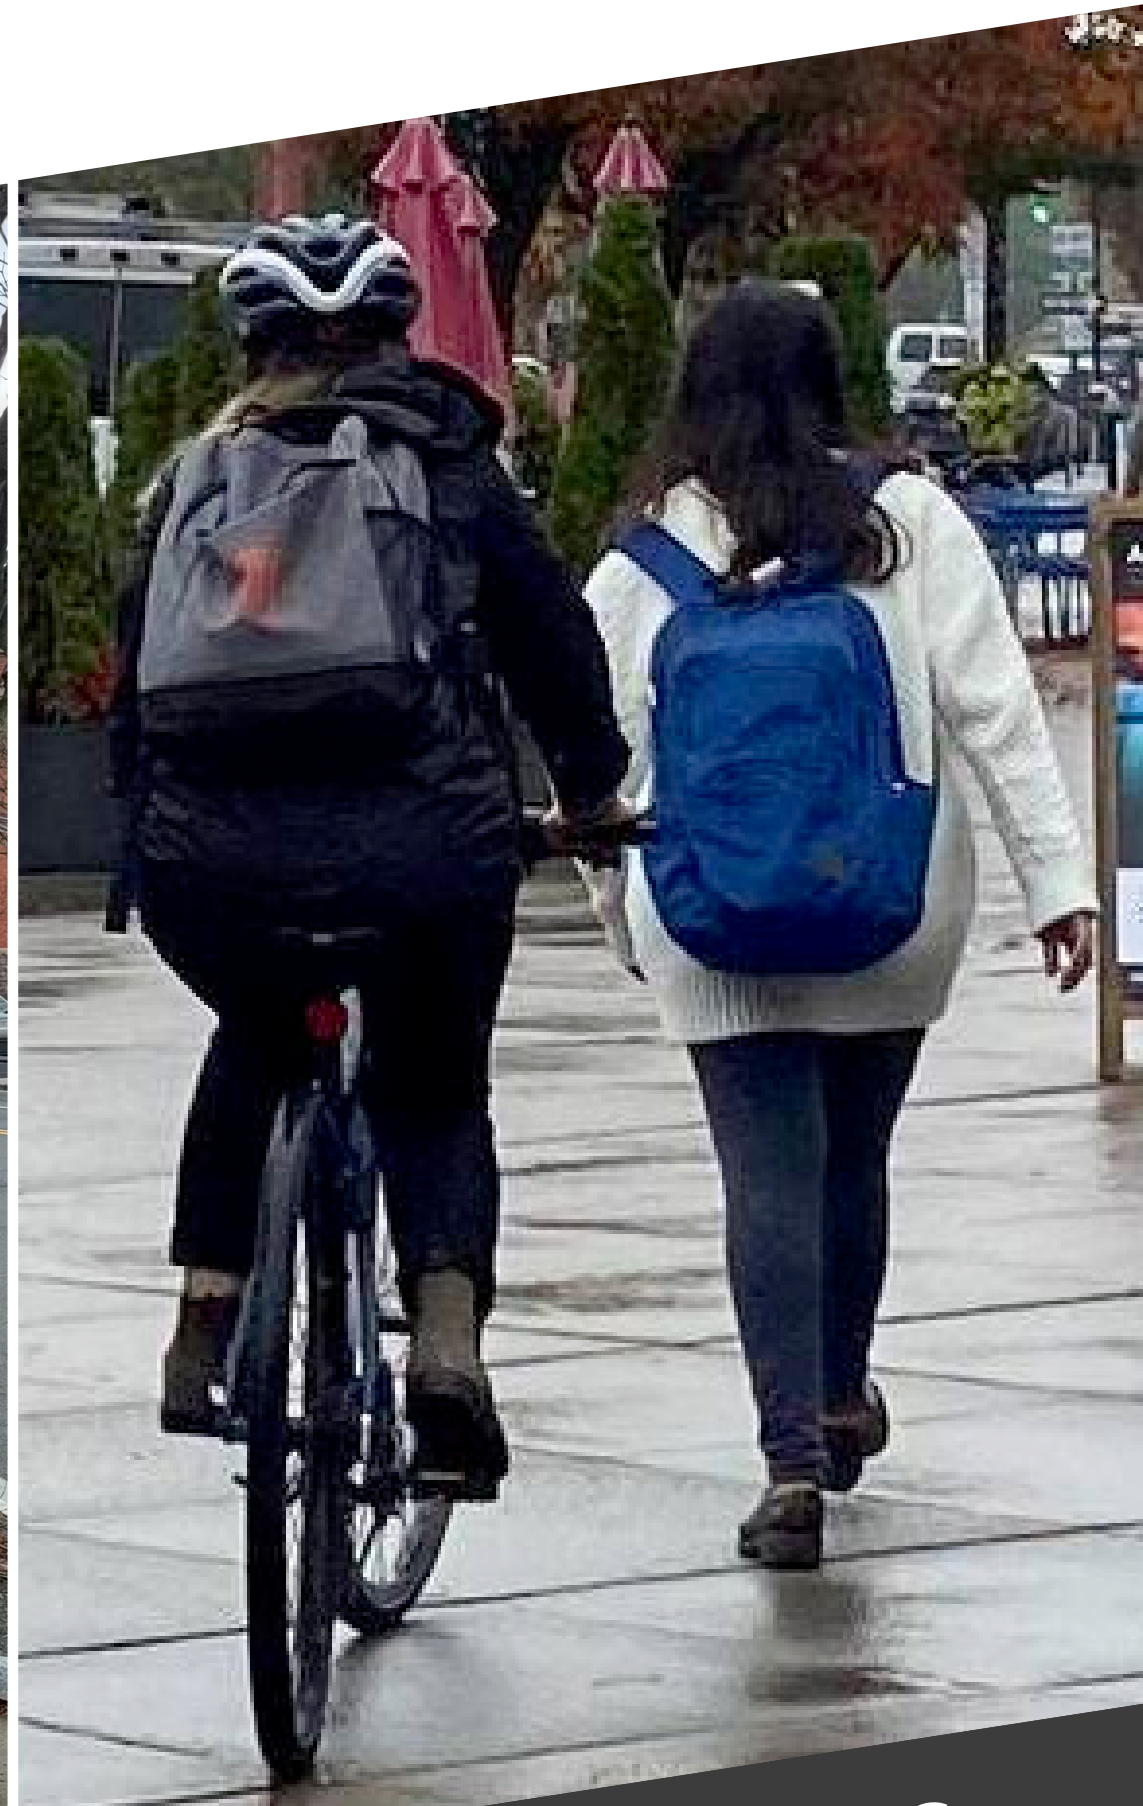
INFLUX OF BIKES AND SCOOTERS ON SIDEWALK

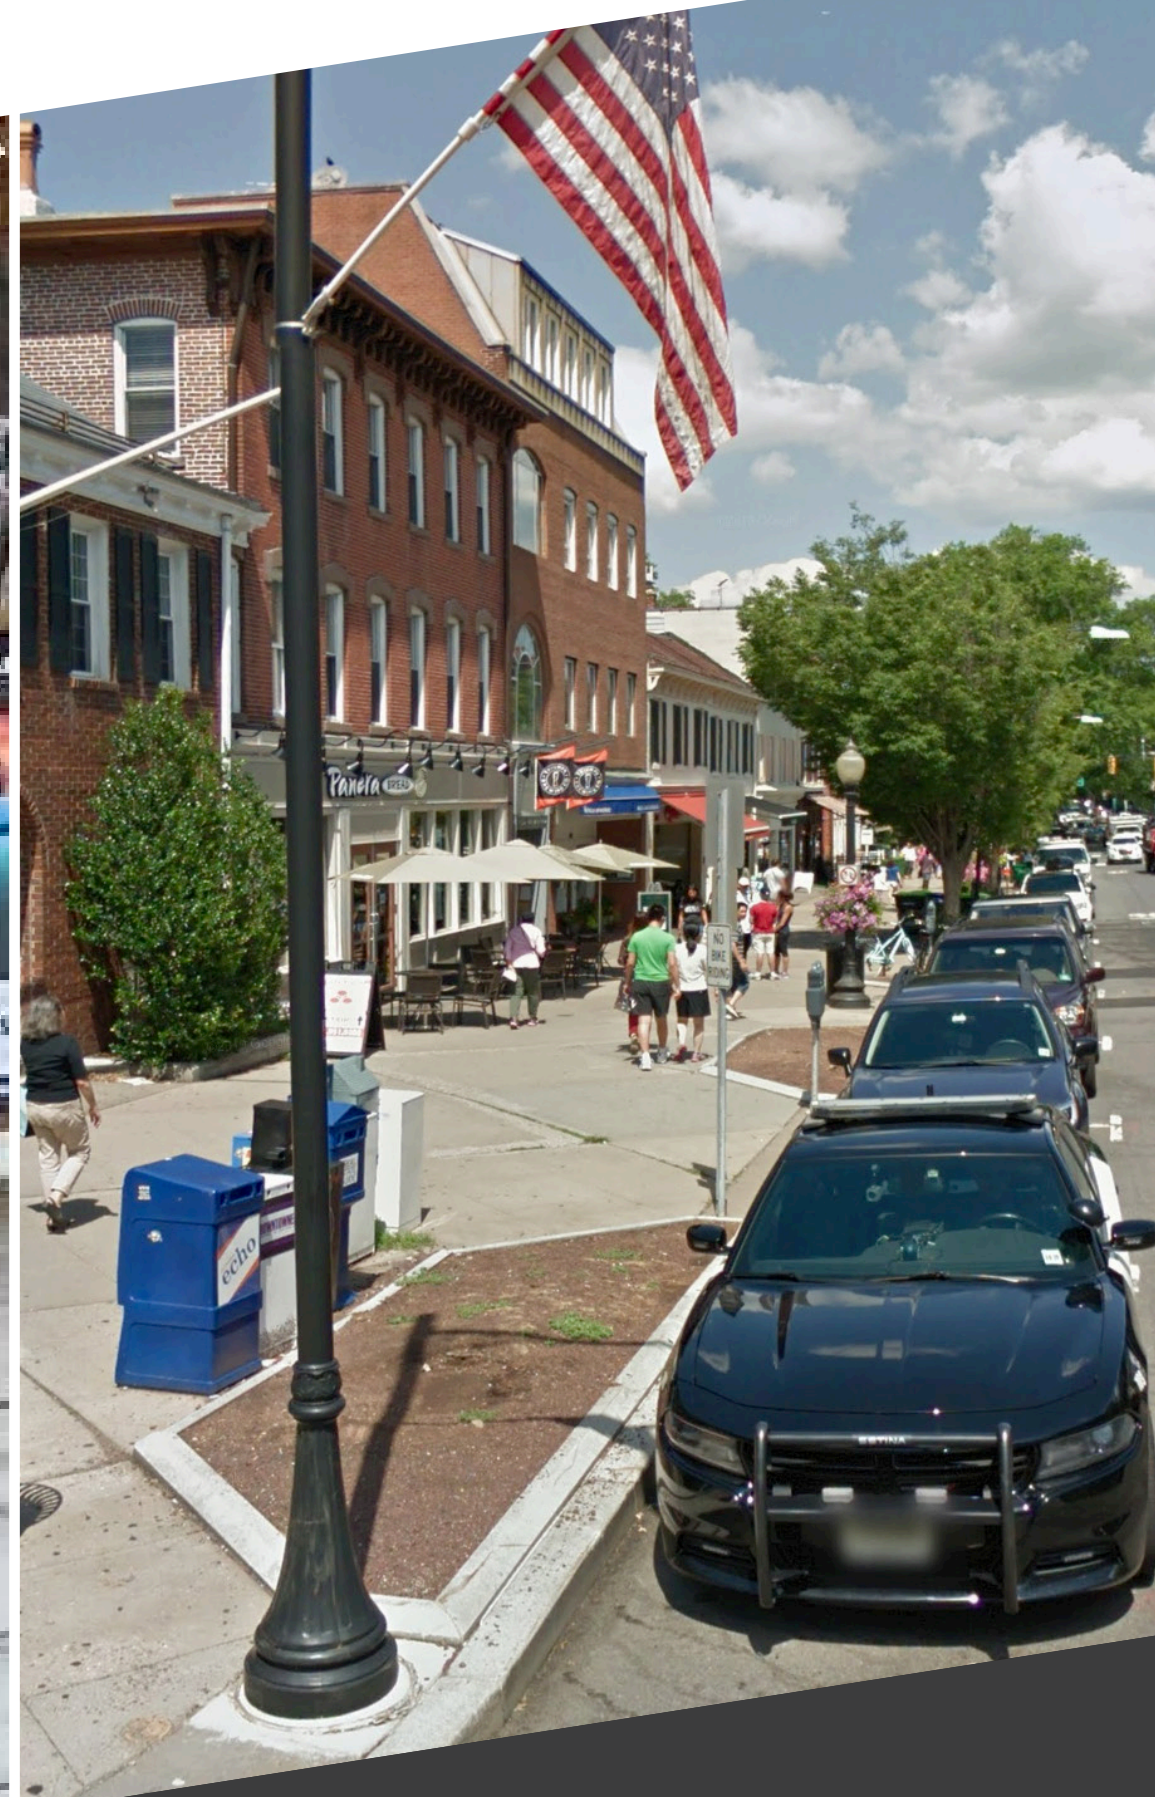
MISSING TREE CANOPY

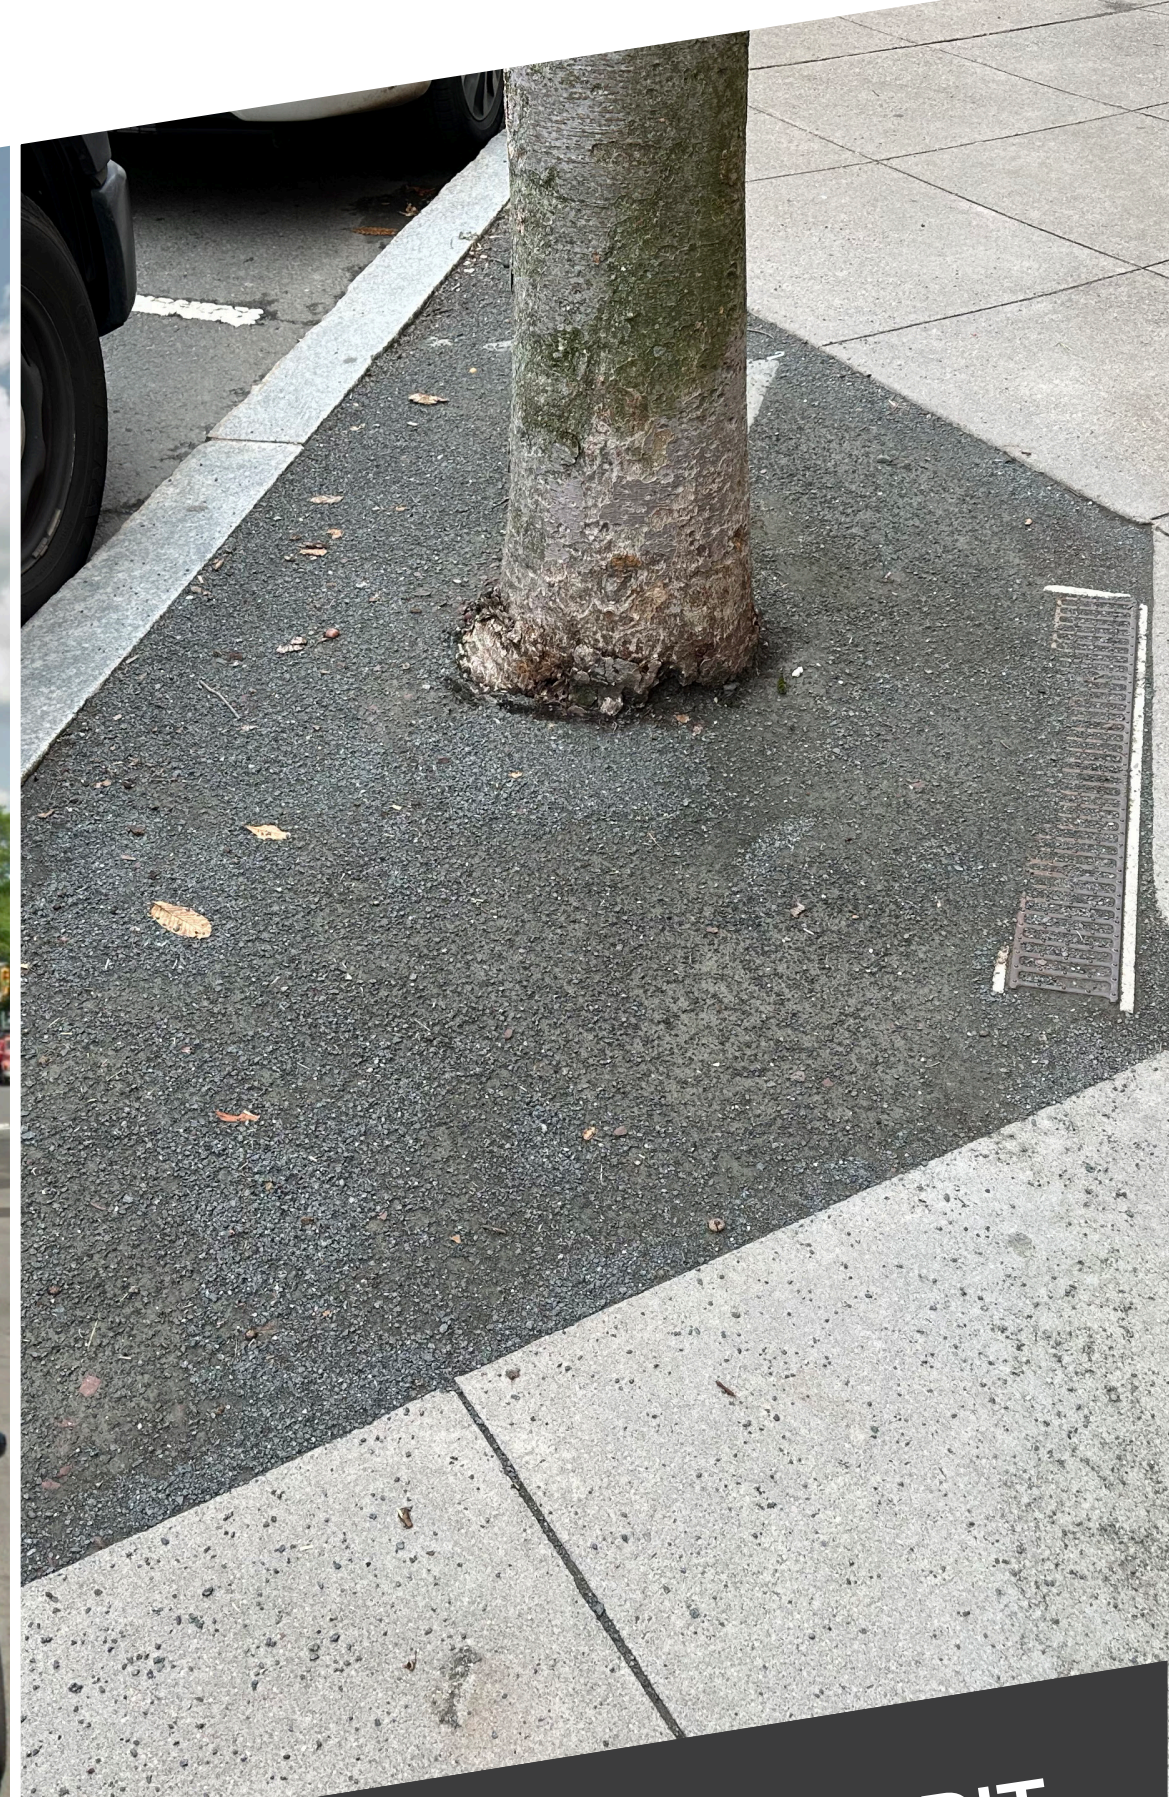
IMPERVIOUS TREE PIT CONDITION

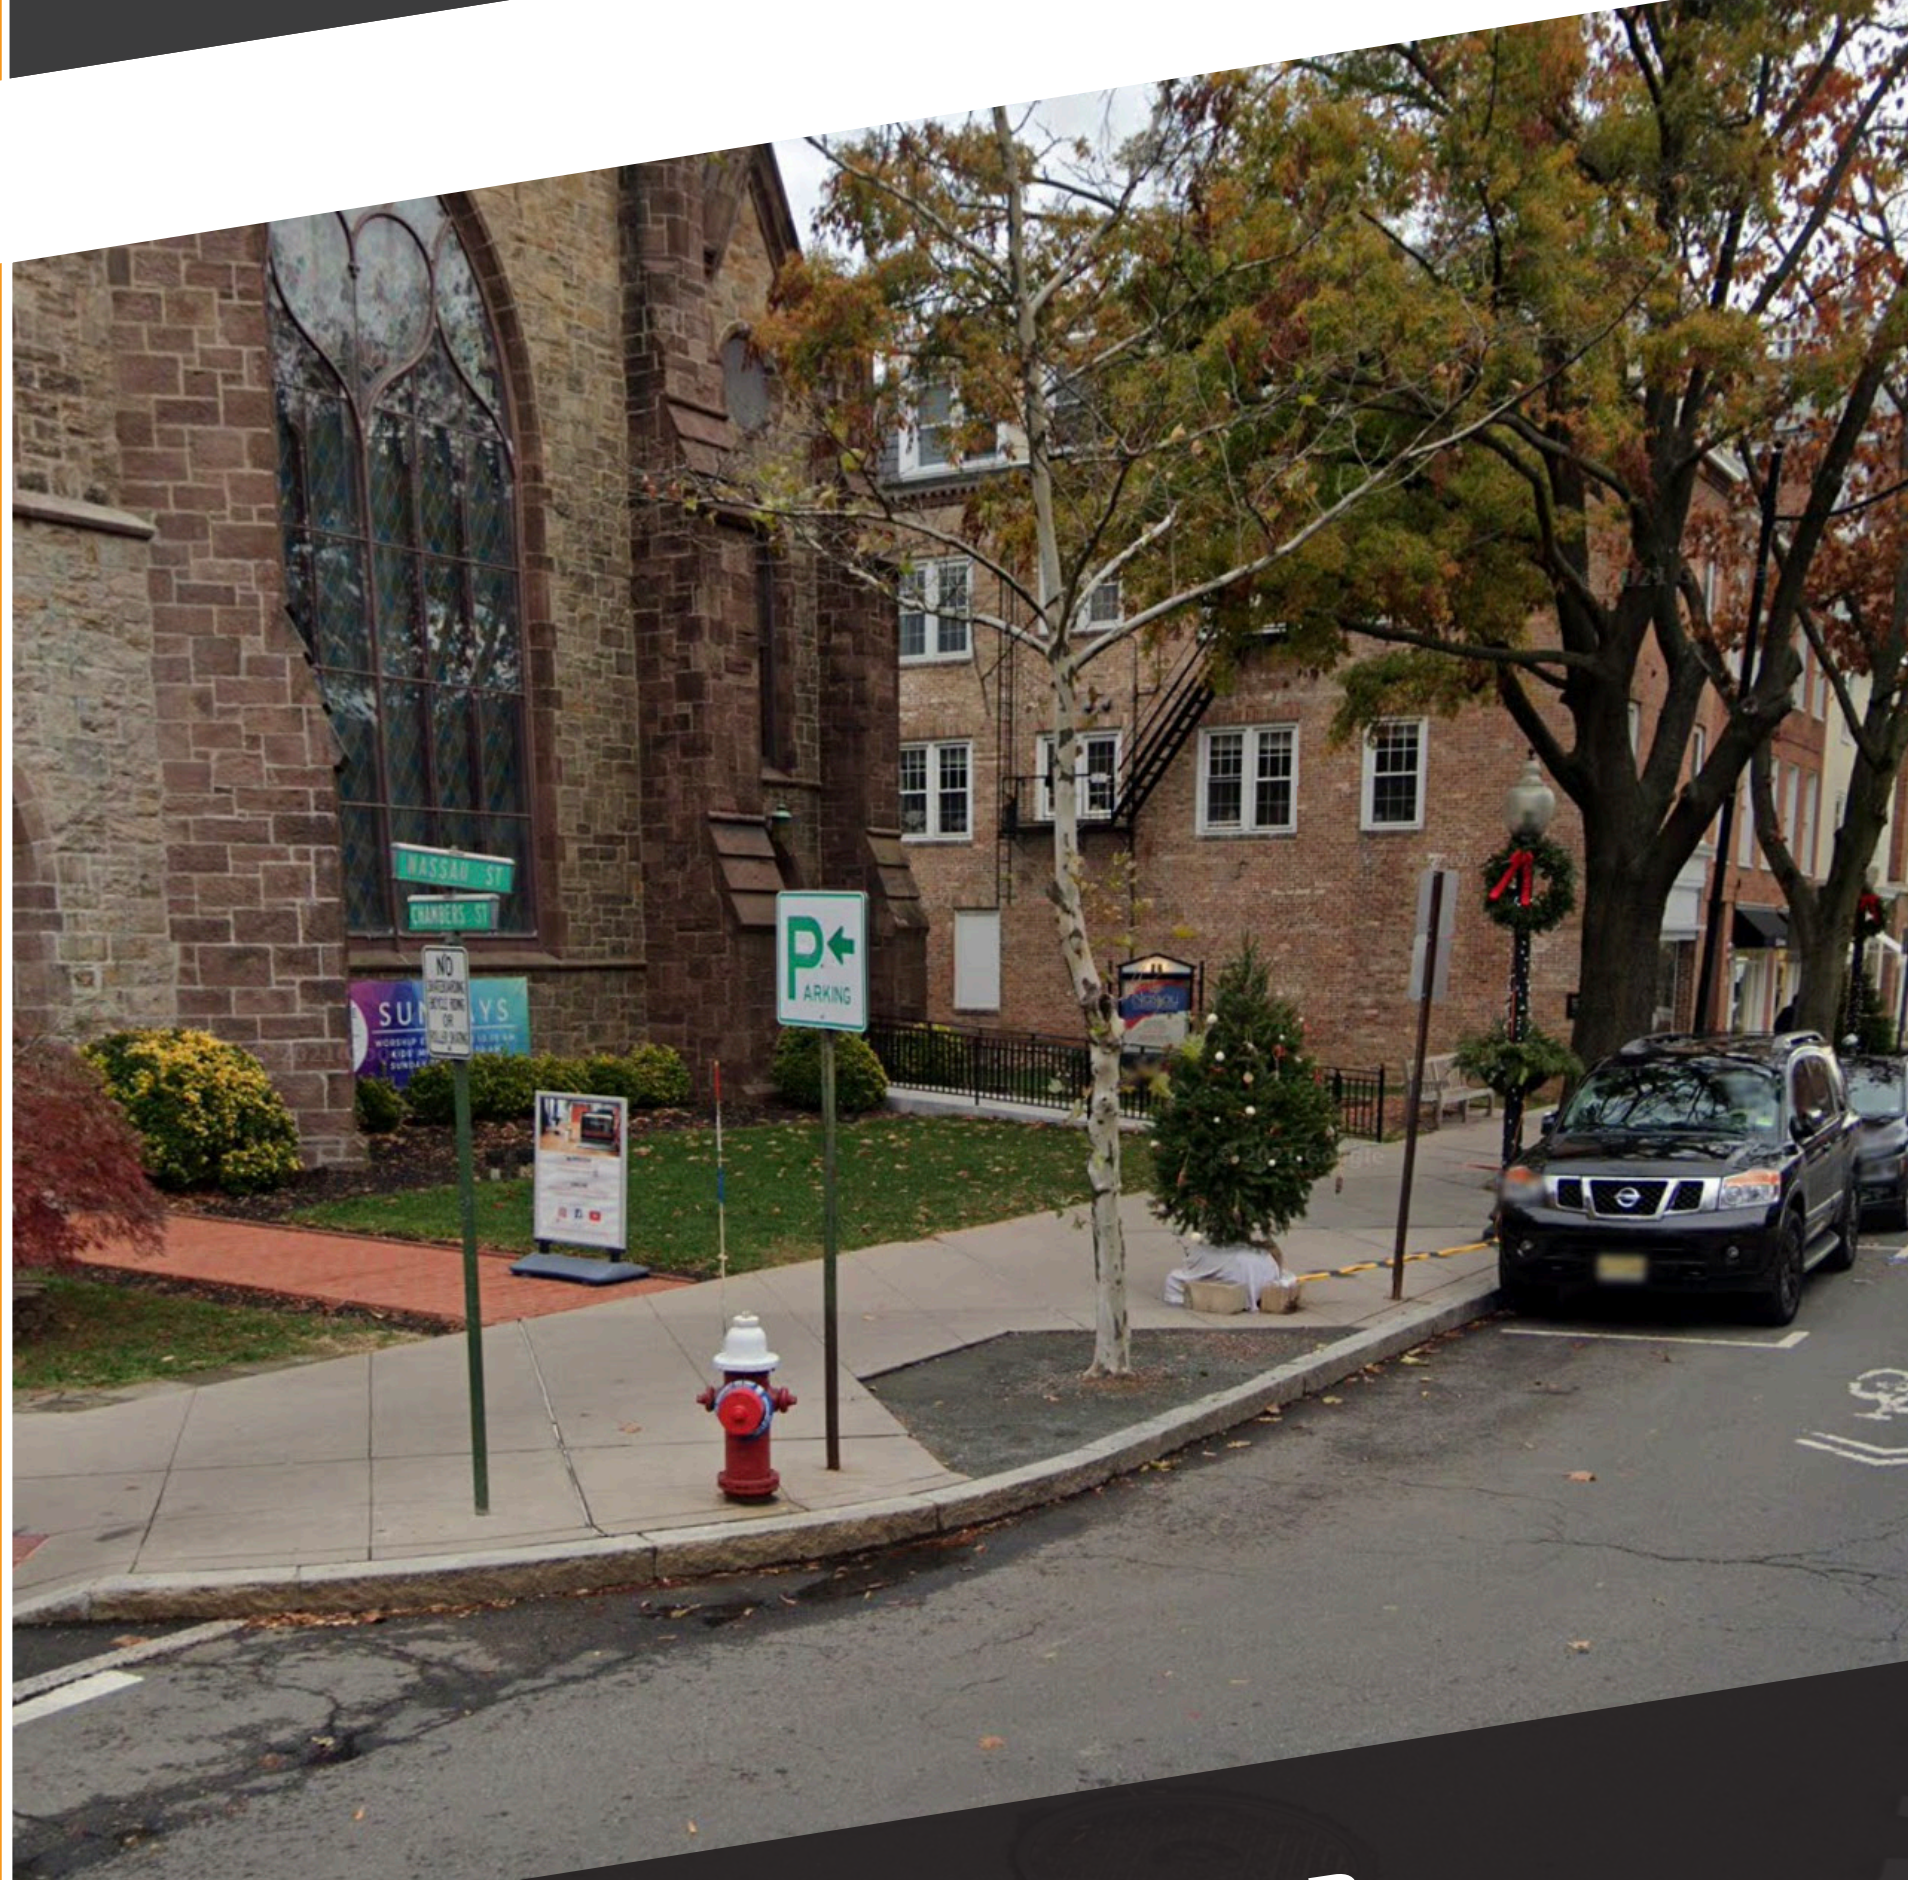
OPPORTUNITY FOR CURB EXTENSIONS AT CORNERS

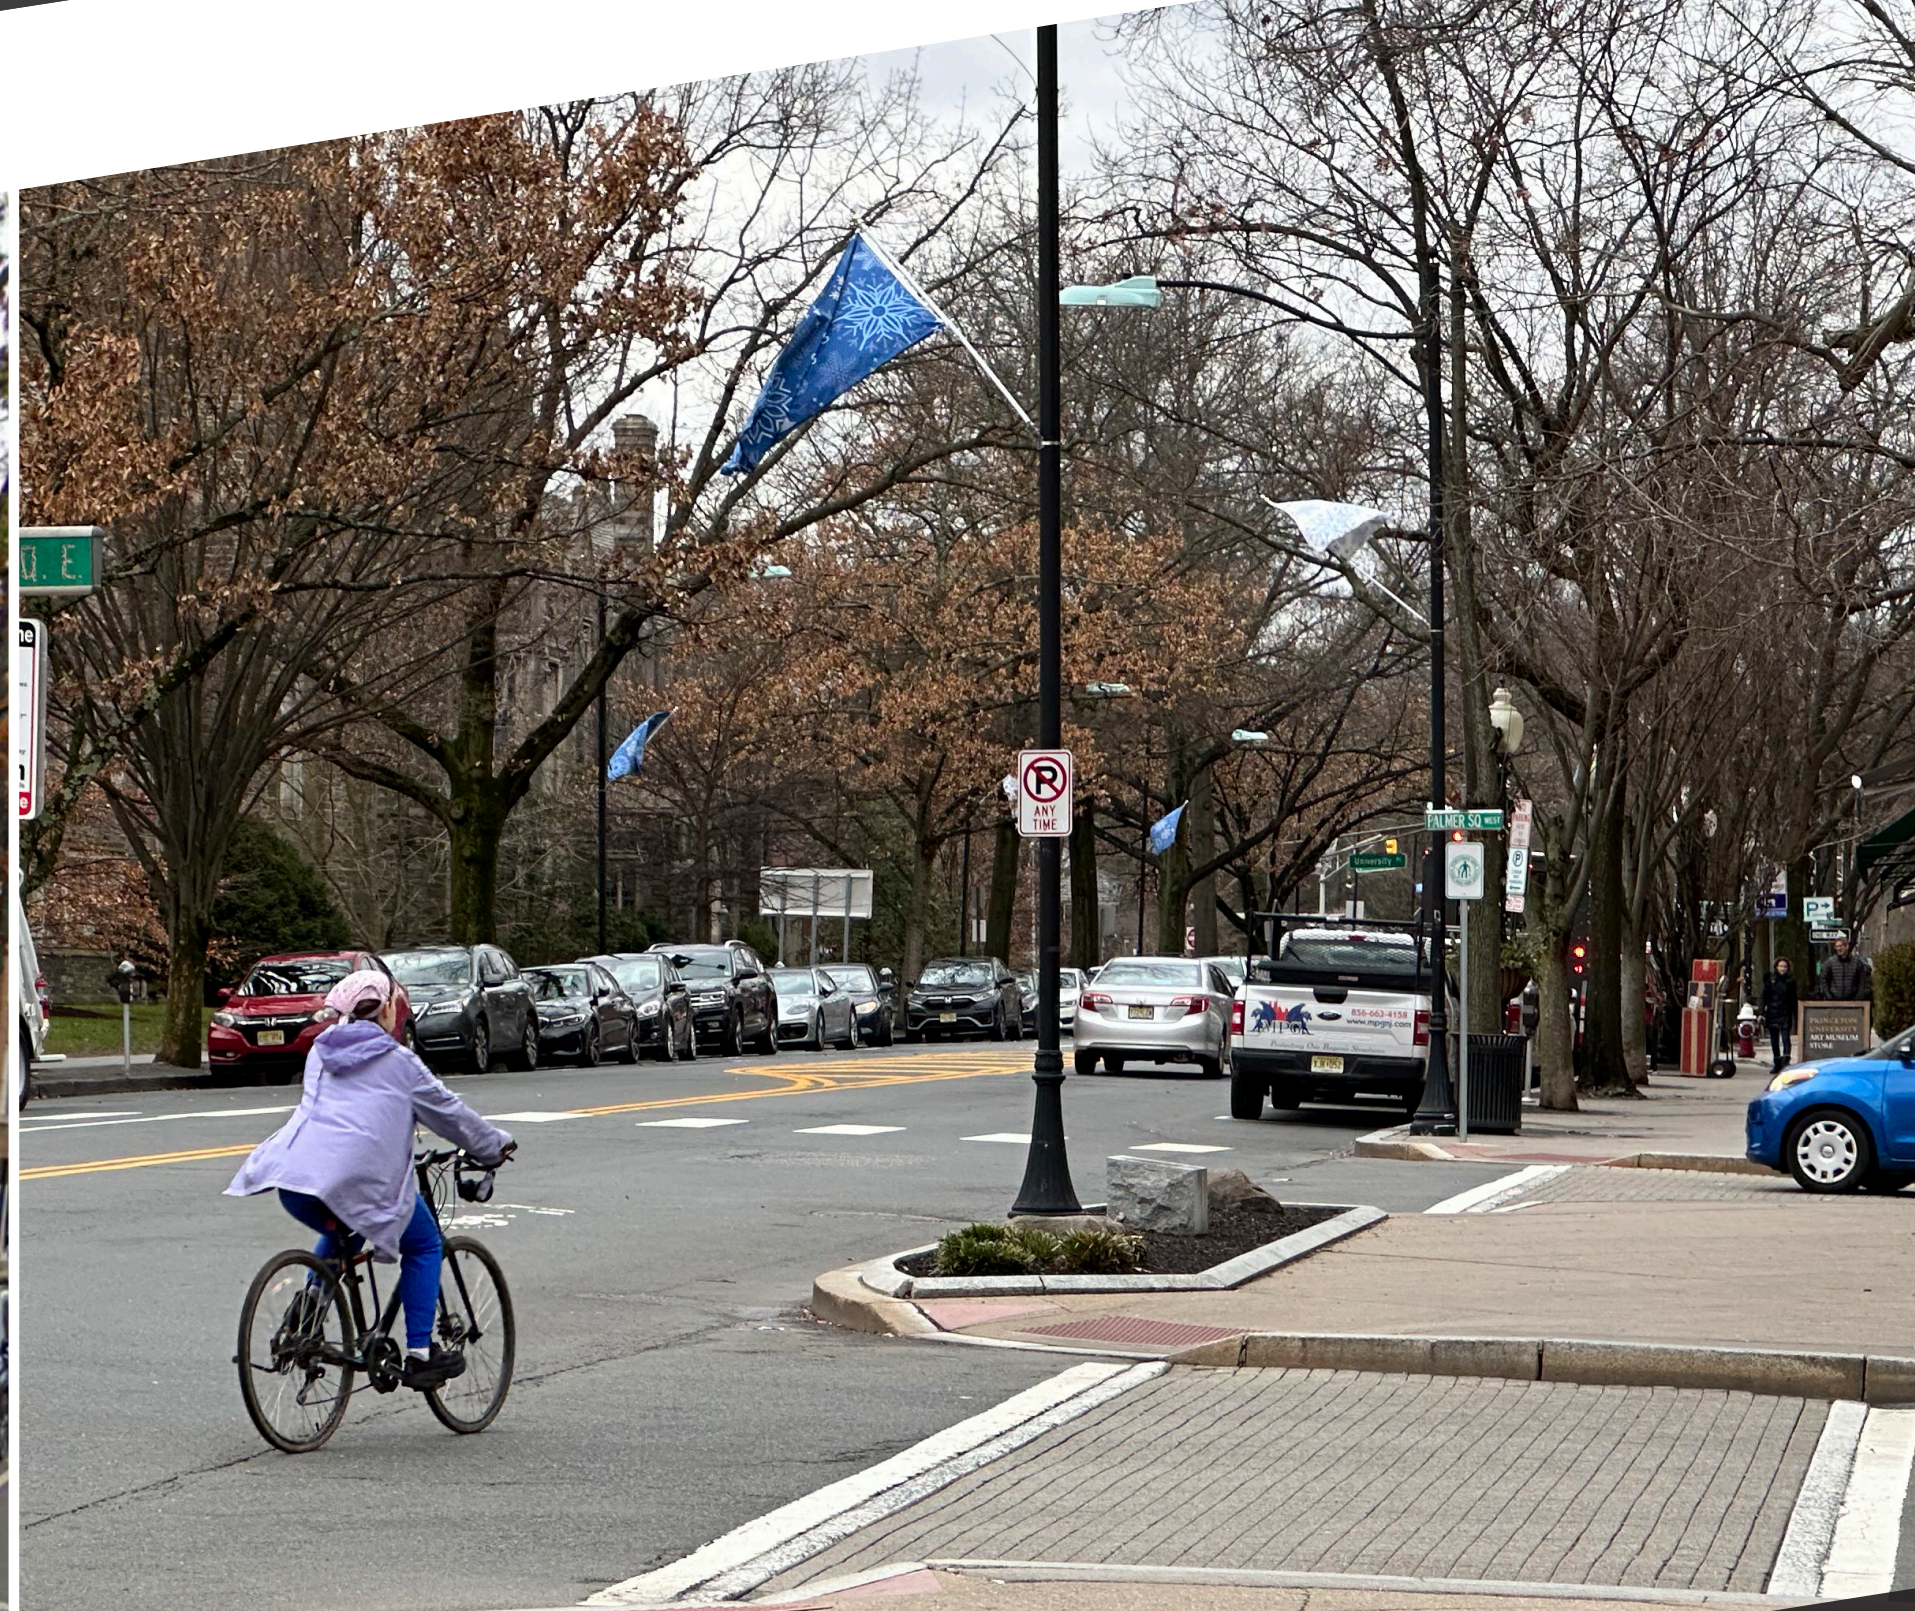
LACK OF BICYCLE INFRASTRUCTURE

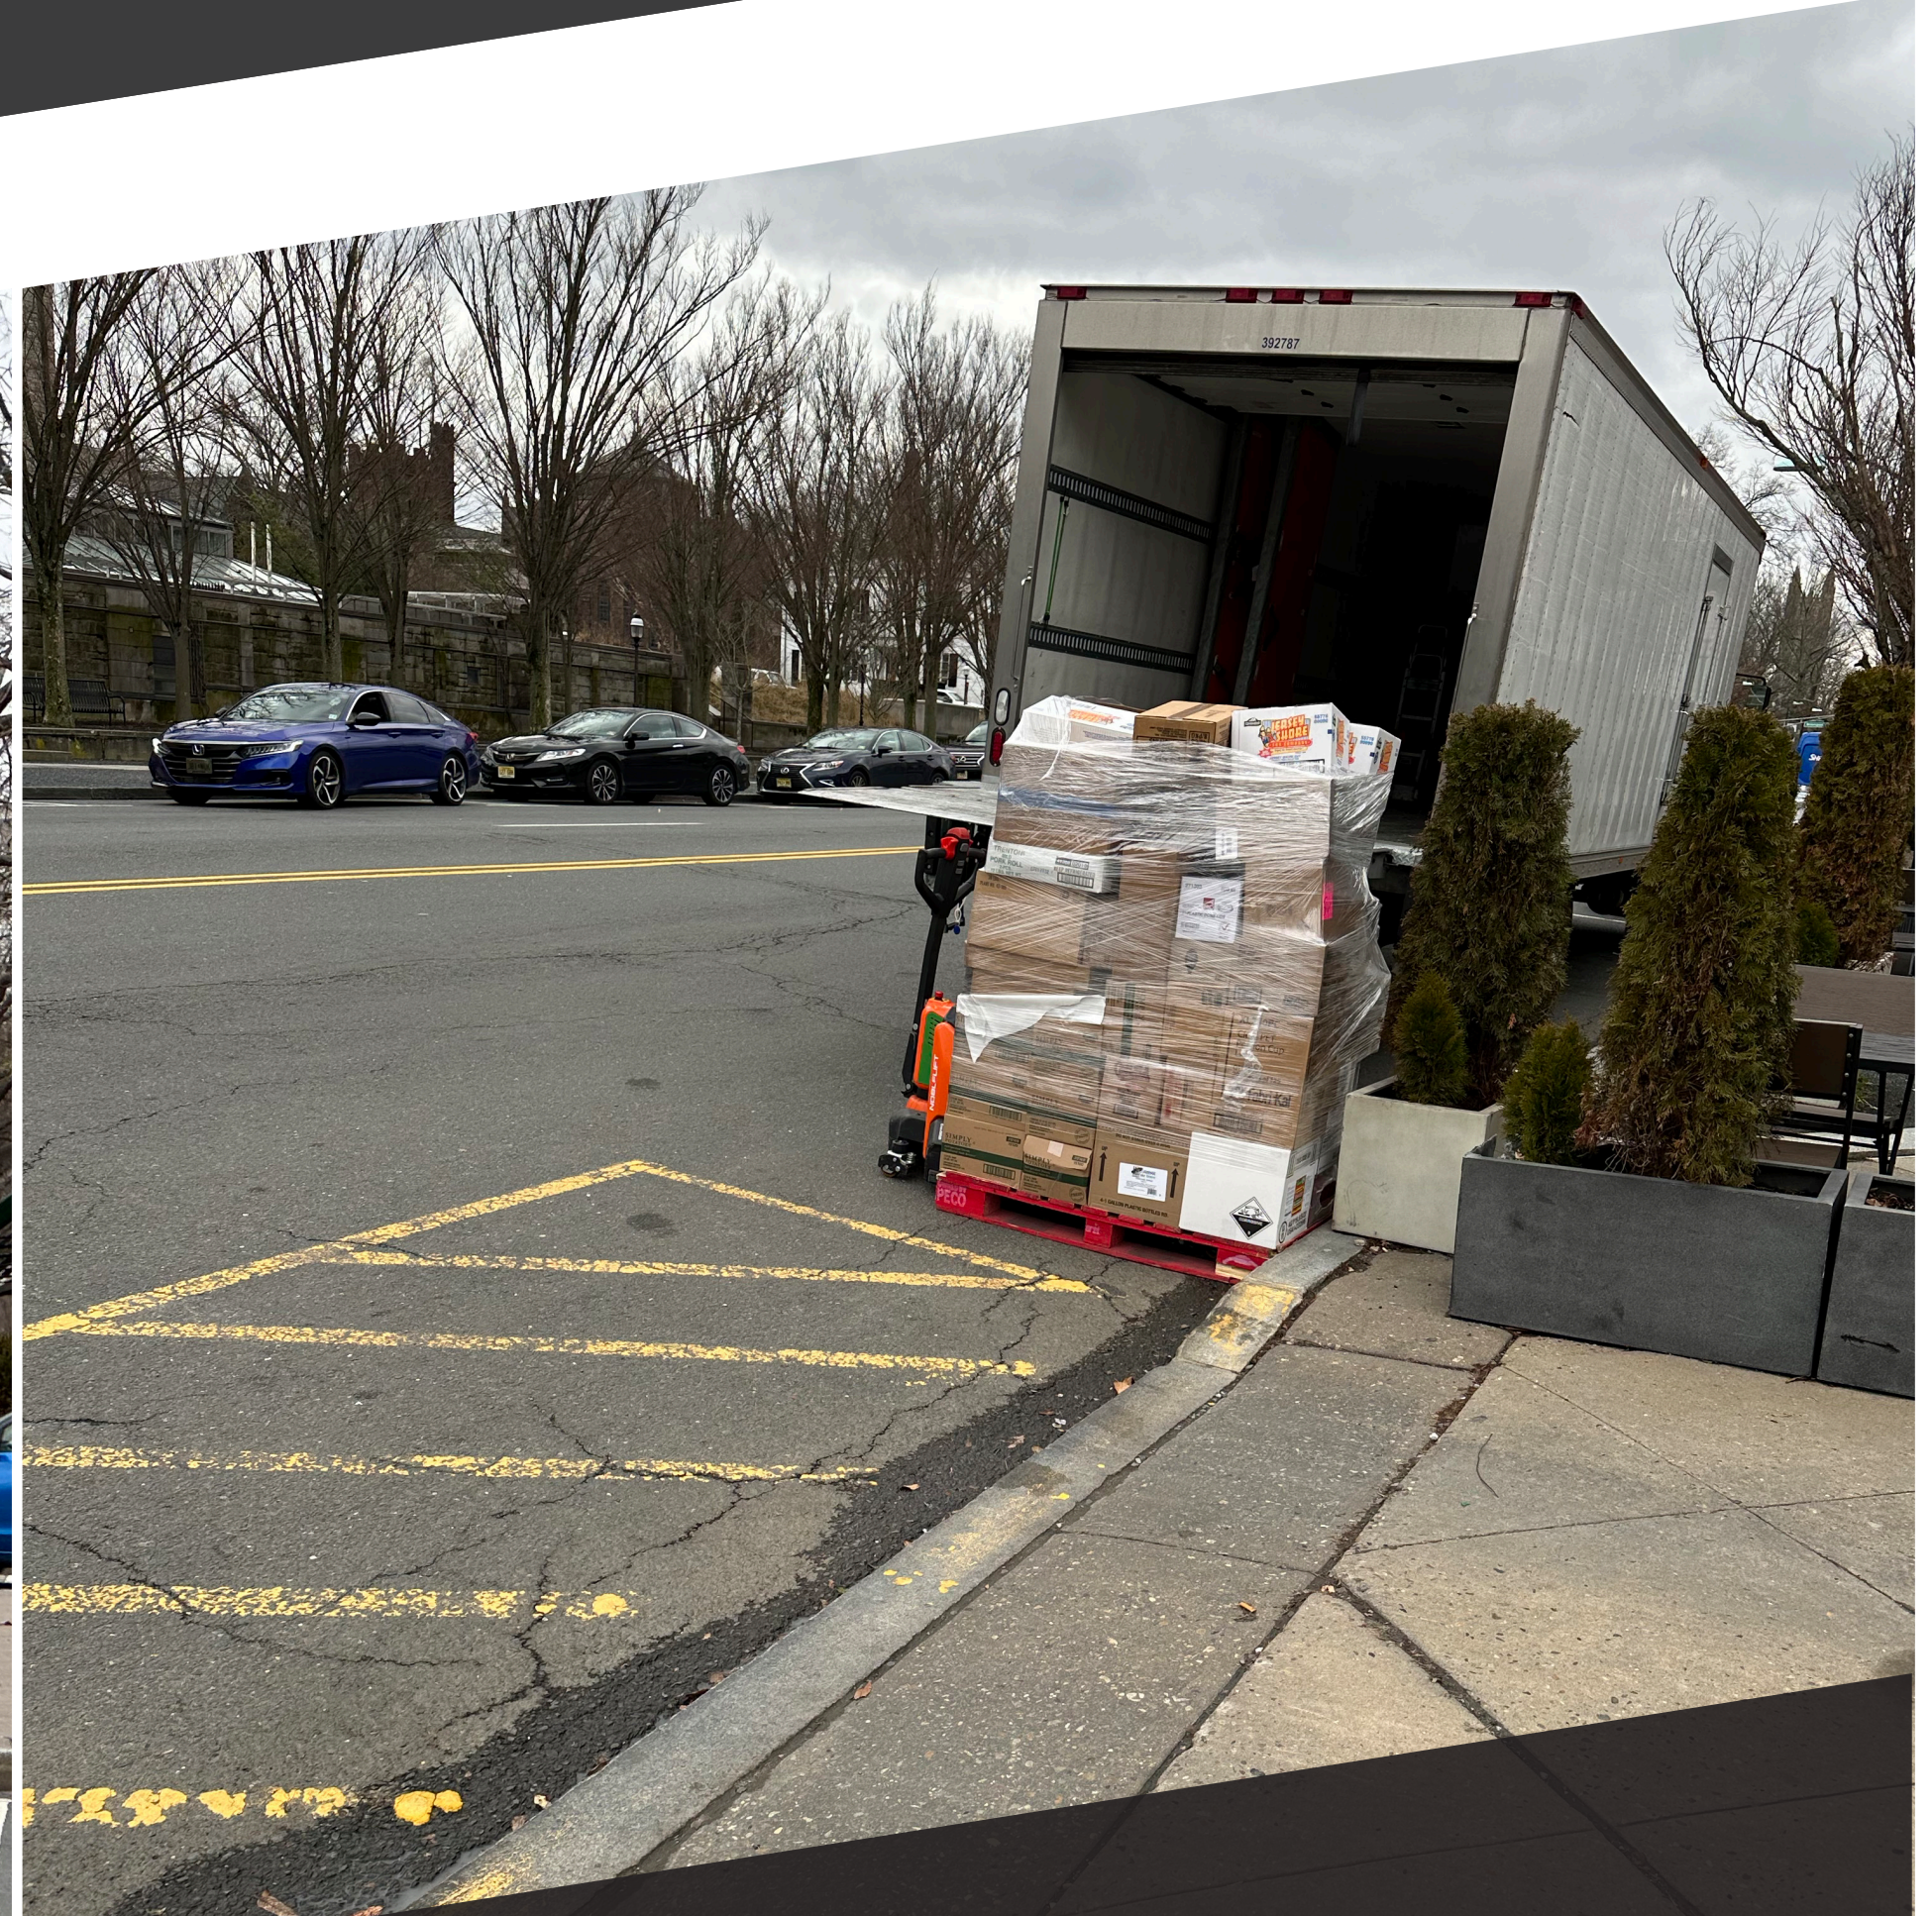
LOADING ZONES
