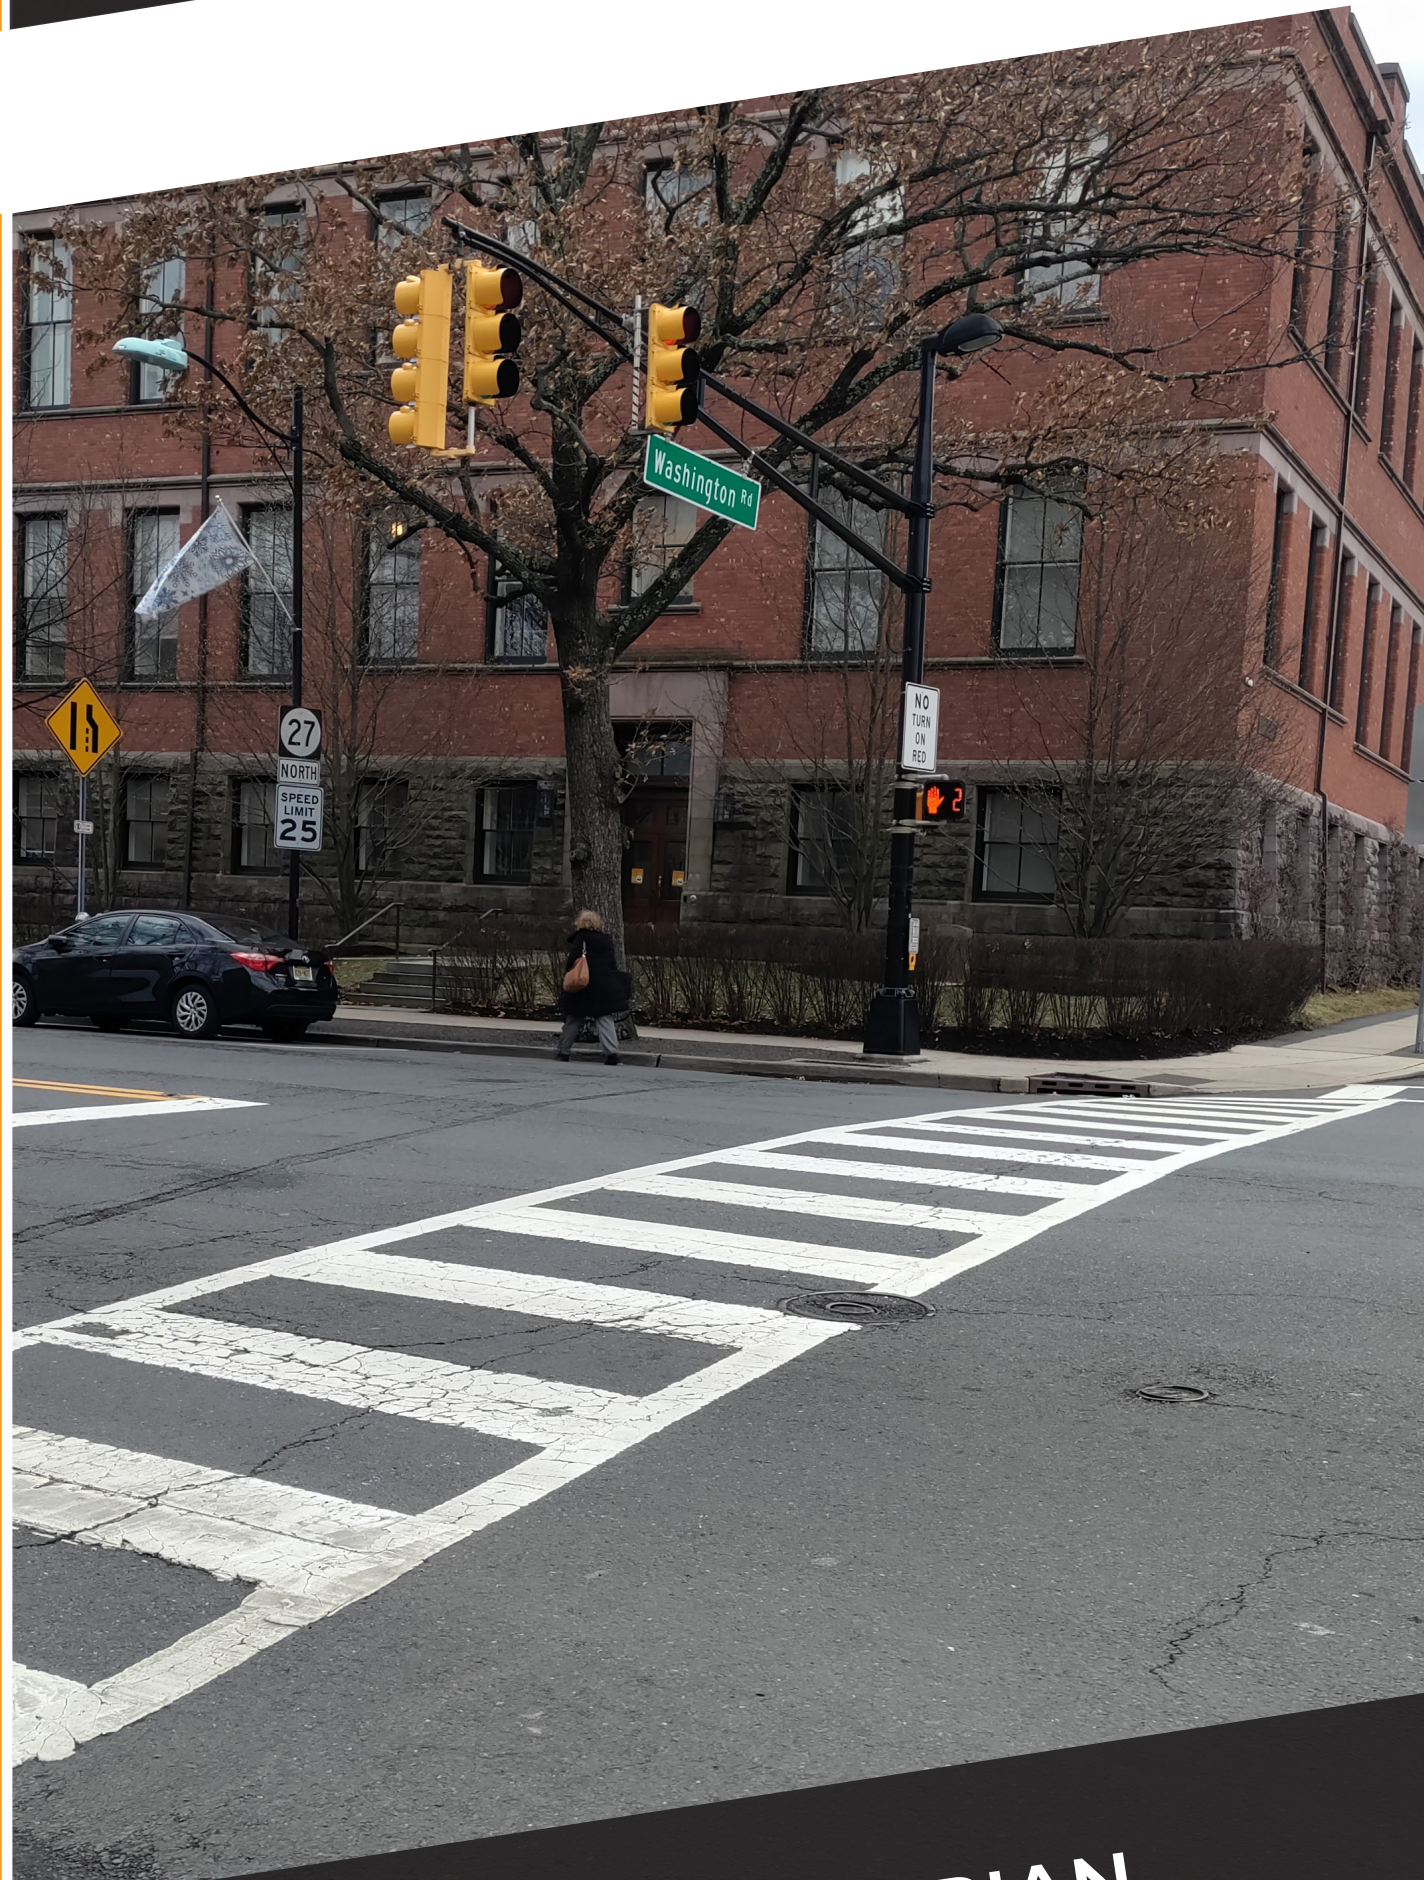
LONG PEDESTRIAN CROSSINGS

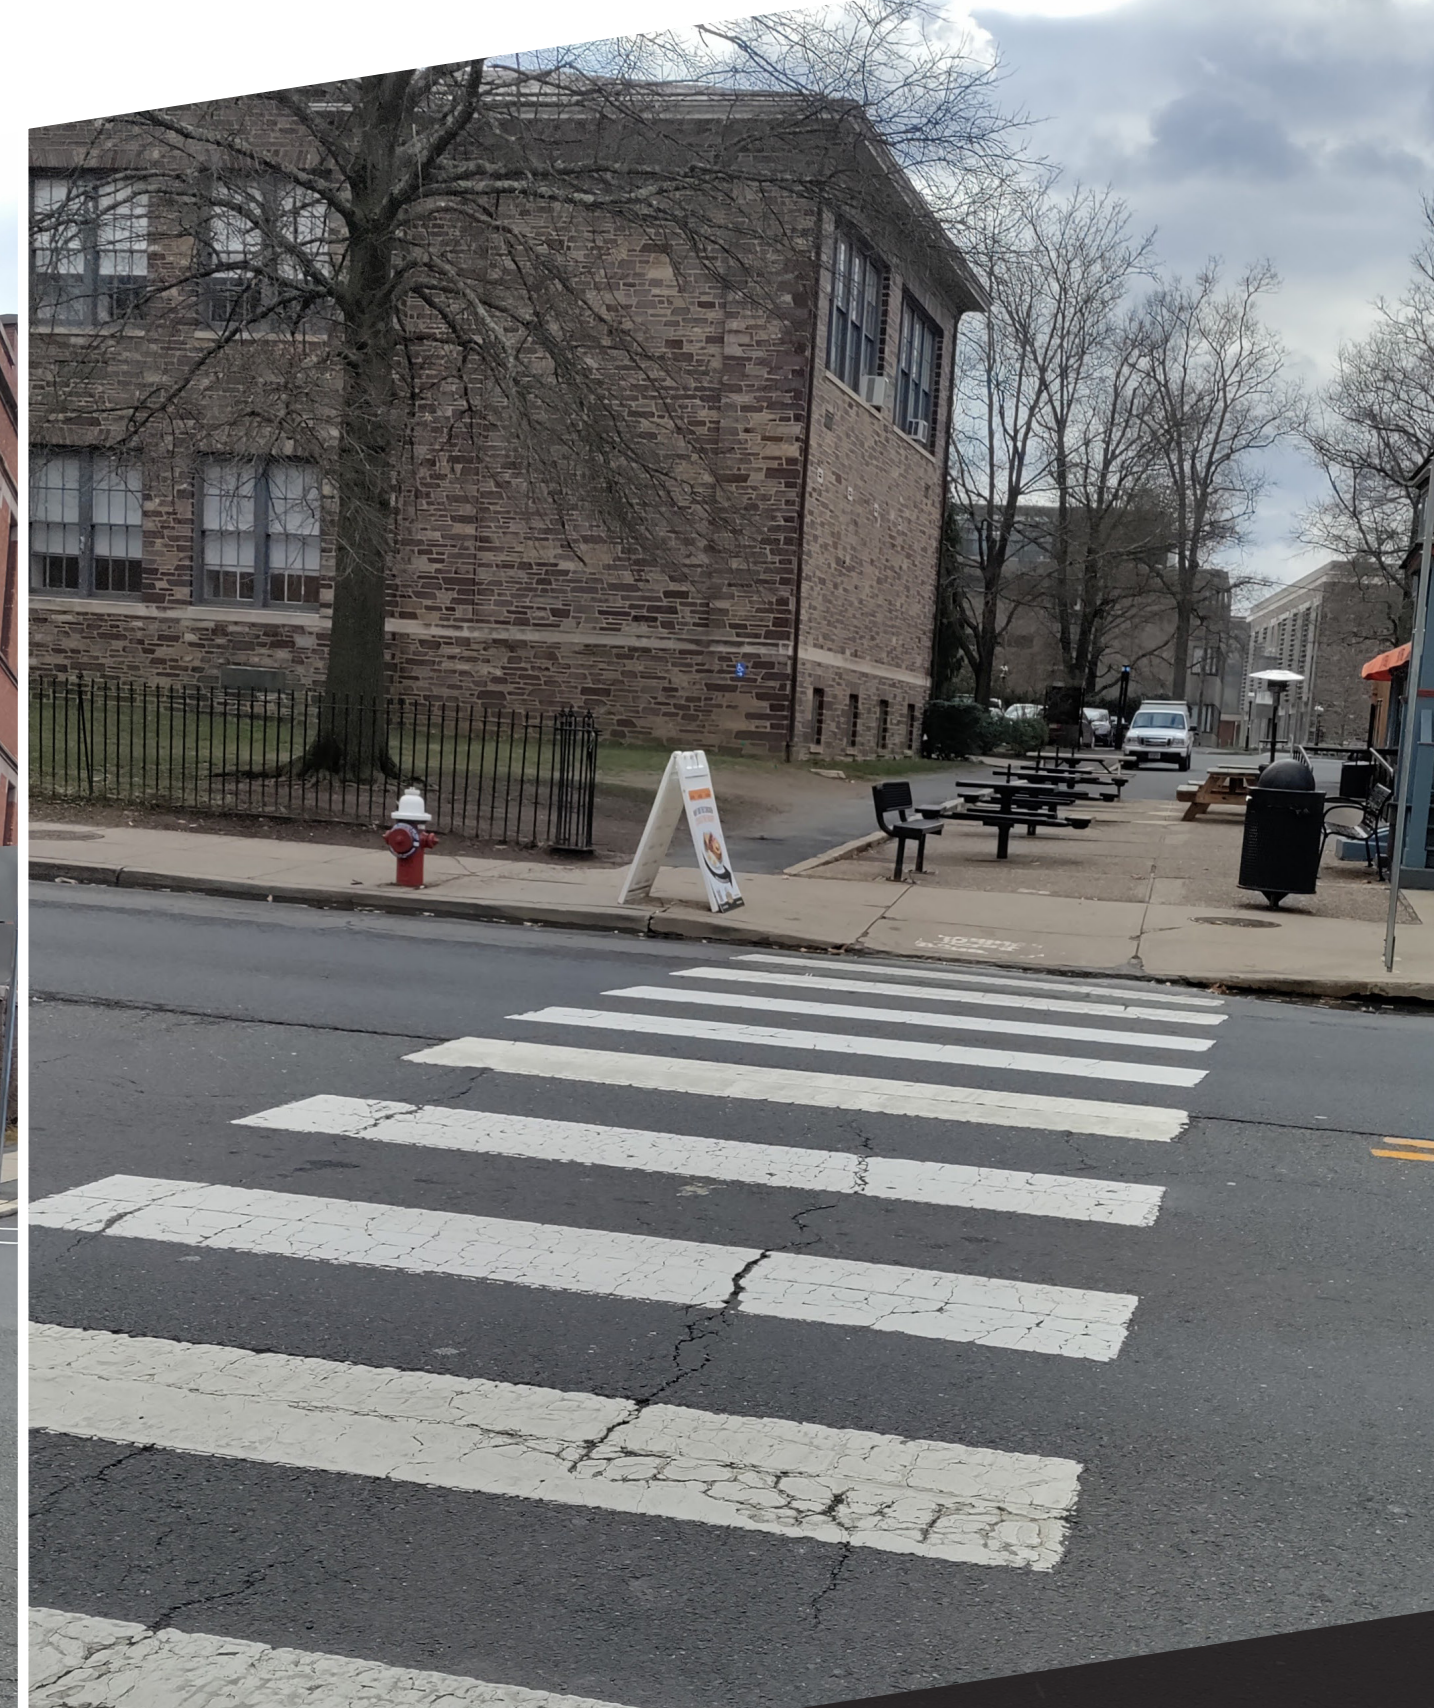
MIDBLOCK CROSSINGS

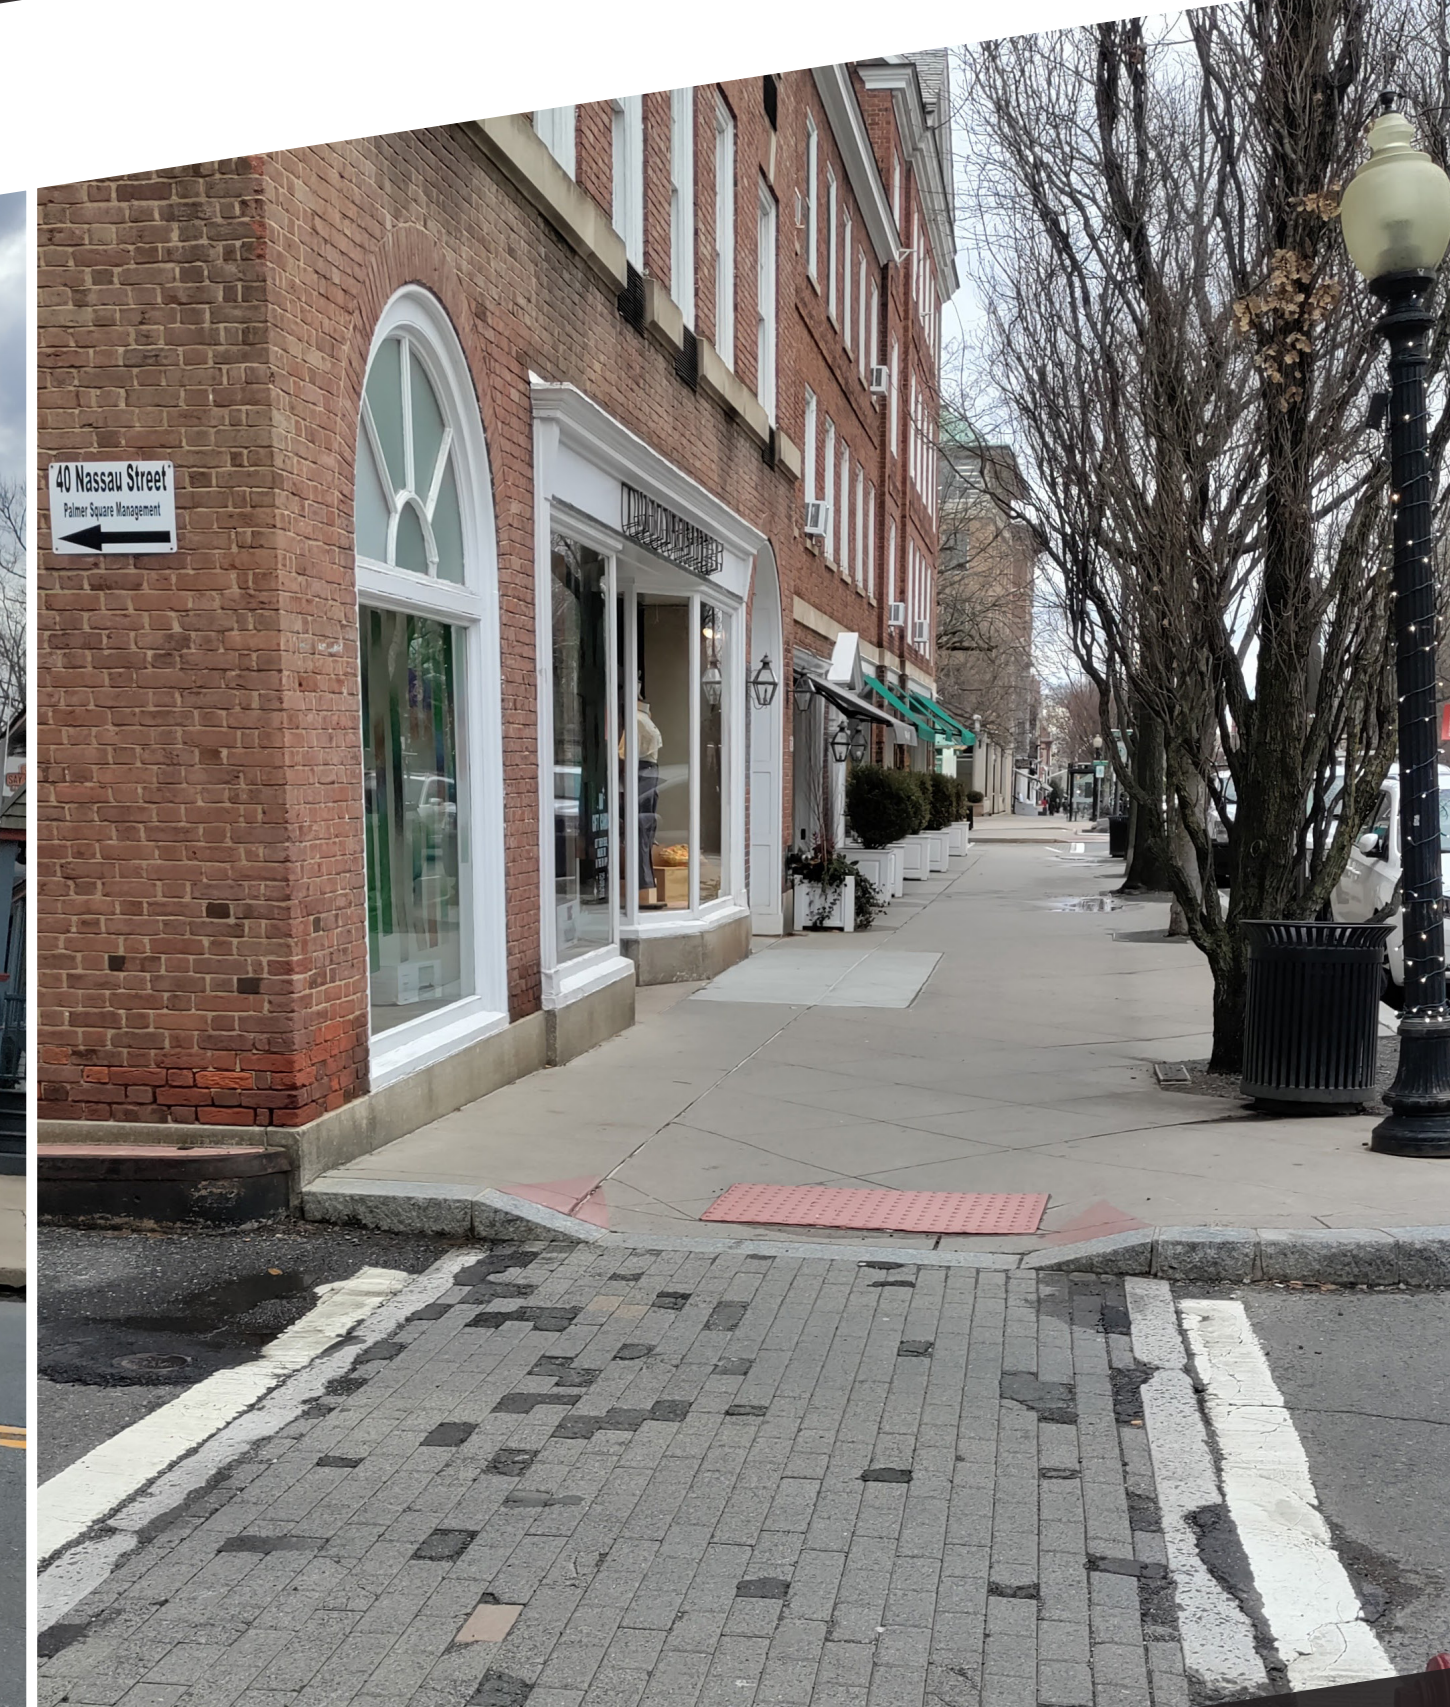
CROSSWALKS IN POOR CONDITION

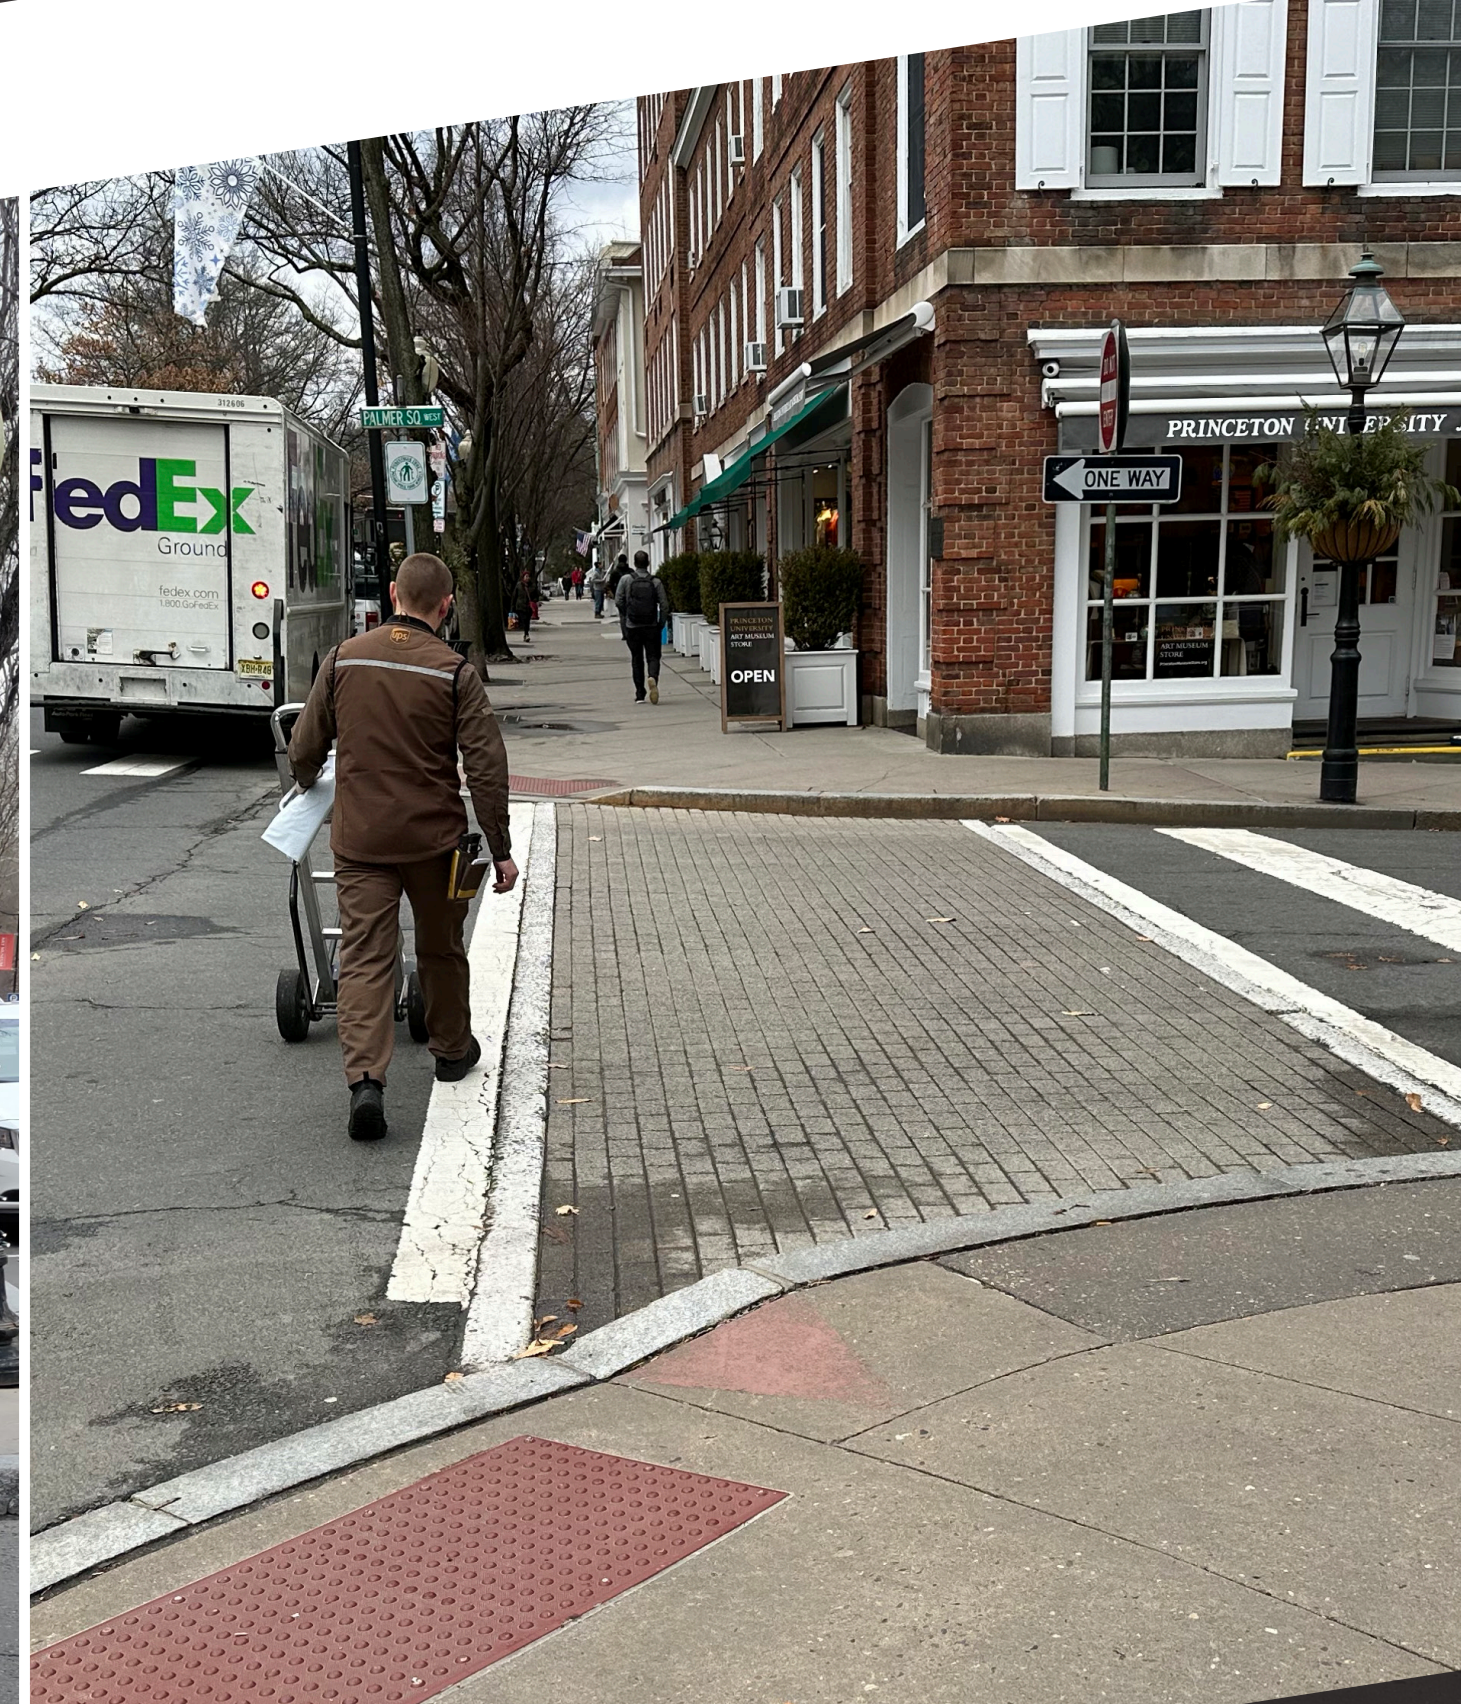
MISALIGNED CURB RAMPS
