FORT GORGES CASEMATE STABILIZATION AND WESTERN VIEWING AREA ACCESS IMPROVEMENTS

ASSESSMENT REPORT AND COST OPINIONS

PERFORMED FOR
CITY OF PORTLAND, MAINE PLANNING DEPARTMENT
389 CONGRESS STREET
PORTLAND, ME 04101

SEPTEMBER 26, 2017

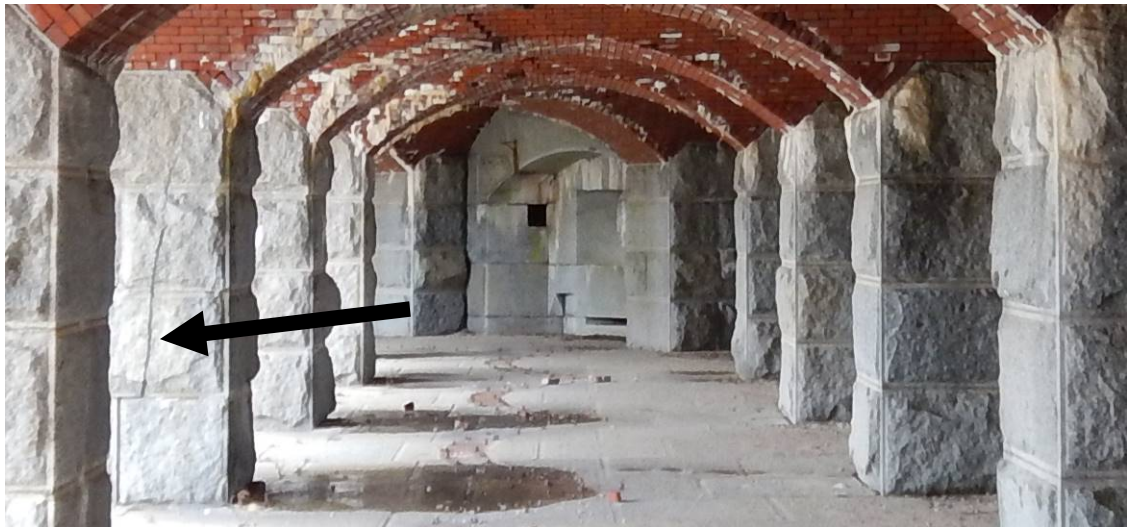
- In many places, the parade level (Tier 1) floor has subsided and is uneven, most likely a result of initial imperfect subgrade compaction and erosion of fine soil particles through the exterior masonry walls on Faces 1 through 5, and through any failures in the fort drainage system. A site survey should be planned to determine elevations of floor stones at specific locations, to determine settlement and movement patterns.
- Some of the granite Parade Wall piers have cracked, presumably because of frost action or settlement. Technology has improved significantly, and it may allow for a drain camera inspection to determine the condition of the drain pipes that travel downward through the Parade Wall piers.

Crack in First Floor Casemate Pier on Parade Ground Wall

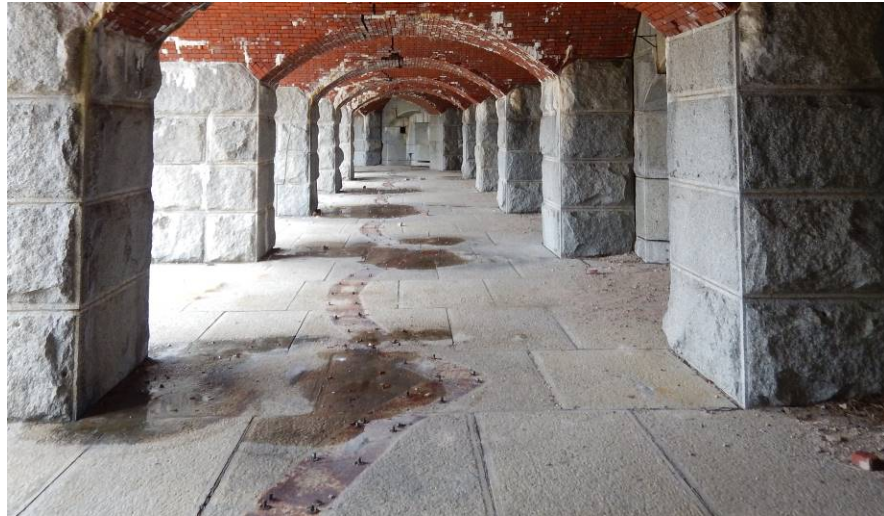
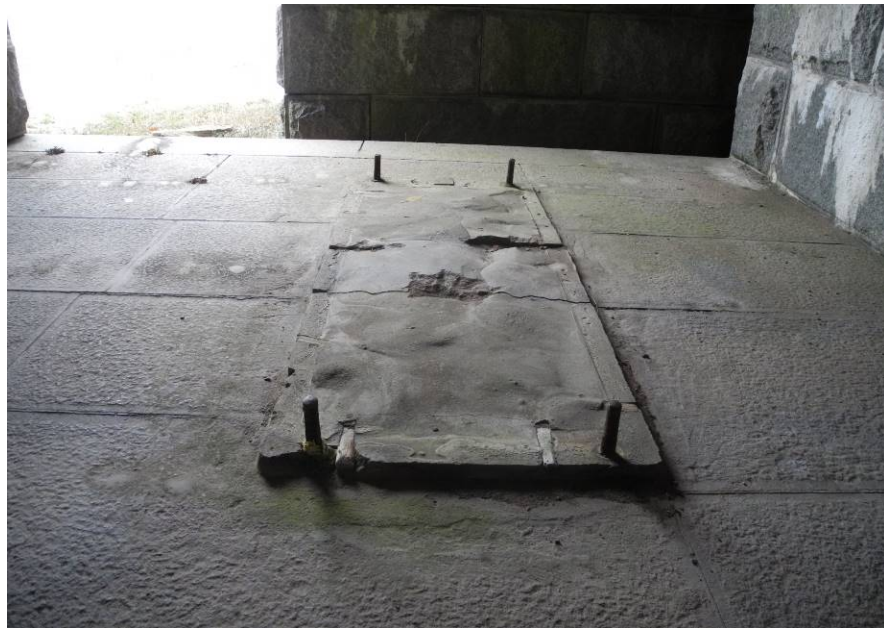
- Iron arc-shaped cannon carriage mounting plates have largely been removed and scrapped, leaving nothing but their rust shadows and protruding bolts extending from the granite floor (Photo #). While we recognize that the extending bolts constitute a tripping hazard, we do not believe that they should be further cut back, despite the fact many visitors enter the fort wearing little more than water shoes, flip flops, or sandals for foot protection. The iron bolts remain as an important engineering element germane to the fort's intended use.

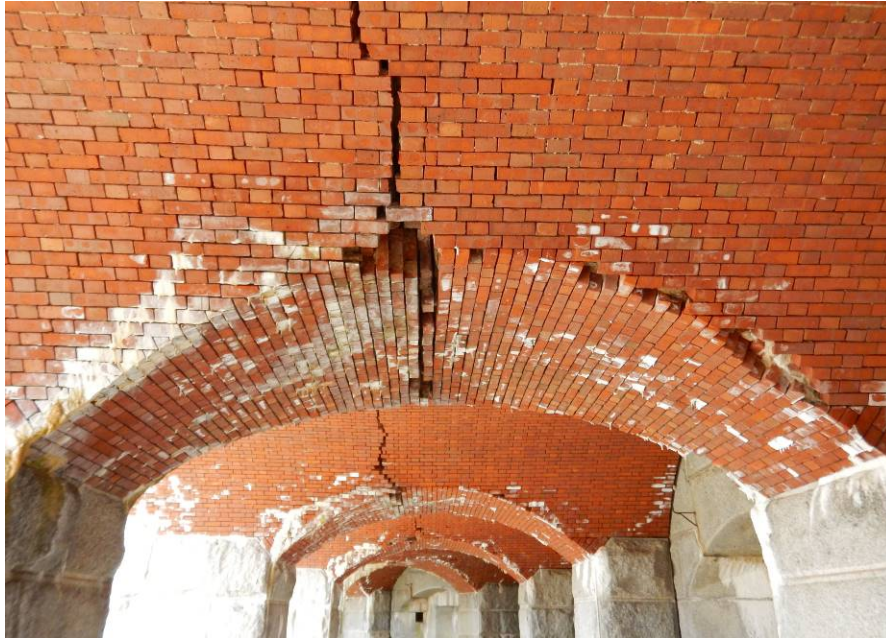
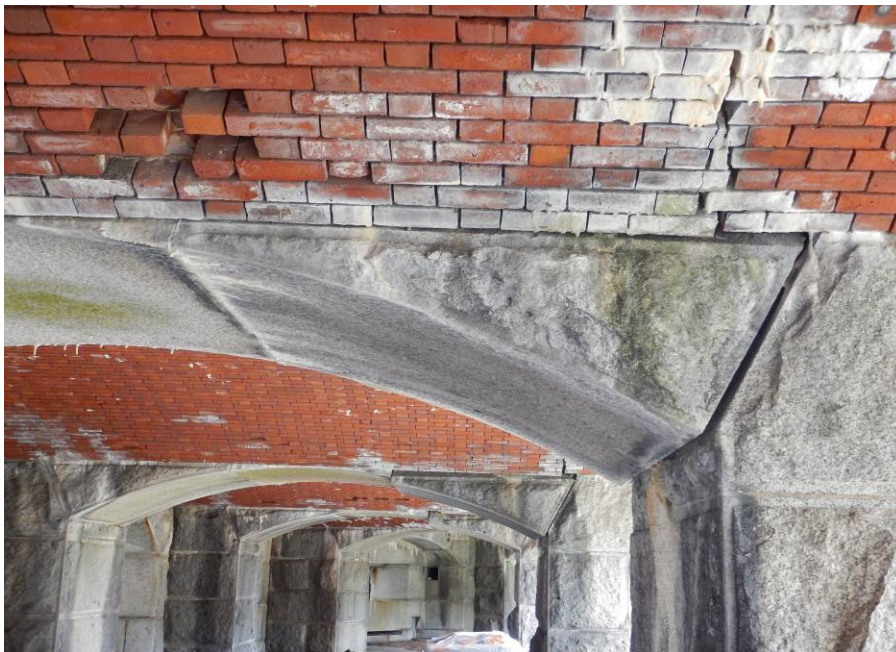
- A series of primarily circumferential cracks traverse the casemate roof arches on both the parade level (Tier 1) and the second level (Tier 2). The cracks appear to begin near the intersection of Faces I-II and wrap around to the intersection of Faces IV-V. We believe that a combination of factors caused these cracks, which we have also seen and stabilized at Fort Popham in Phippsburg, a “sister fort” that guards the mouth of the Kennebec River.

Top photo: First Tier circumferential crack; bottom photo: Second Tier circumferential crack.

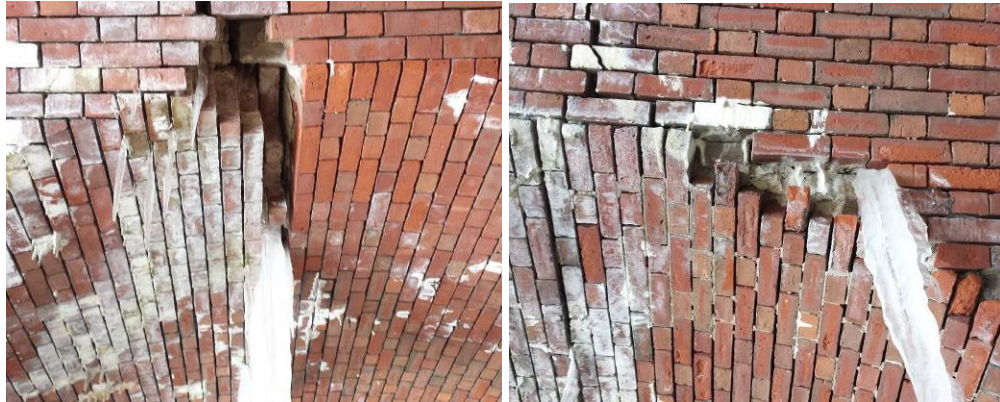
- In many locations, brick masonry has been damaged and is loose or already fallen out. Sound loose bricks should be removed, labeled, and stored as necessary in a secure casemate or officers' quarters location for re-use in repairs.

Typical First-Tier Casemate Damage along circumferential cracks and arch intersections.

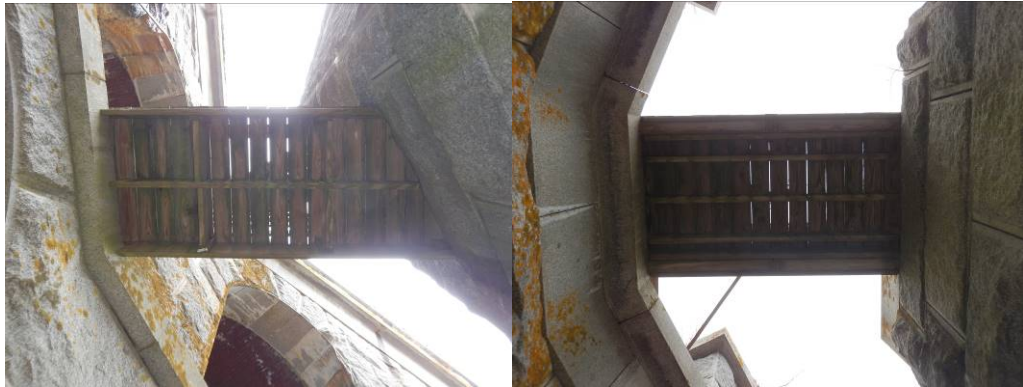
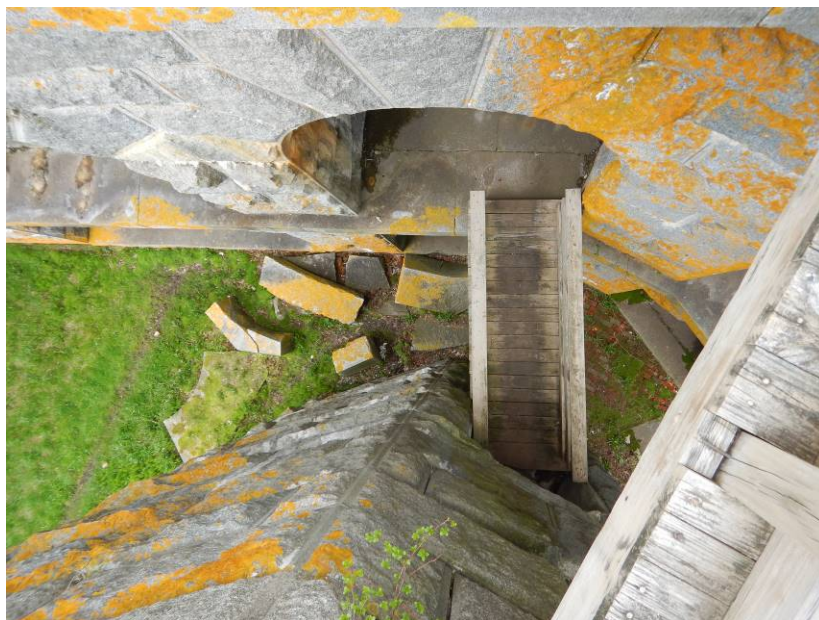
Photo 4.3 and Photo 4.4: Tier 2 (left) and Barbette Tier (right) bridges viewed from below.
Photo 4.5 (below): Note skew where Tier 2 bridge spans from casemate 246 to tower.

- Replace the bridges. While general replication of the existing bridges, with improved wooden railings, is feasible, we recommend replacement with galvanized steel structures with galvanized floor grating and rails to generally match the Army Corps Work.

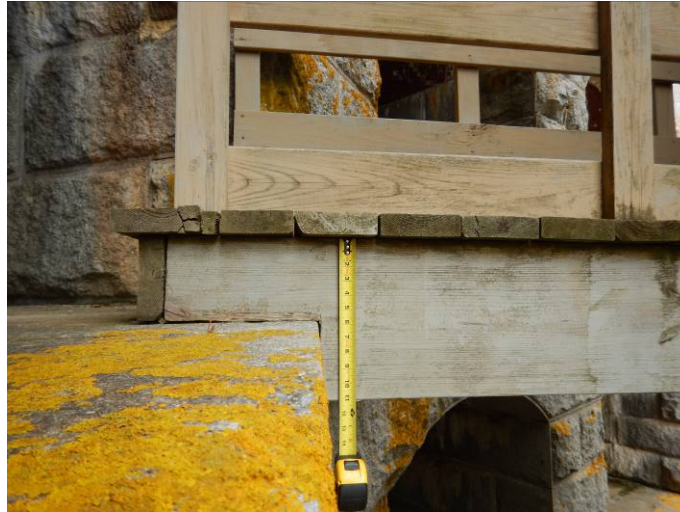
- Bridge bearing beams are not significantly rotted, but the notches in the bearing ends, created to lower the step height onto the bridge, are subject to stress concentrations and could fail under unplanned heavy loads or construction loads.

Photo 4.7 Bearing end of Tier 2 Bridge at Casemate 246.

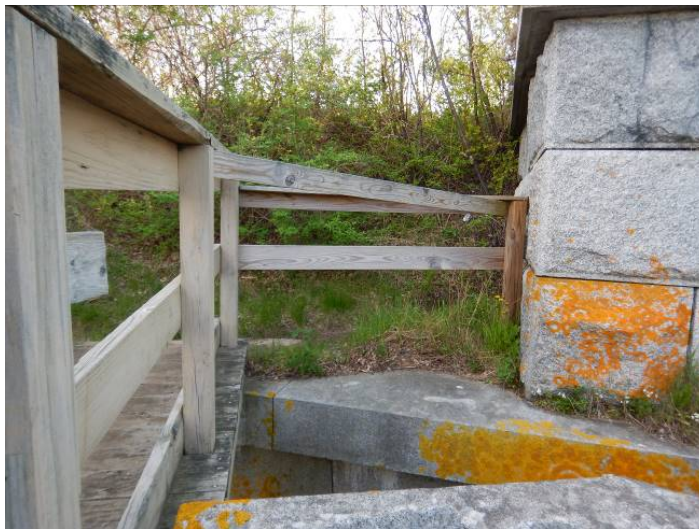
- Bridge railings are not expected to have a significant lifetime, and present significant falling risk. Although the fort is a “pass at your own risk” structure, the weak railings create unnecessary safety concerns due to their lack of code required (but not necessarily applicable) and remaining strength. Weathering, vandalism, and routine use have weakened the railing structures, and increased fort use only highlights the need for railing and bridge replacement.

Photo 4.8 Unsafe Railing System at Barbette Tier Bridge and Path

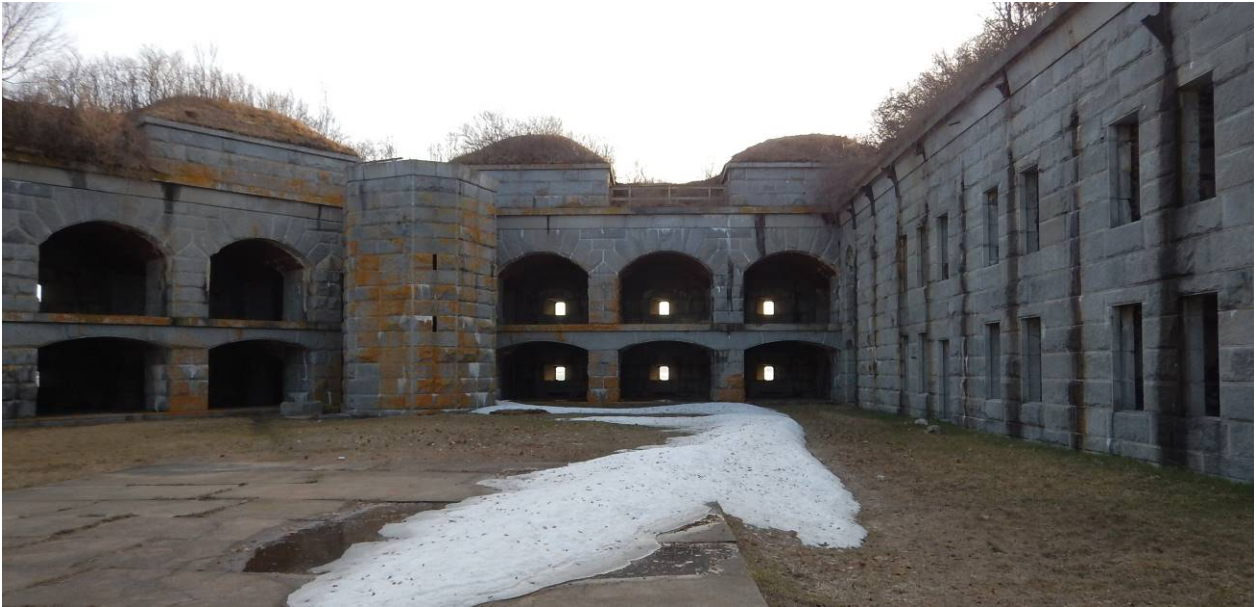
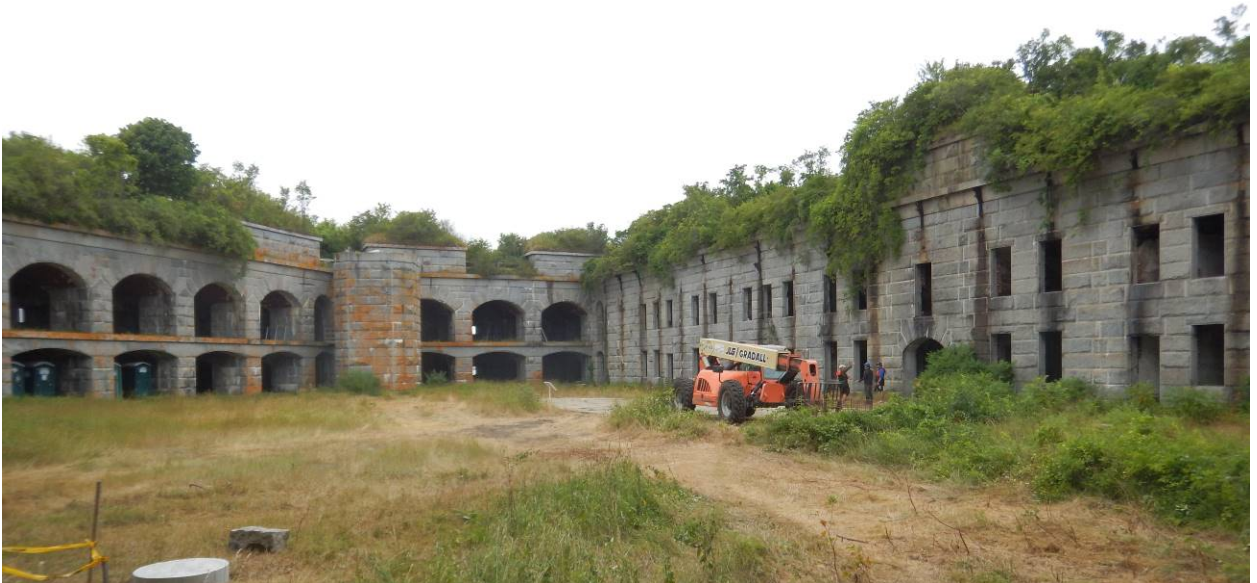
Photo 3.1 and 3.2: West Viewing Area in winter and summer. Barbette Tier explodes in dense, mostly invasive foliage.

- Dense overgrowth regenerates annually, providing the overgrown fort roof so well known today. When the fort was occupied by a caretaker as late as 1910, the roof vegetation was much shorter and more manicured.
- Existing railings consist of pressure-treated railings installed several years ago. The railings suffer from weathering, vandalism, and normal wear and tear, and currently provide a false sense of security to visitors.

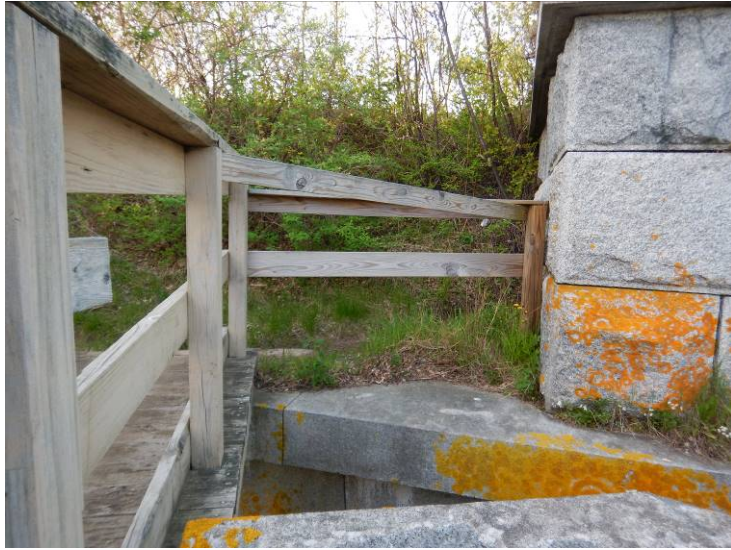
Bridge and Barbette Tier Railings

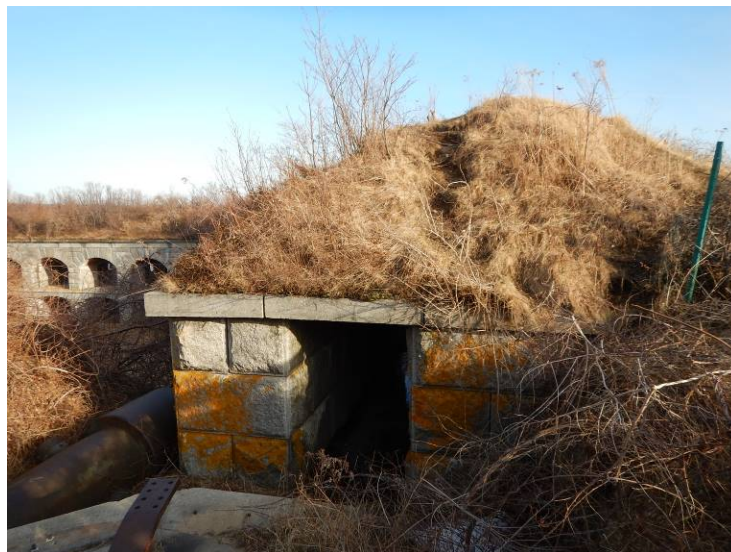
- On Face V, two passage structures provide protected access to small powder magazines located on the barbette tier. These structures, in turn, are covered with several feet of earth, creating high-points that visitors regularly climb to get better views of the surrounding harbor. The steep slopes falling toward the exterior fort walls present a safety hazard that realistically cannot be mitigated without full-time staff working on the barbette tier.

Steep slopes (parados) atop Barbette Powder Magazine passages
