Infrared Thermographic Roof Inspection

**Town of Deep River
Town Hall & Deep River Water Treatment Plant
100 Deep River Road & 177 River Road
Deep River, Ontario
K0J 1P0**

Inspection Date: **June 4, 2024**
Verification Date: **June 5, 2024**
Representative: **Mr. Matthew McNeely**

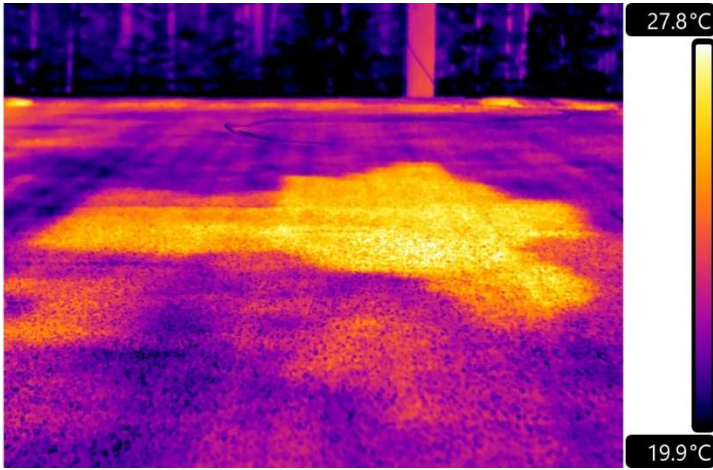
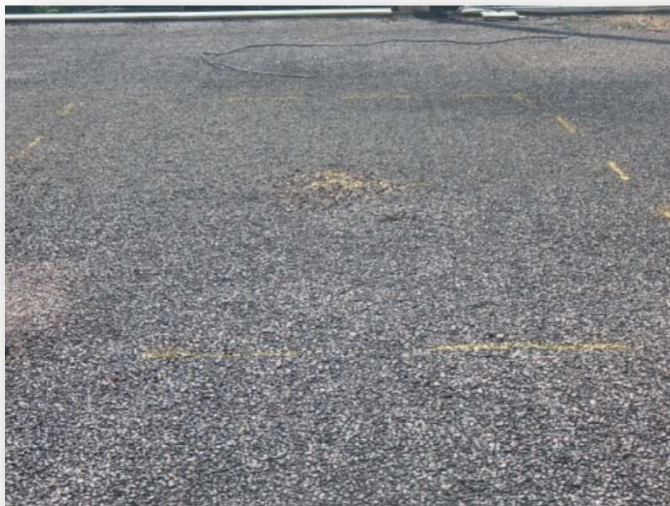
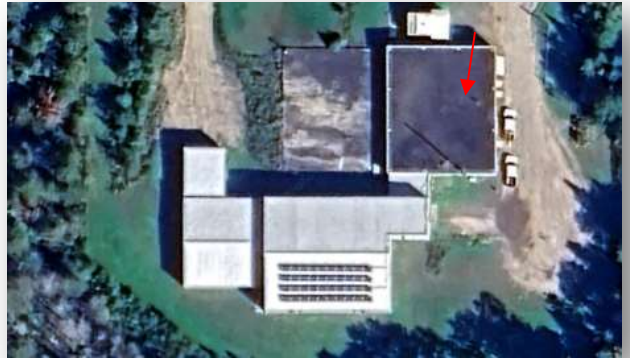
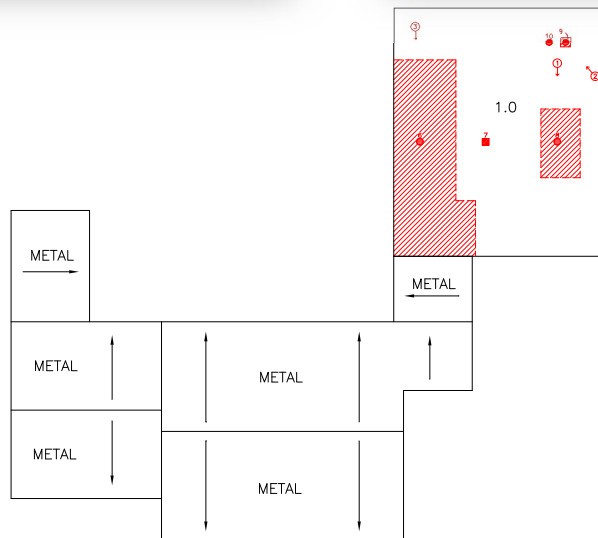
Vantage Point #1

Thermogram looking at confirmed anomaly on Roof Section 1.0 – Water Treatment Plant.

Verified Probe #8 – Wet.

Anomaly Area...
252 sqft

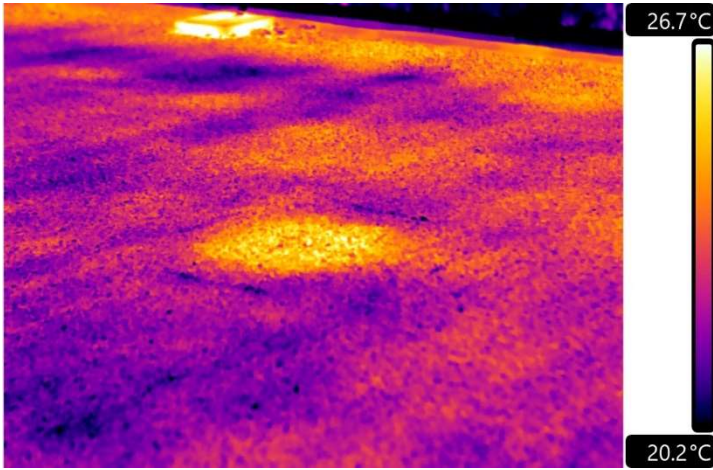
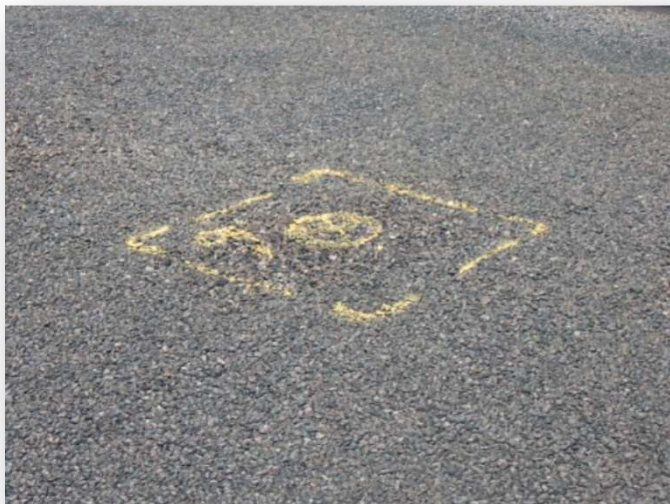
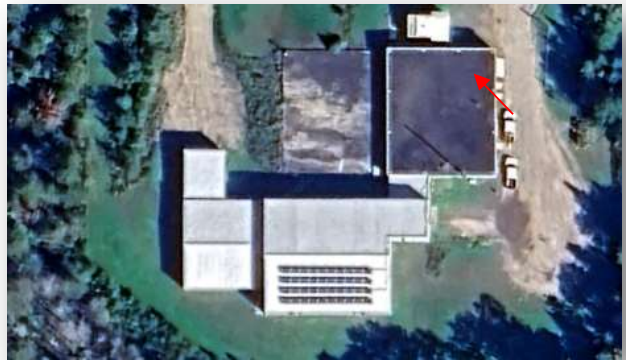
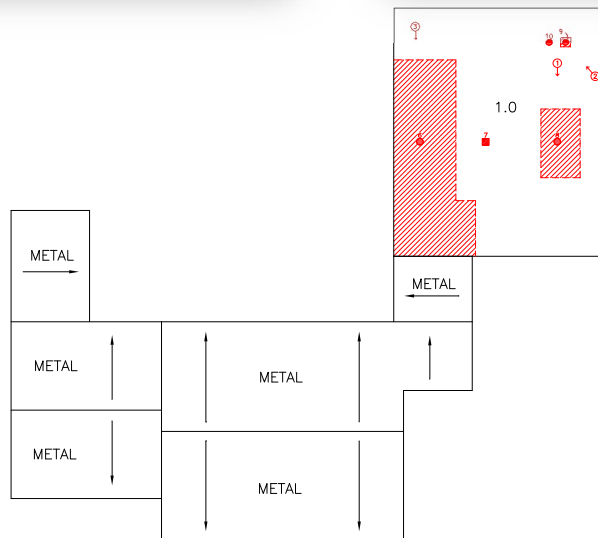
Vantage Point #2

Thermogram looking at confirmed anomaly on Roof Section 1.0 – Water Treatment Plant.

Verified Probe #9 – Wet.

Anomaly Area...
9 sqft

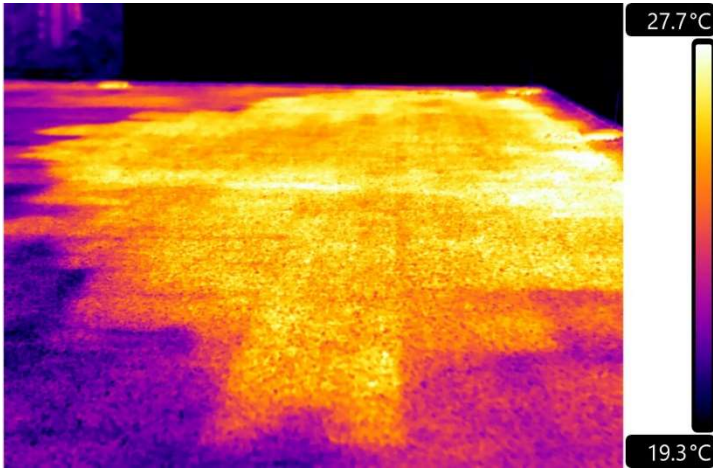
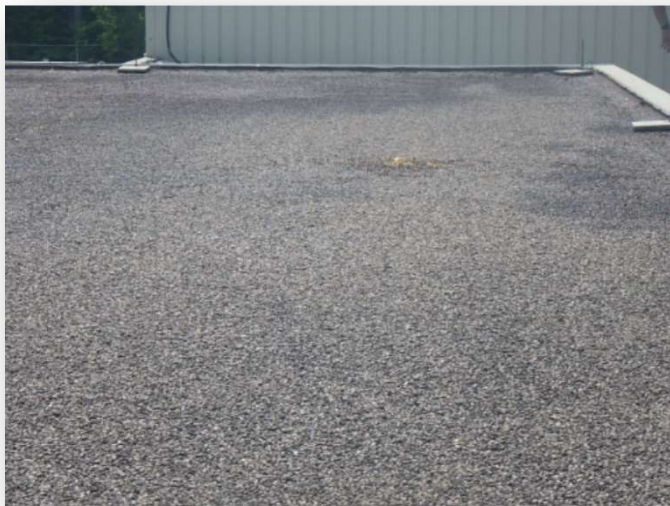
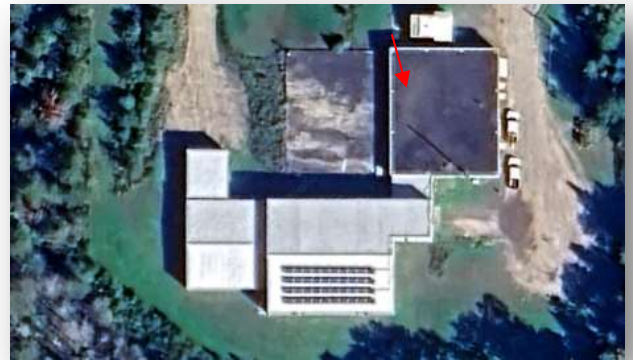
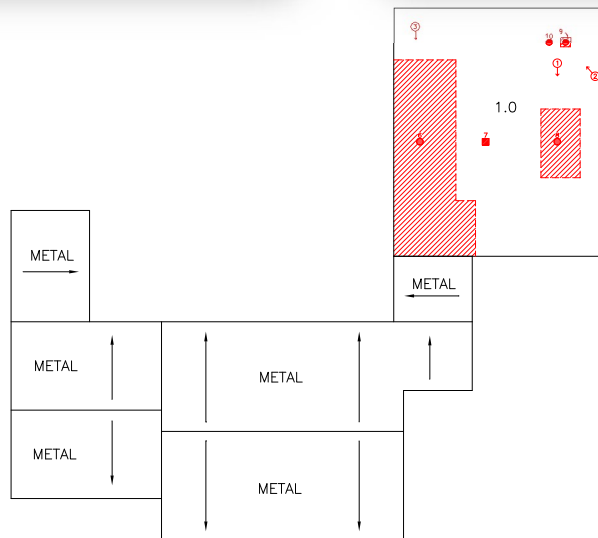
Vantage Point #3

Thermogram looking at confirmed anomaly on Roof Section 1.0 – Water Treatment Plant.

Verified Probe #6 – Wet.

Anomaly Area...
1,242 sqft

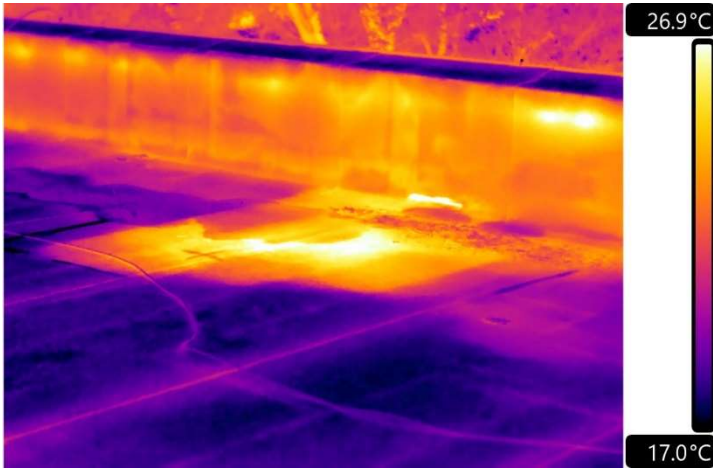
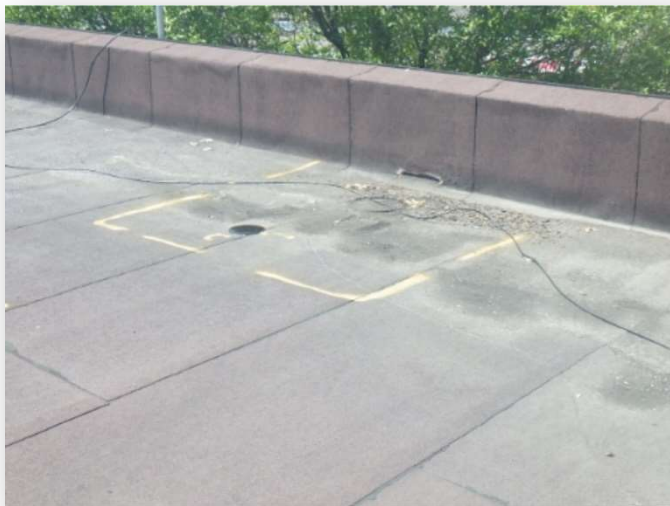
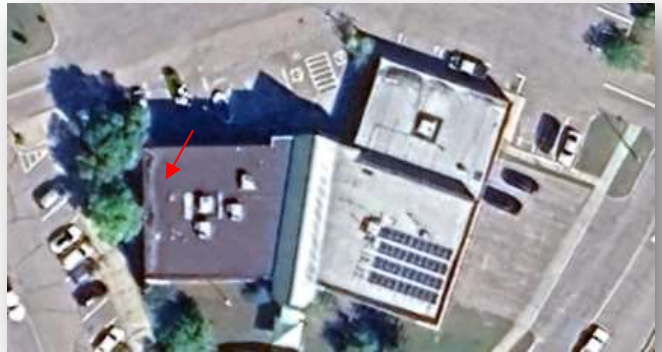
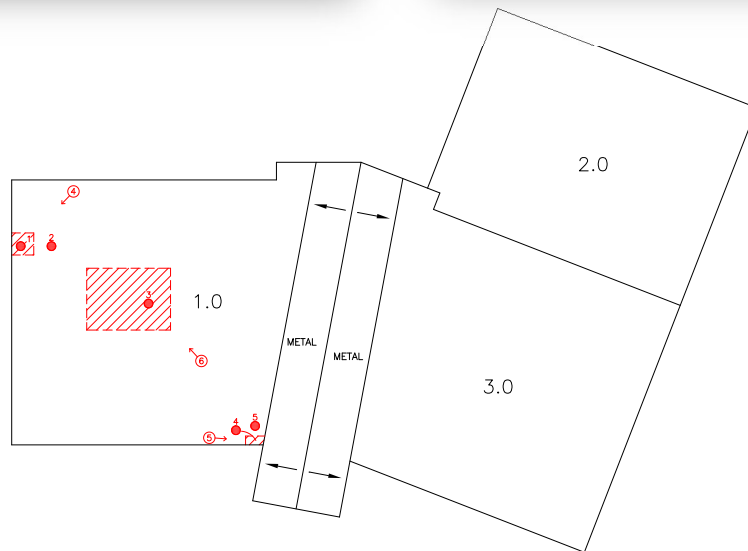
Vantage Point #4

Thermogram looking at confirmed anomaly on Roof Section 1.0 – Town Hall.

Verified Probe #1 – Wet.

Anomaly Area...
25 sqft

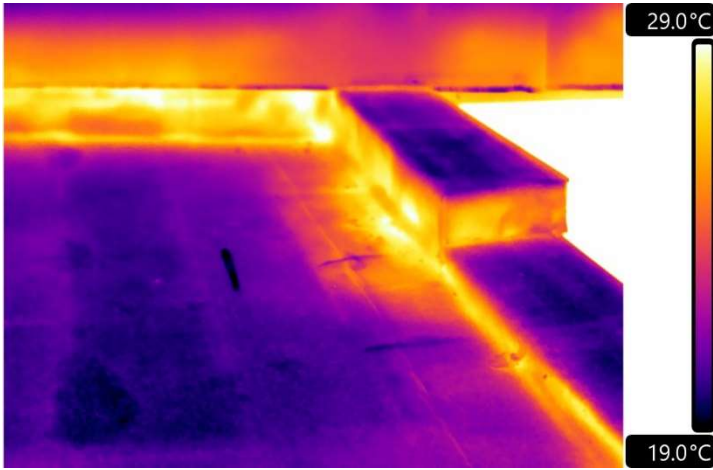
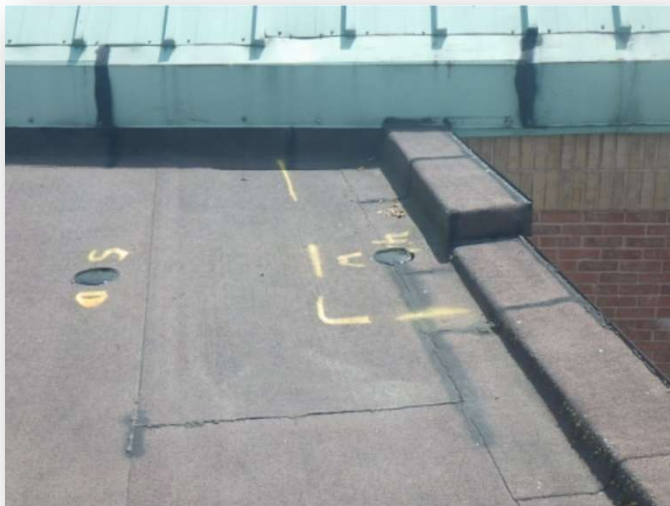
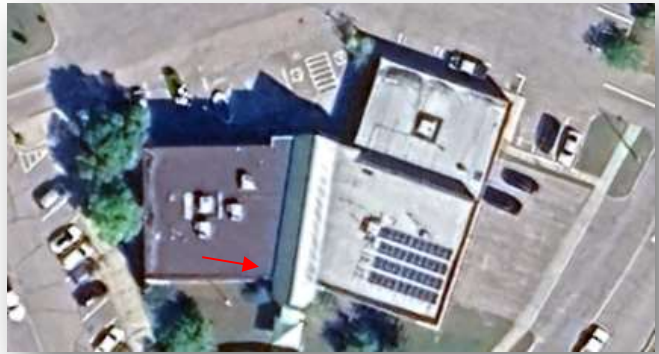
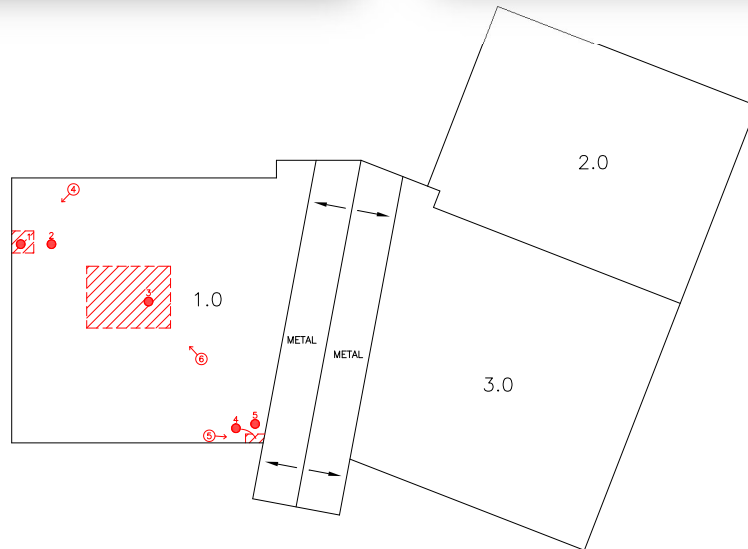
Vantage Point #5

Thermogram looking at confirmed anomaly on Roof Section 1.0 – Town Hall.

Verified Probe #4 – Wet.

Anomaly Area...
8 sqft

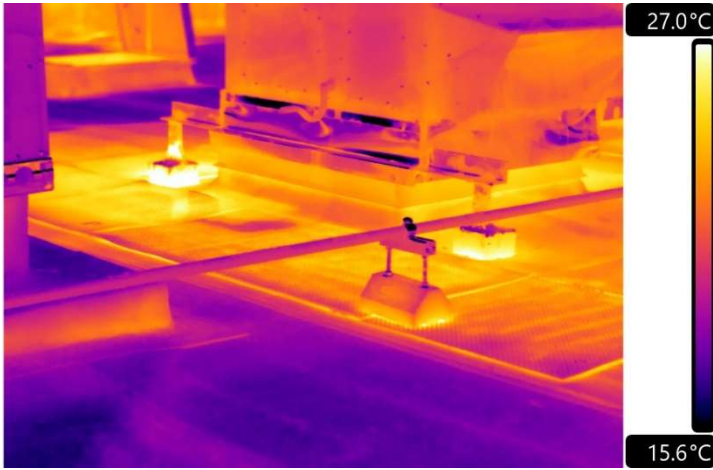
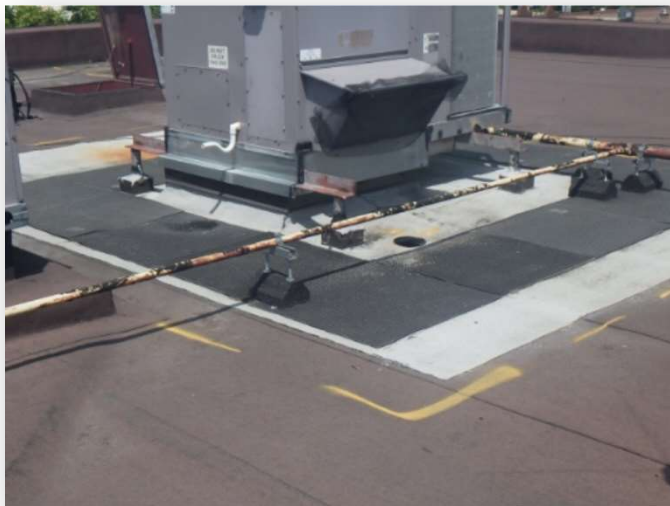
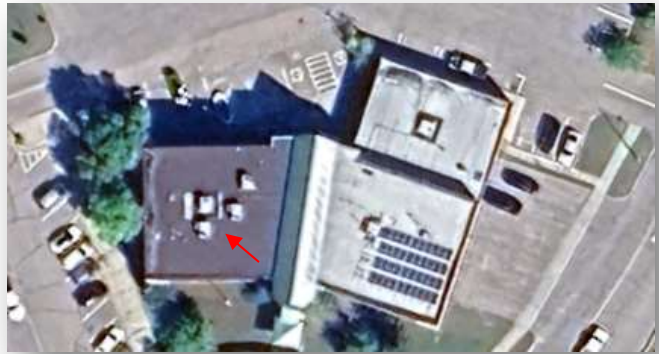
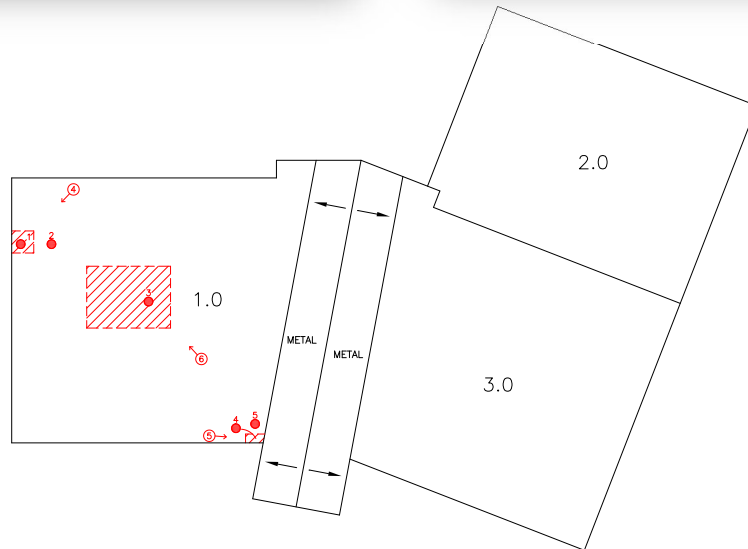
Vantage Point #6

Thermogram looking at confirmed anomaly on Roof Section 1.0 – Town Hall.

Verified Probe #3 – Wet.

HVAC unit shown inside confirmed anomaly.

Anomaly Area...
266 sqft

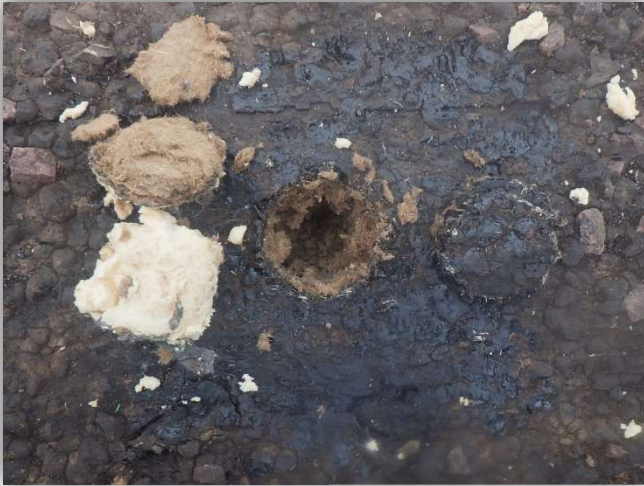
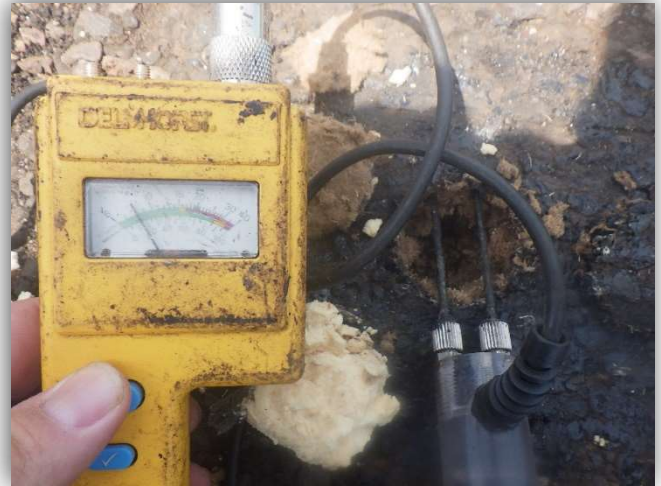
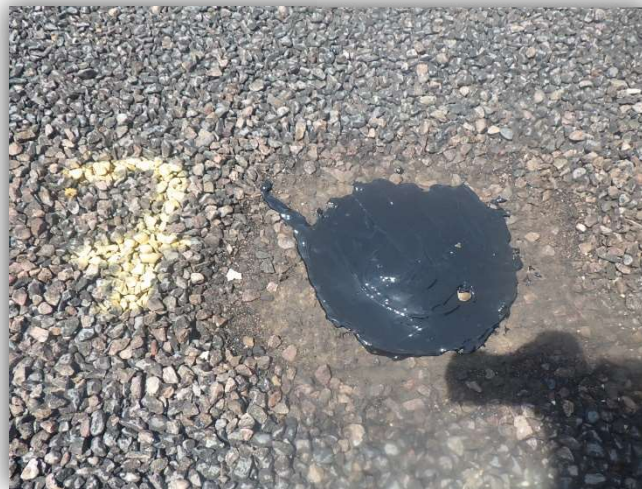
Core Cut #7

Core Assembly - Roof Section 1.0 – Water Treatment Plant

Layer Type	Description	Condition	Thickness
Surfacing	3/8" Gravel	-	-
Membrane	Built Up Roof - Asphalt & Gravel	Poor	-
Felts	4 Ply	Dry	-
Insulation	Fibreboard	Dry	1/2"
Insulation	Polyisocyanurate	Dry	2"
Vapour Barrier	None	-	-
Deck	Metal	Poor – Minor Rust	-

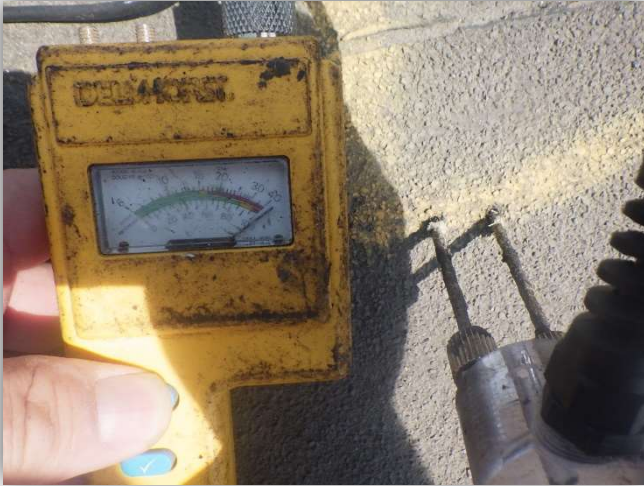
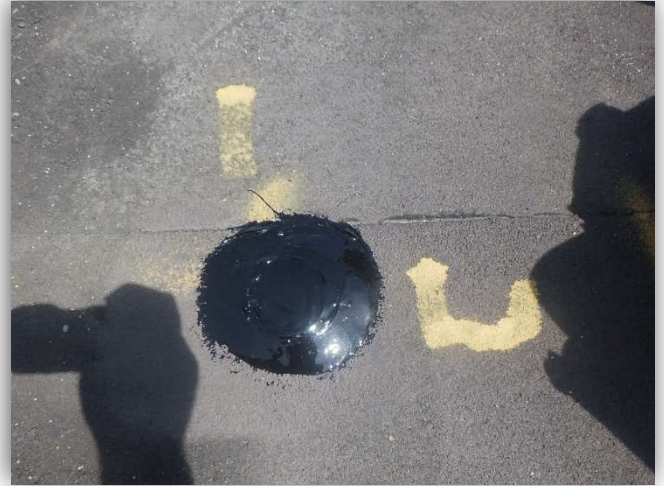
Probe #1 Roof Section 1.0 – Town Hall

Moisture Probe Reading: Wet Insulation

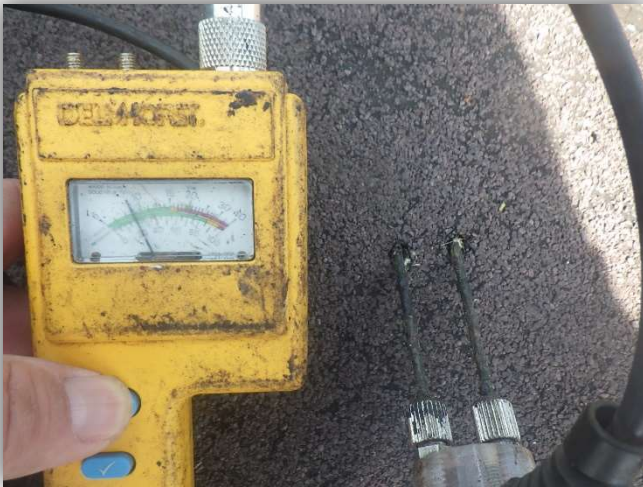
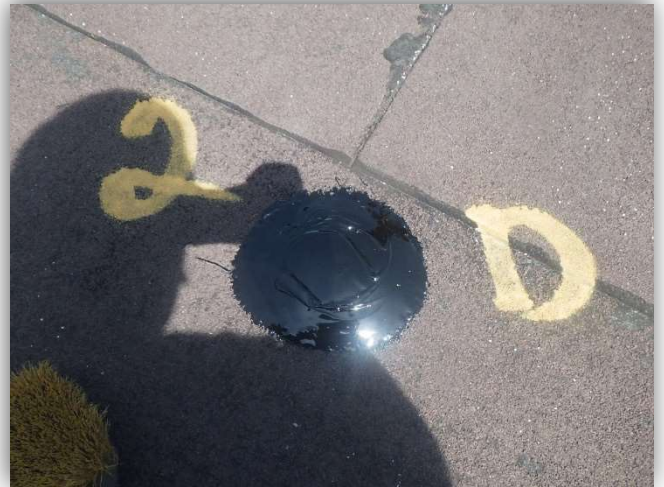
Probe #2 Roof Section 1.0 – Town Hall

Moisture Probe Reading: Dry Insulation

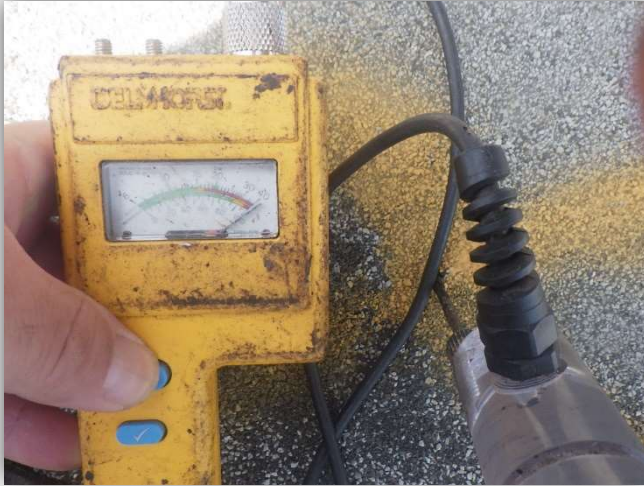
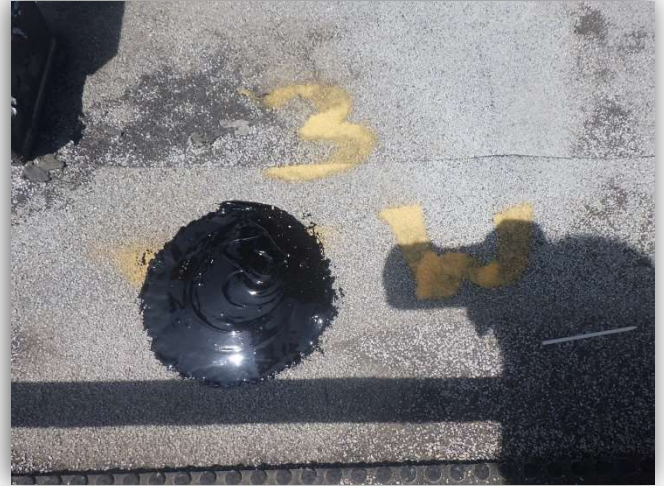
Probe #3 Roof Section 1.0 – Town Hall

Moisture Probe Reading: Wet Insulation

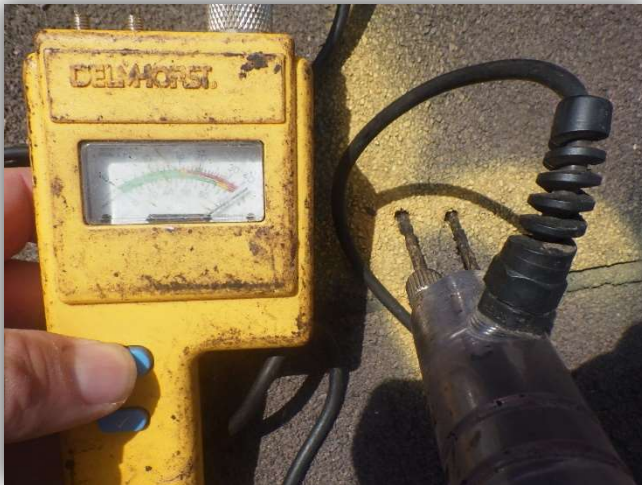
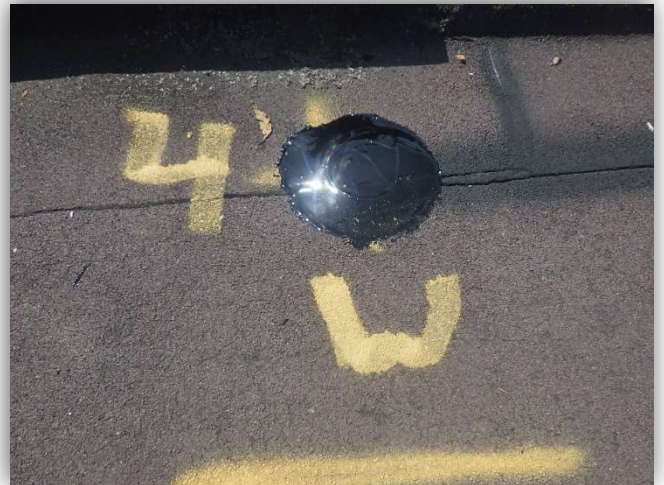
Probe #4 Roof Section 1.0 – Town Hall

Moisture Probe Reading: Wet Insulation

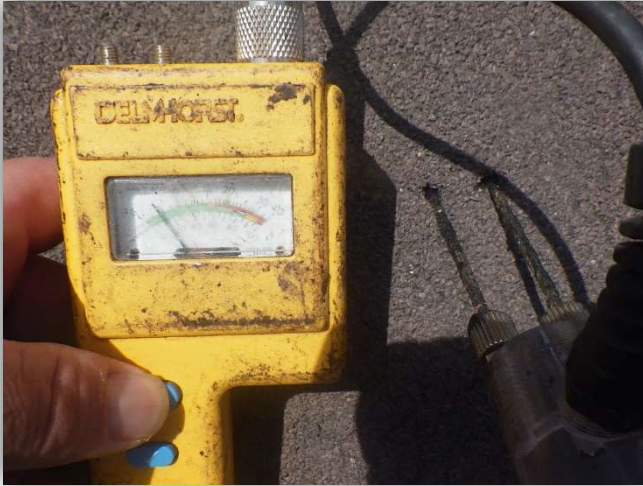
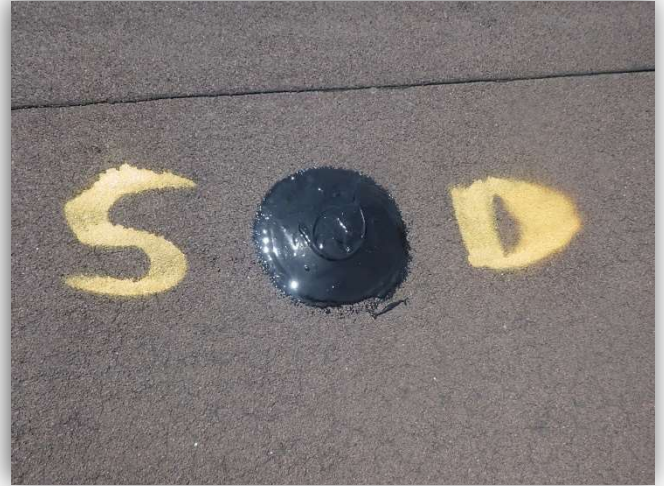
Probe #5 Roof Section 1.0 – Town Hall

Moisture Probe Reading: Dry Insulation

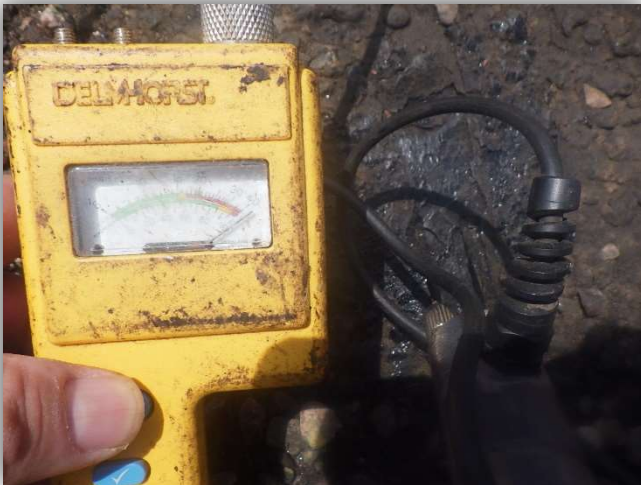
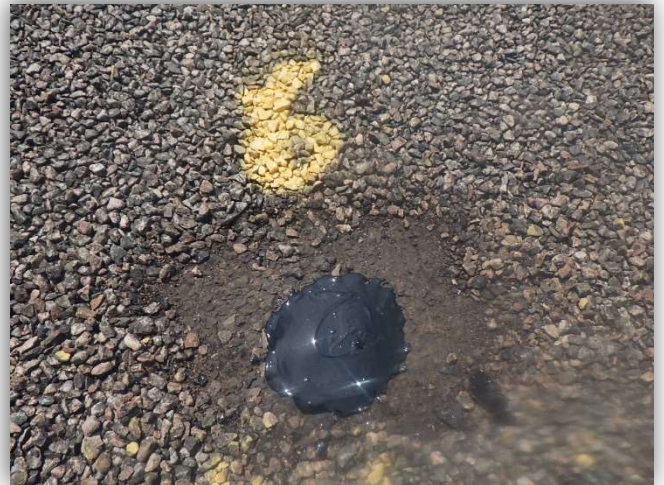
Probe #6 Roof Section 1.0 – Water Treatment Plant

Moisture Probe Reading: Wet Insulation

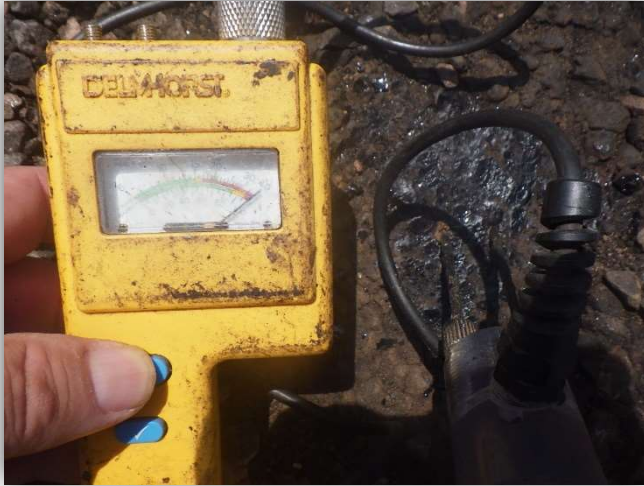
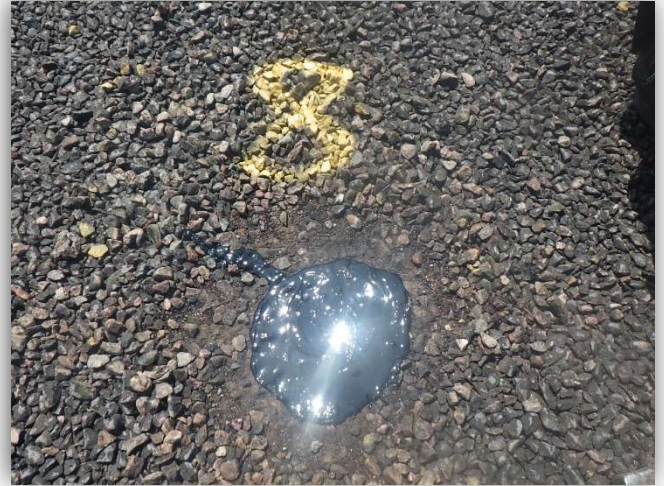
Probe #8 Roof Section 1.0 - Water Treatment Plant

Moisture Probe Reading: Wet Insulation

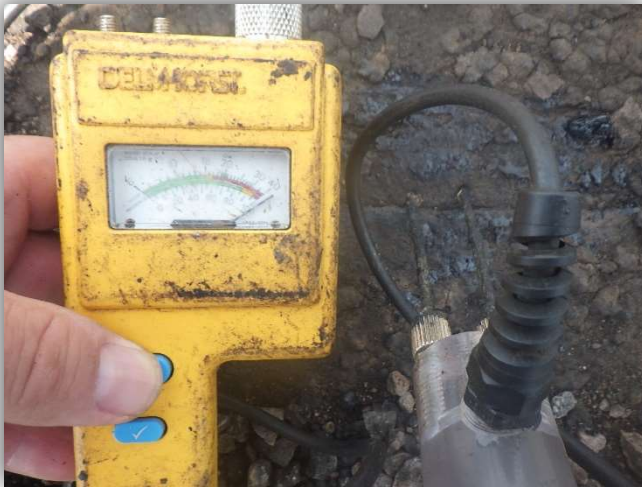
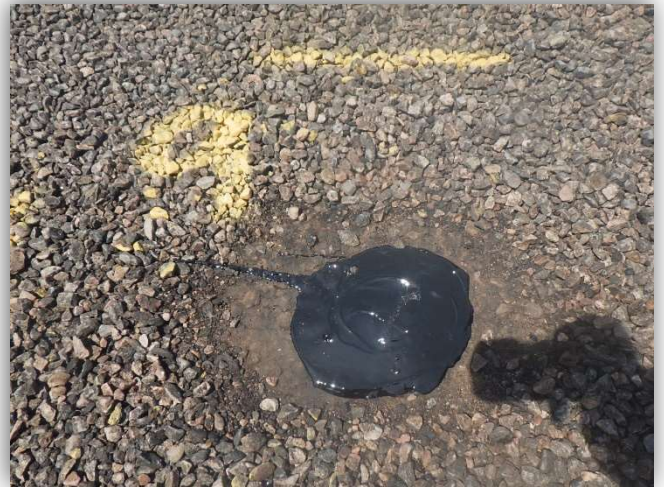
Probe #9 Roof Section 1.0 - Water Treatment Plant

Moisture Probe Reading: Wet Insulation

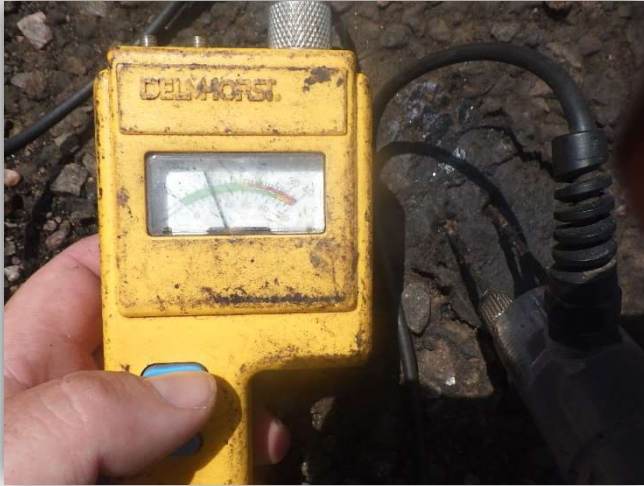
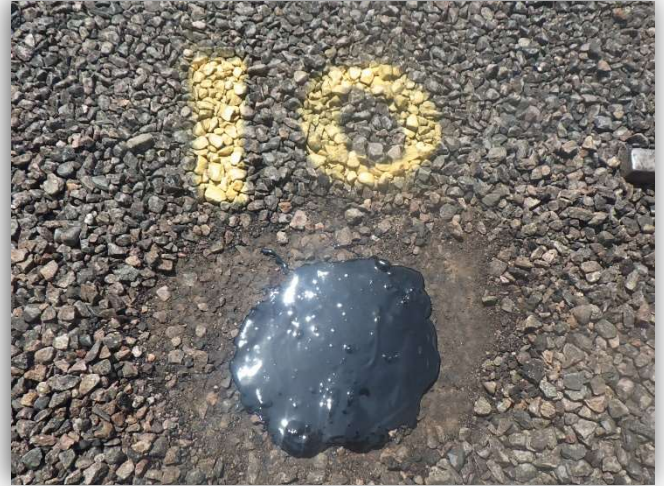
Probe #10 Roof Section 1.0 - Water Treatment Plant

Moisture Probe Reading: Dry Insulation
