MEMORANDUM

TO: City of Lake Stevens c/o Shannon Farrant
FROM: Erik Davido, PE; Jack Lasley, PE; & Joe Brascher
DATE: May 11, 2023
RE: Lake Stevens Hydrology Modeling – Brief Overview of Calibration and Scenarios

1 PROJECT OVERVIEW

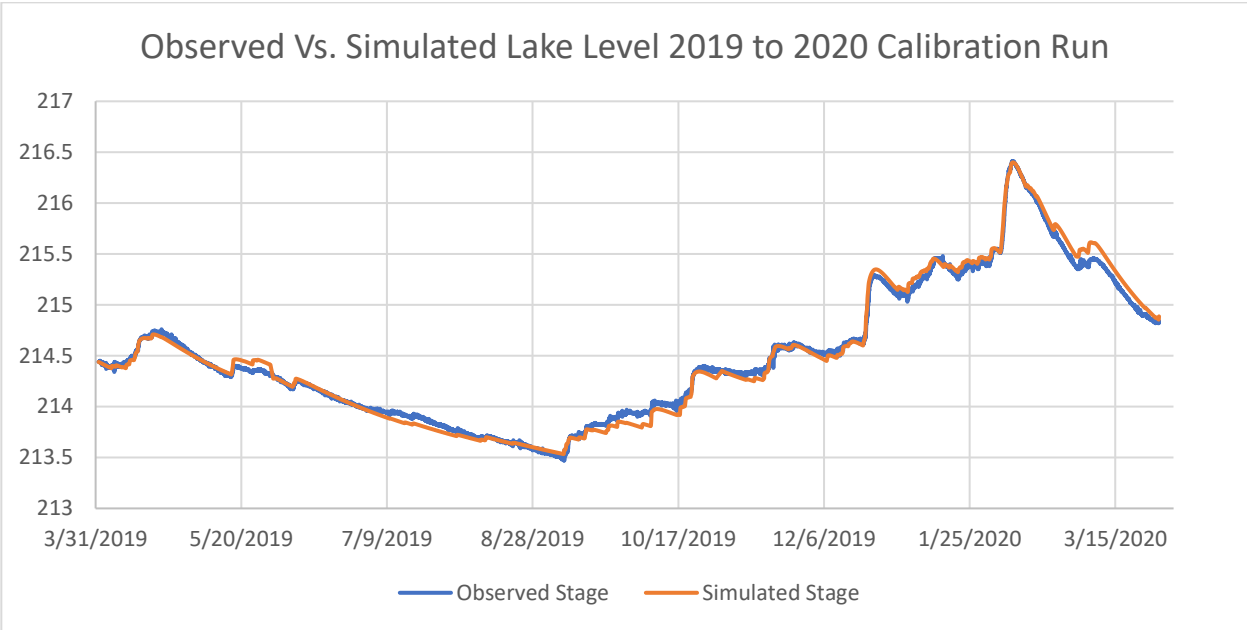
Figure 2 – Original Calibration Model Results

Maximum observed lake level: **216.41'**
 Minimum observed lake level: **213.47'**
 Maximum simulated lake level: **216.39'**
 Minimum simulated lake level: **213.53'**

Modeling and calibration was conducted for a 10-yr analysis between October 1st, 2010 to to September 30th, 2020. In February 2020, Lake Stevens water levels reached some of the highest stages ever recorded resulting in flooding in the downtown corridor of Lake Stevens. Throughout the analysis, the February 2020 peak stage is used as a key comparison point. Figure 2 shows a graph of the original calibration results and Figures 3 through 5 show photos fo the outlet channel during the February 2020 event.

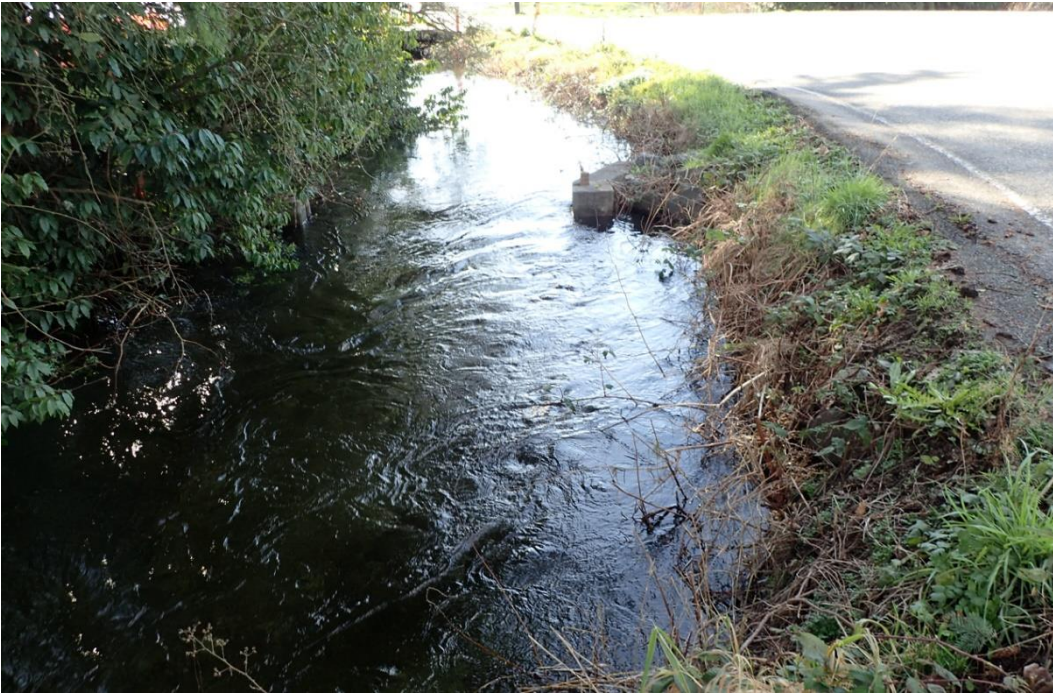
Figure 3 - Photograph of lake outlet weir (looking upstream) during February 2020 peak lake level stage (day after storm).

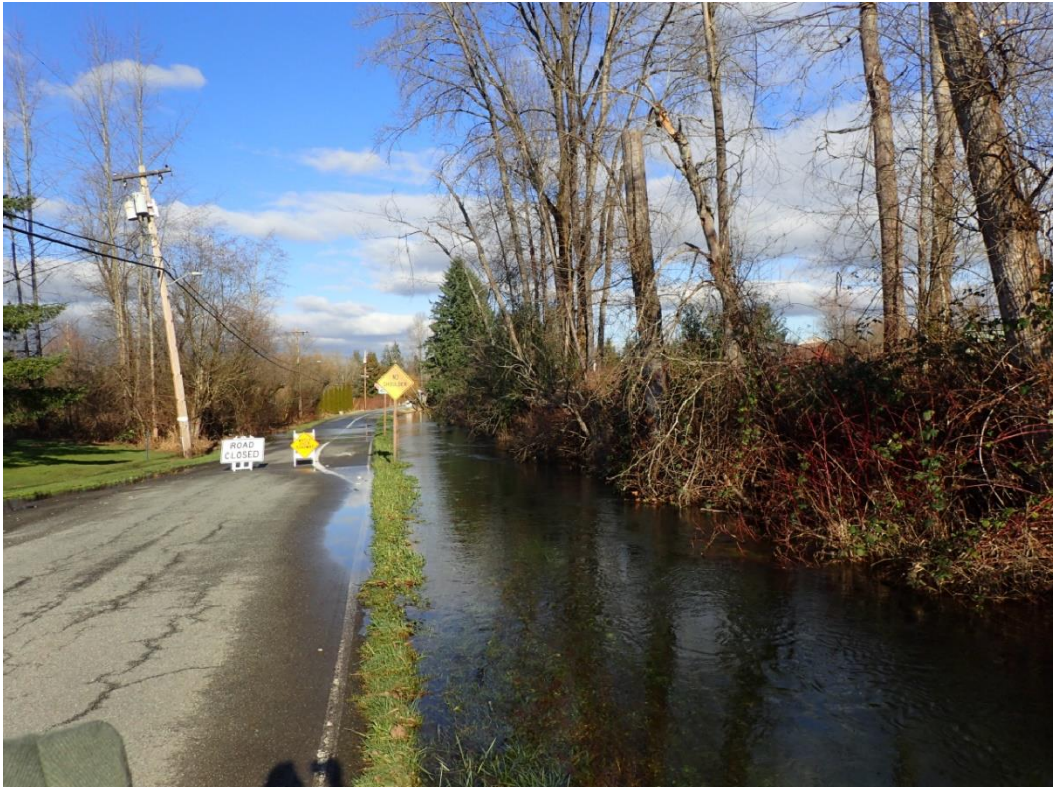
Figure 4 - Photograph along Hartford near fire station (looking downstream) during February peak lake level stage.

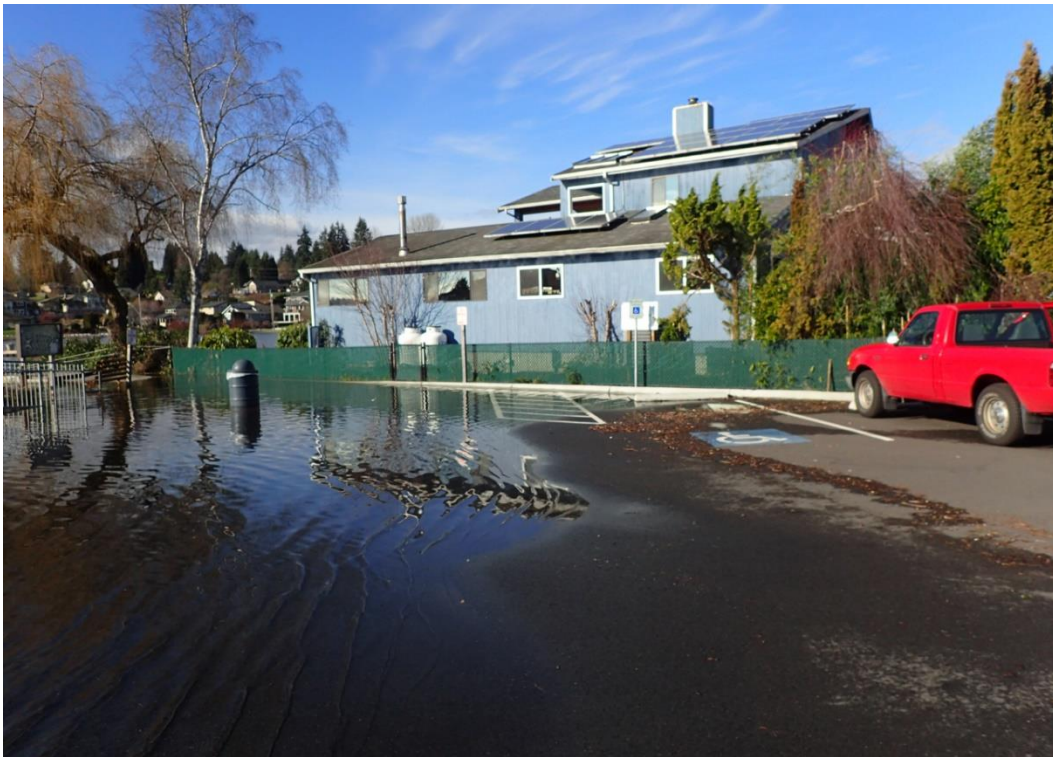
Figure 5 - Photograph of Lake at North Cove boat launch during February peak lake level stage.

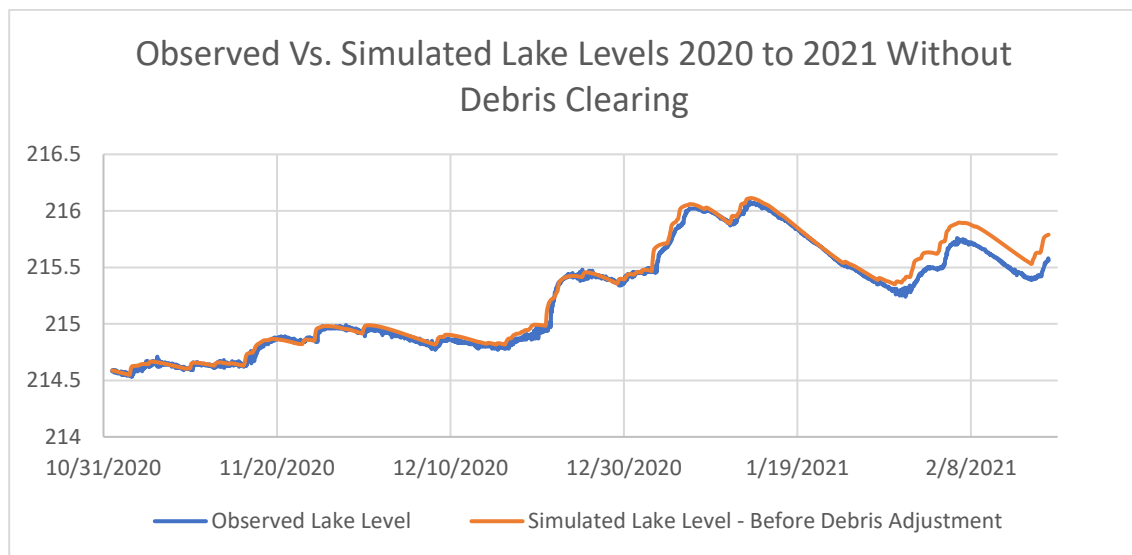
Figure 6 - Original calibration compared with observed data.

Debris clearing was conducted in January 2021; a divergence between the original calibration and observed lake levels can be seen after January 2021 in Figure 6. Note, that the original 10-year calibration was between 2010 and 2020 so the simulated lake level in 2021 is an extrapolation of the previous 10 years of data; with no debris clearing conducted. However, Figure 7 shows the model adjusted for the debris clearing and more closely matches the observed lake level.

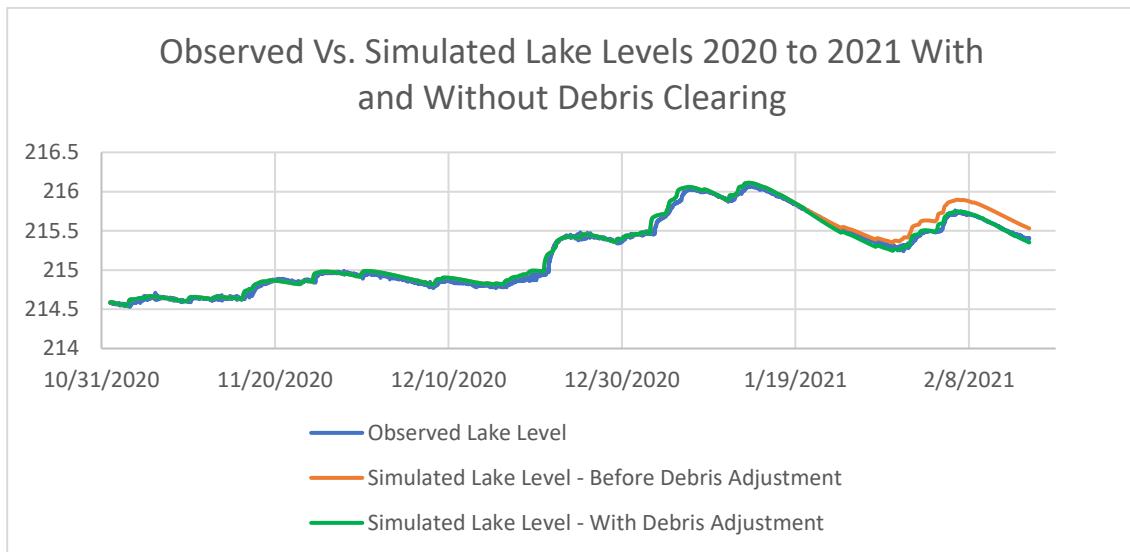
Figure 7 - Original calibration and debris clearing adjustment compared with observed data.

Maximum observed lake level: **216.08'**

Minimum observed lake level: **214.53'**

Maximum simulated lake level (prior to debris clearing): **216.11'**

Minimum simulated lake level (prior to debris clearing): **214.55'**

Maximum simulated lake level (with debris clearing): **216.11'**

Minimum simulated lake level (with debris clearing): **214.55'**

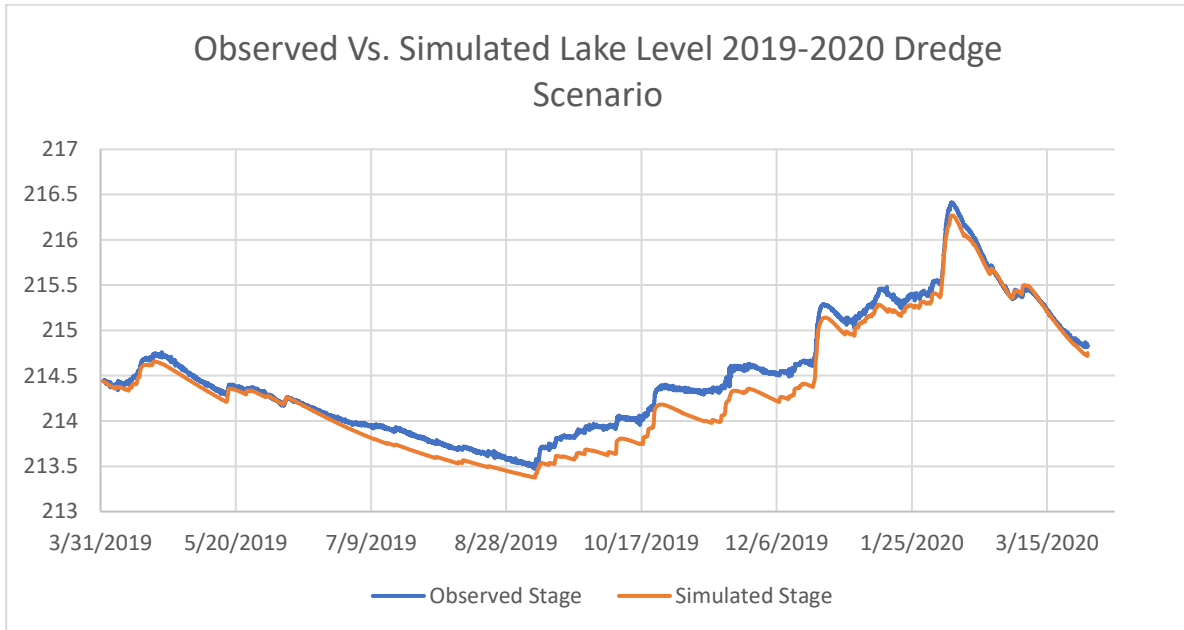
Figure 8 - Dredged simulation compared to observed data.

Maximum observed lake level: **216.41'**
Minimum observed lake level: **213.47'**
Maximum simulated lake level: **216.27'**
Minimum simulated lake level: **213.37'**

Lake Outlet dredging occurred in September 2021. Similar to the debris adjustment, model adjustments and recalibration were conducted to better align simulated data with observed data. Figure 8 compares the simulated dredged channel scenario compared to observed conditions for a “what could have been” comparison. Modeling shows that dredging the lake outlet reduces the highest simulated lake level by nearly 0.14’ (1.68”) compared to observed data; this equates to nearly 140 ac-ft of storage differential.

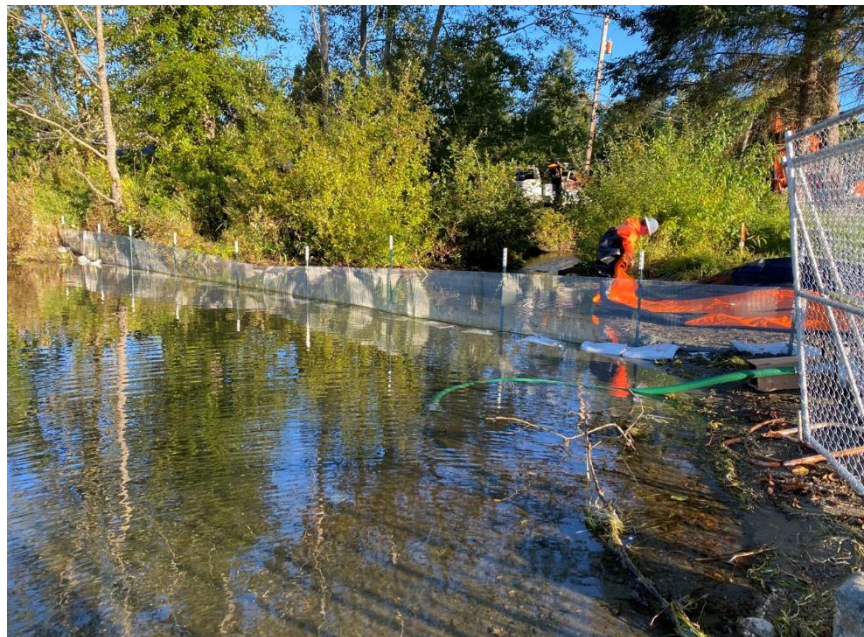
Figure 9 photograph at the mouth of the Lake Outlet (looking downstream) prior to dredging as cofferdam and bypass pumps are installed.

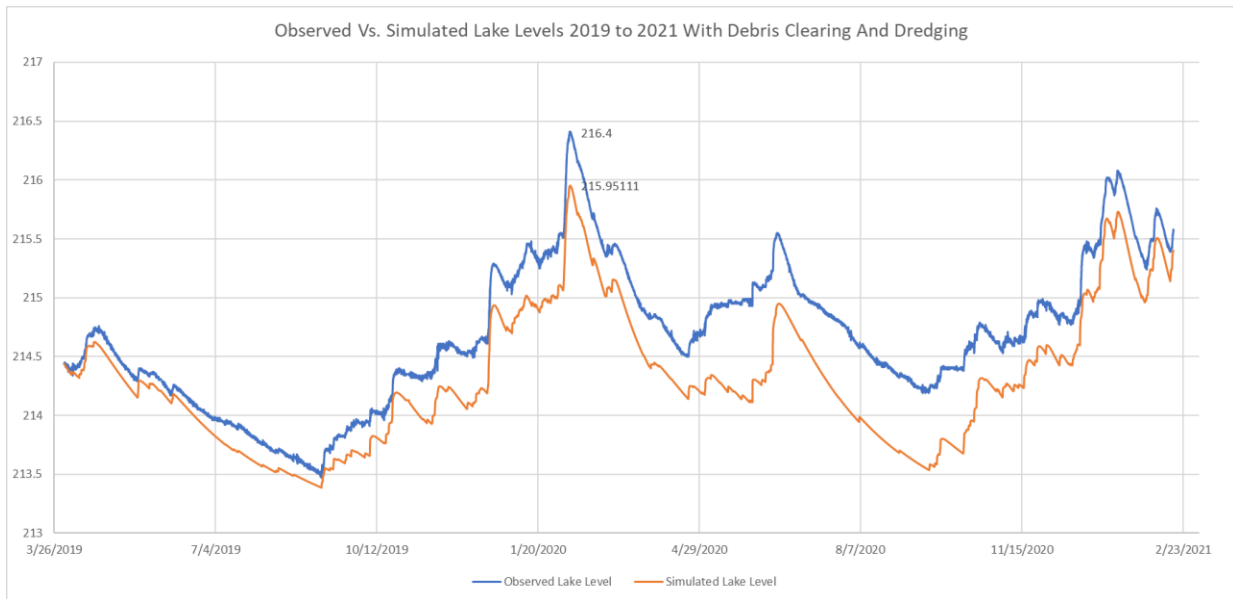
Figure 10 - Cleared and dredged simulation compared to observed data.

Maximum observed lake level: **216.41'**

Maximum simulated lake level: **215.95'**

Combining the results of the debris clearing and dredged channel modifications significantly reduces the peak lake level compared to the observed data during the February 2020 event (nearly 0.46' or 5.5"). Anecdotally, post debris clearing and dredging, the City has seen less flooding in the downtown corridor and lower lake levels in 2022 and 2023. The "cleared and dredged" baseline scenario is used for the remainder of the analysis.

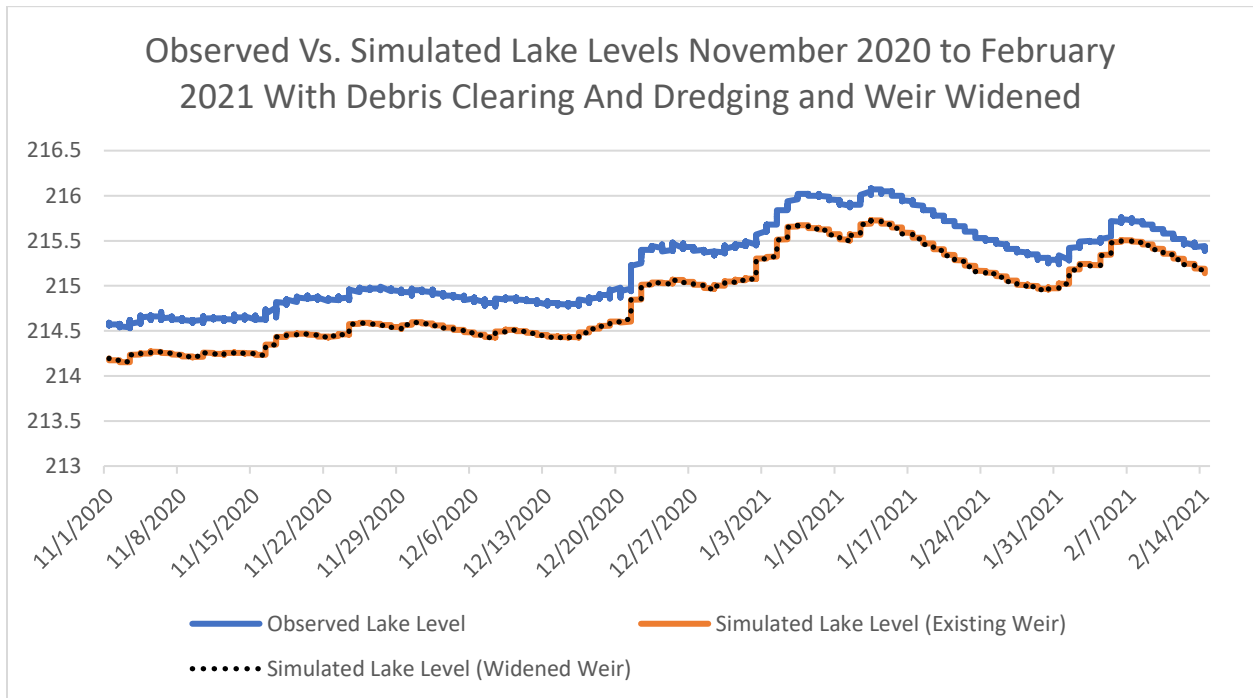
Figure 11 - Cleared and dredged existing weir width and wider weir width simulation compared to observed data.

Maximum observed lake level: **216.08'**

Minimum observed lake level: **214.53'**

Maximum simulated lake level (cleared and dredged with wider weir): **215.72'**

Minimum simulated lake level (cleared and dredged with wider weir): **214.15'**

The existing weir is approximately 10' wide; a widened weir (30') was modeled to analyze if an increased weir width would further decrease peak lake levels. However, compared to the cleared and dredged existing weir scenario there is little to no difference. Further modeling analysis has shown that the weir is not the hydraulic control on the outlet channel; the channel cross section itself controls flows.

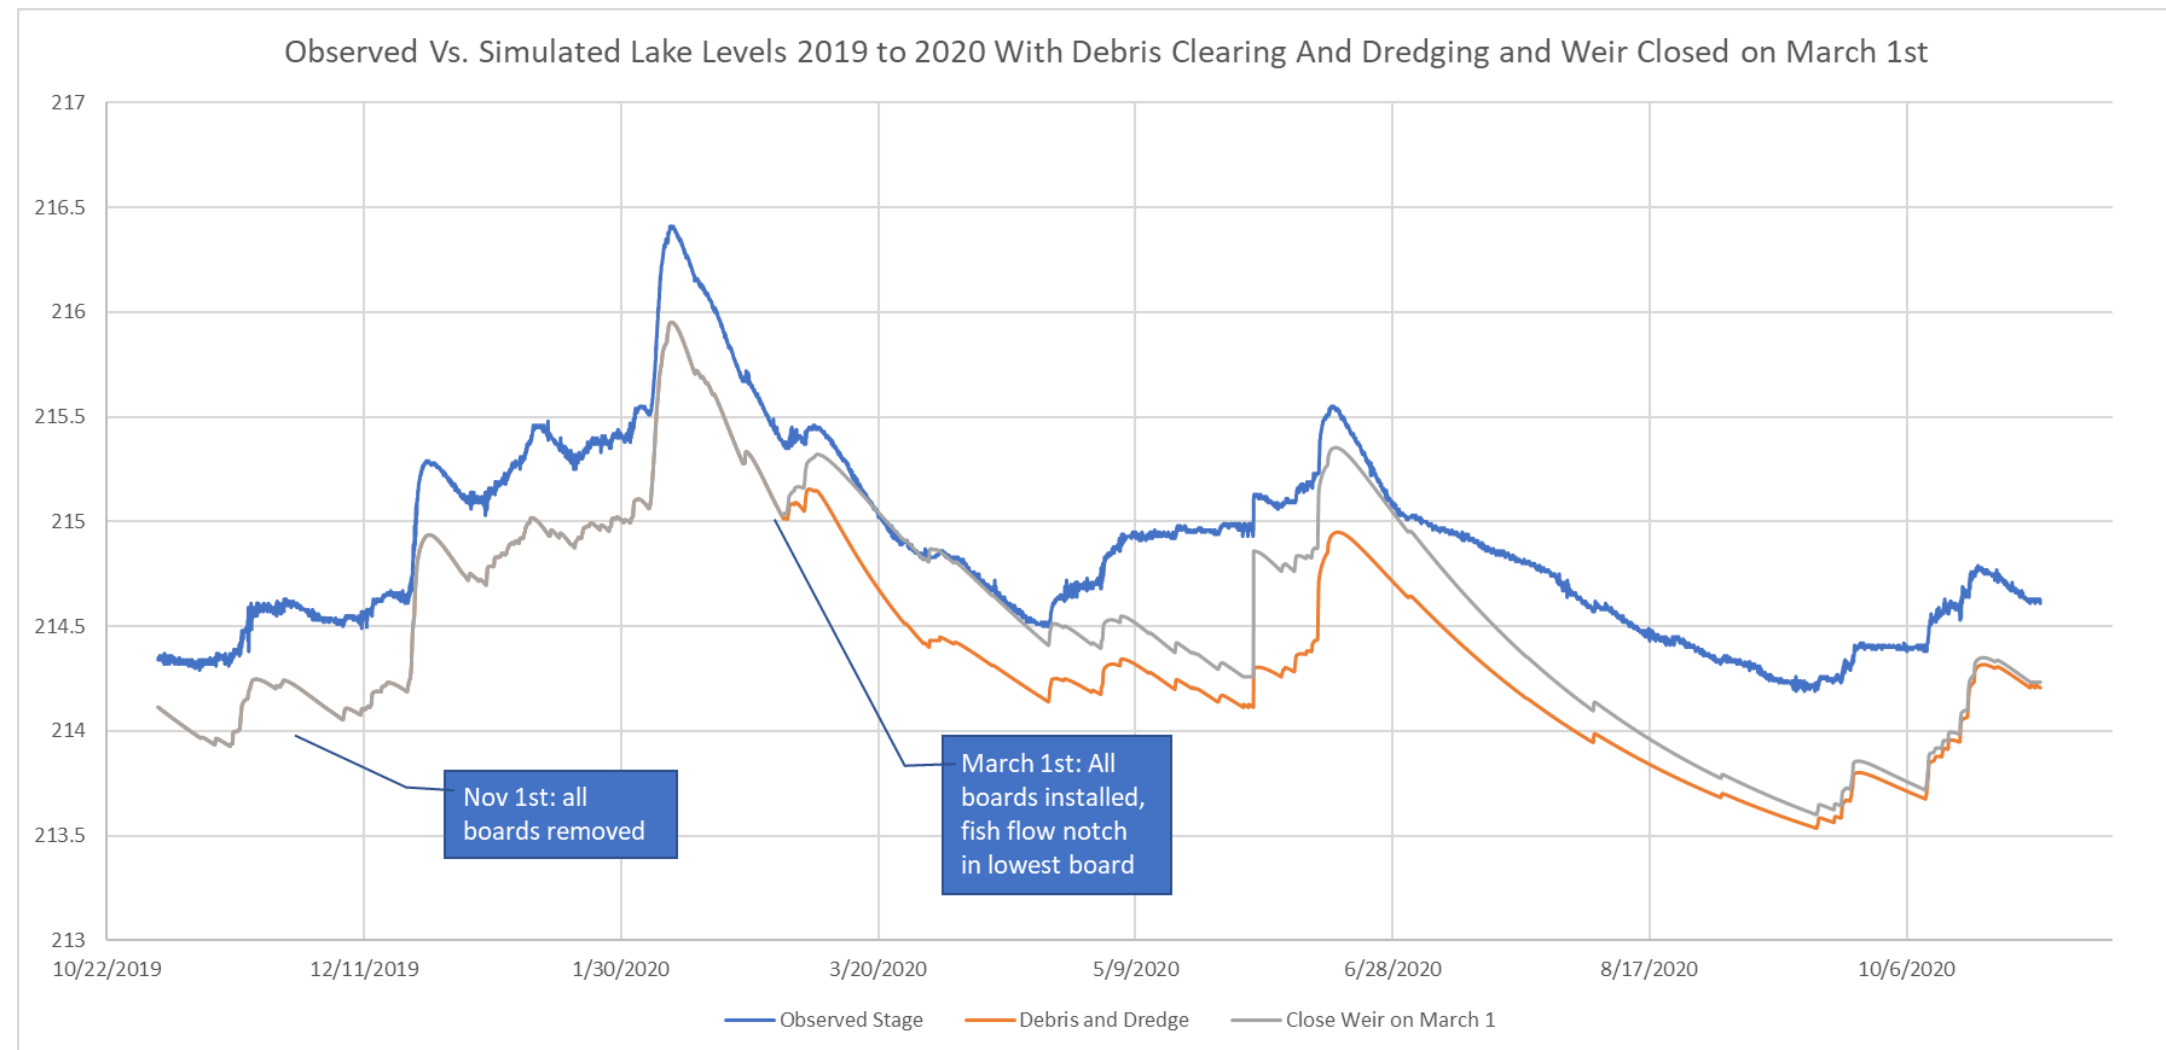
Figure 12 - Cleared and dredged simulation with revised weir management plan.

The current lake level management plan is shown in the figure below. In this analysis, the goal was to review preliminary results answering the following question: can a simpler weir management plan work to reduce peak lake levels yet allow enough lake storage for water release throughout the summer?

Contrary to the existing lake level management plan, this scenario removed all weir boards on November first and then put the weir in channel between March – October. During this period, the weir was set at an arbitrary height so that water never overtopped the weir and only flows via the fish notch were released downstream. The results shown in Figure 12, demonstrate that a simpler lake level management plan could likely be used and would answer the original driving question for this analysis scenario; changing the weir management plan could retain more storage in Lake Stevens at the end of the wet season which might allow for additional flow release in the lake outlet throughout the summer and early fall months for fish while still satisfying lake level management goals regarding recreation. Further analysis and refinement would be needed.

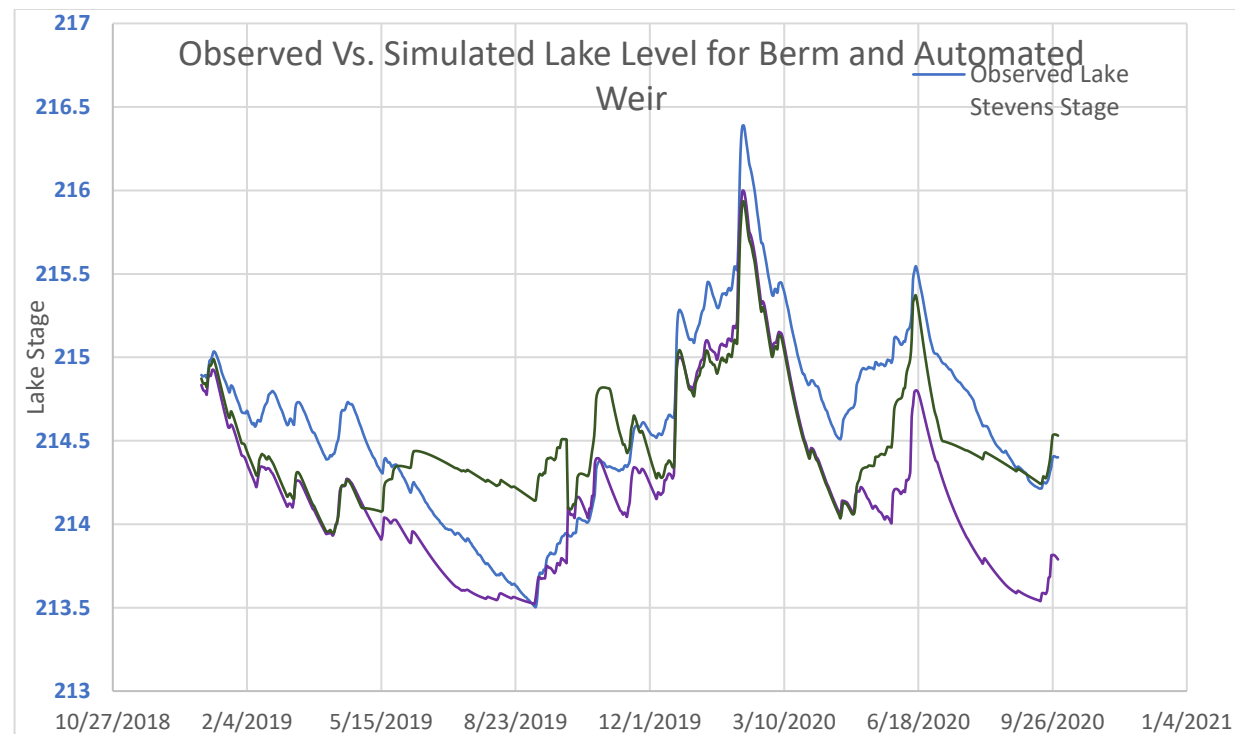
Figure 13 - Simulated berm and automated weir lake level compared to observed data.

Berm	Automated Weir (with Fish Passable Orifice)
<ul style="list-style-type: none"> Berm elevation set to 213.5 	<ul style="list-style-type: none"> The velocity leaving the weir/notch should not exceed 4 ft/s (when the weir is in-channel). The minimum flow leaving the weir should be approximately 2 cfs (when the weir is in-channel). The lake level should not drop below 213.5. The idea is to keep as much water in the lake from spring into summer to allow for approximately 2 cfs release and ideal lake levels for recreation throughout the summer. The lake level and level downstream of the weir should never exceed a 6" difference (i.e. minimum required jumping distance required for fish passage. Note, in the current model when the weir is deployed, water never overtops the weir).

The project team conducted hydraulic modeling of the lake outlet for the full 10-year analysis period for both the berm and automated weir. As seen in the summary figures, lake levels with the automated weir are often above elevation 214 and 2 cfs of flow is able to be released throughout the dry months for fish passage. Looking at the berm simulation, the lake level fluctuates more throughout the year yet nearly matches the peak lake level of the automated weir during the february 2020 event; however, you can see that outlet channel flows do dip below 2 cfs during throughout the analysis. The berm would likely have considerable savings in construction and operations/maintenance costs.

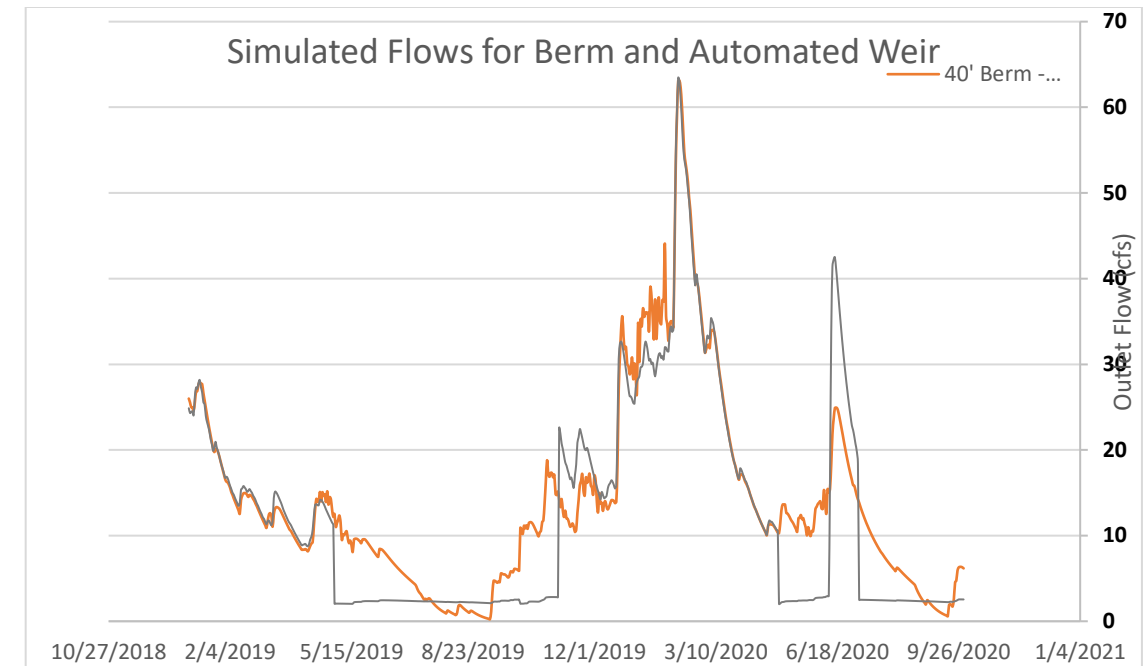
Figure 14 - Simulated berm and automated weir flows in outlet channel.

Some parameters related to fish passage are shown in Table 2 for the entire 10-yr period. With a set berm elevation, there were multiple days in the analysis with zero flows in the outlet channel and flows less than 2 cfs; the automated weir never has zero flow days and can nearly always release 2 cfs of flow when the weir is in-channel. Another metric reviewed by the project team was the depth of flow over the weir; 1 ft min of flow depth is an initial conservative depth reviewed to provide data metrics. As we can see, there are multiple days throughout the analysis duration where flow depth over the berm are below 1 ft. If the berm design option is selected, further refinement and satisfying parameters clarification would be needed.
