One Community Around The Lake

Lake Stevens Lake Management Program Overview

SHANNON FARRANT AND SETH WALTZ

FEBRUARY 24, 2026

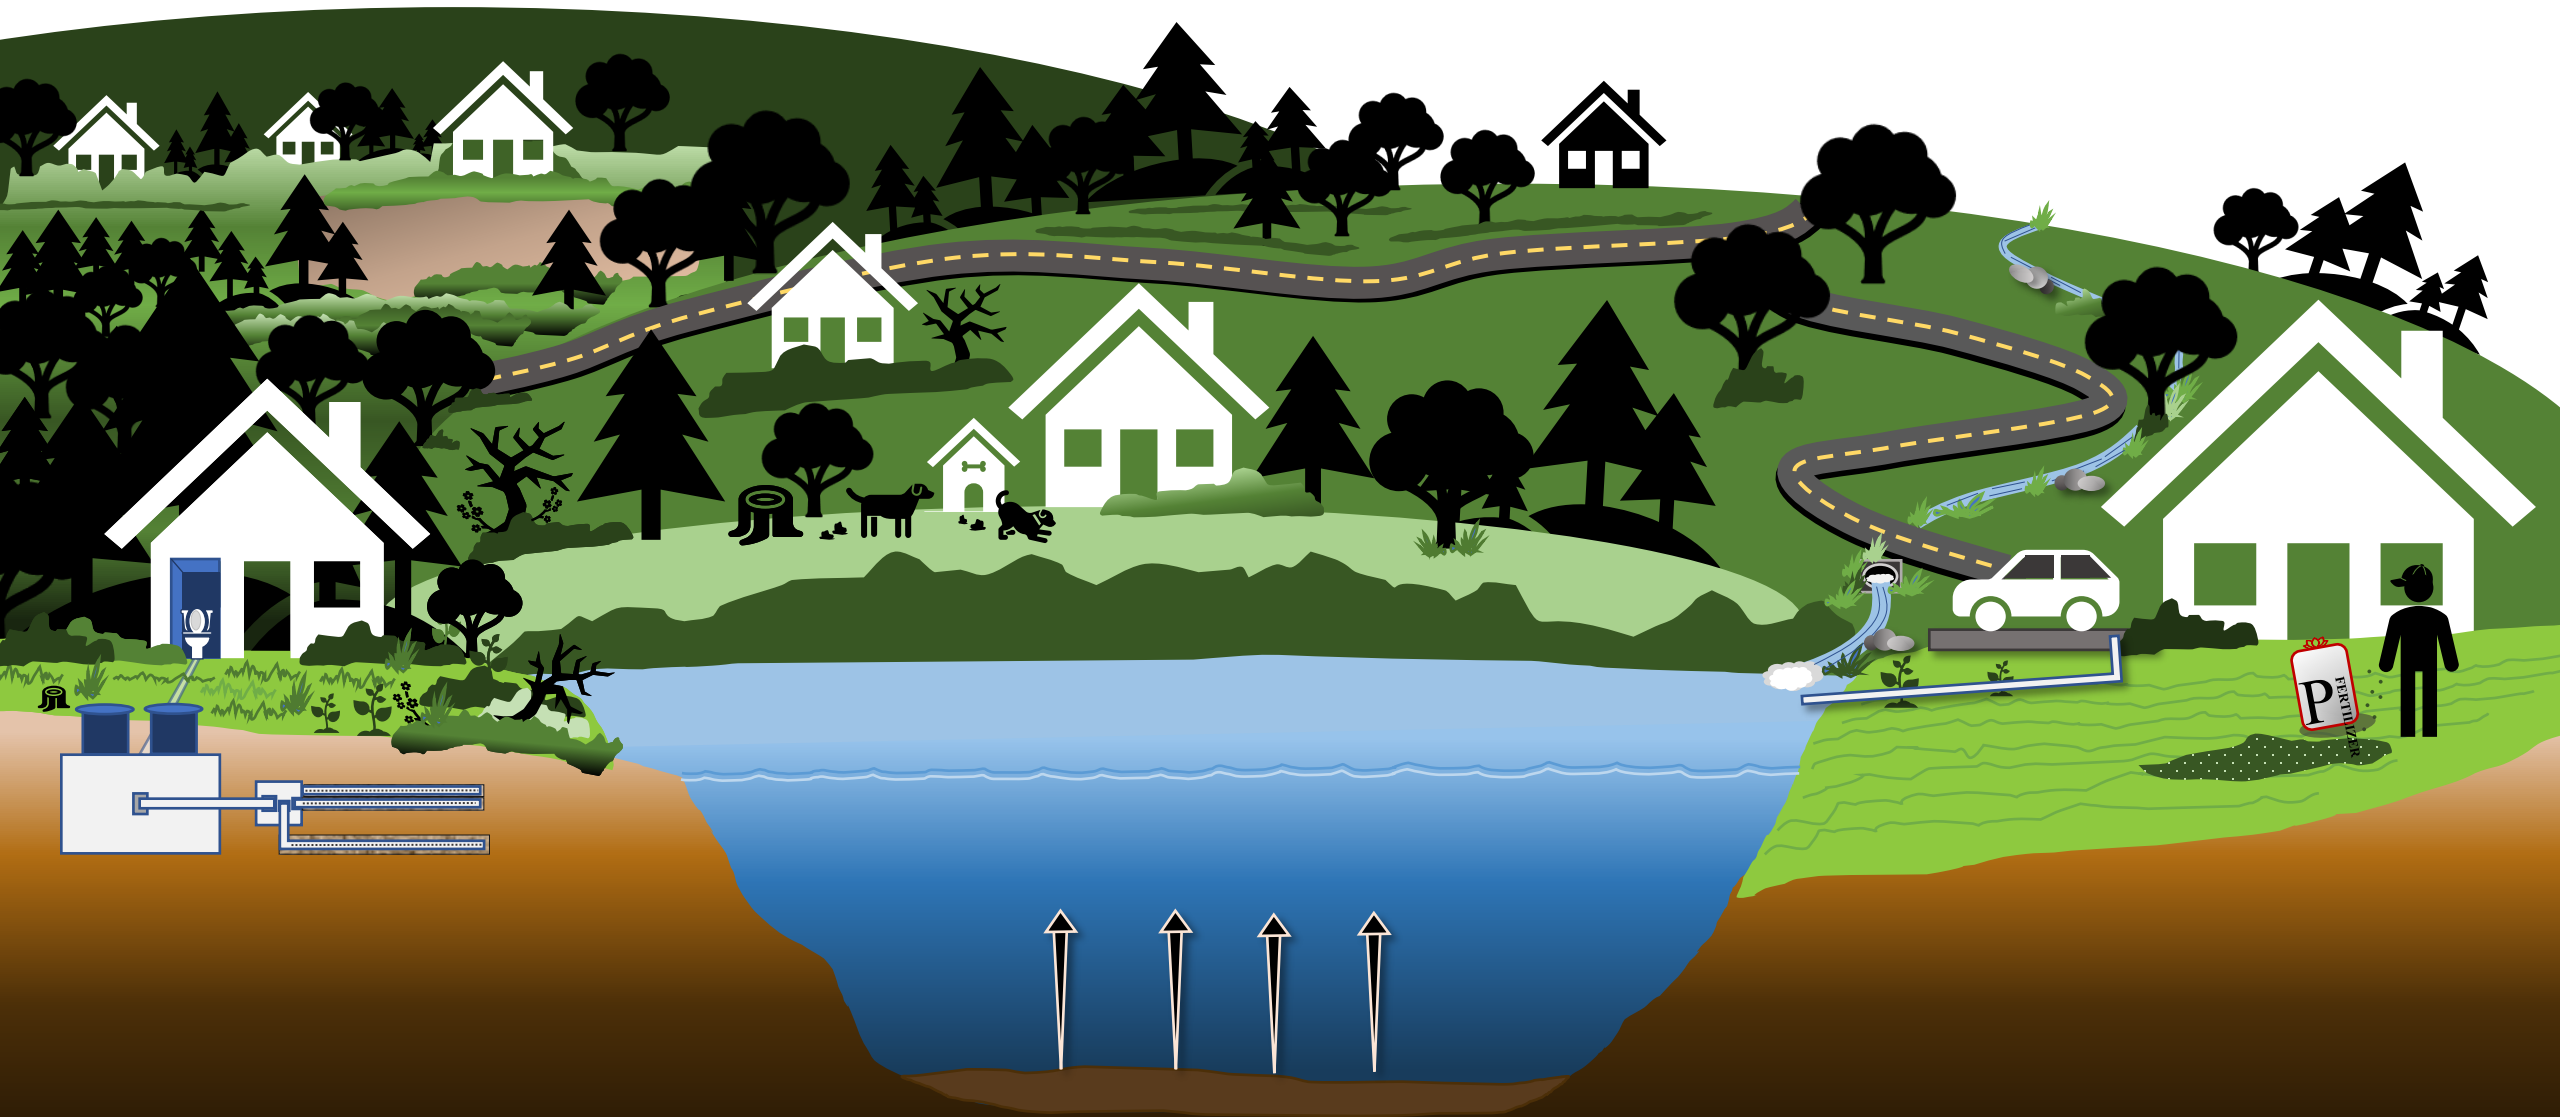
All that Phosphorus builds up at the lake bottom which can recycle back into the water which is called - INTERNAL LOADING

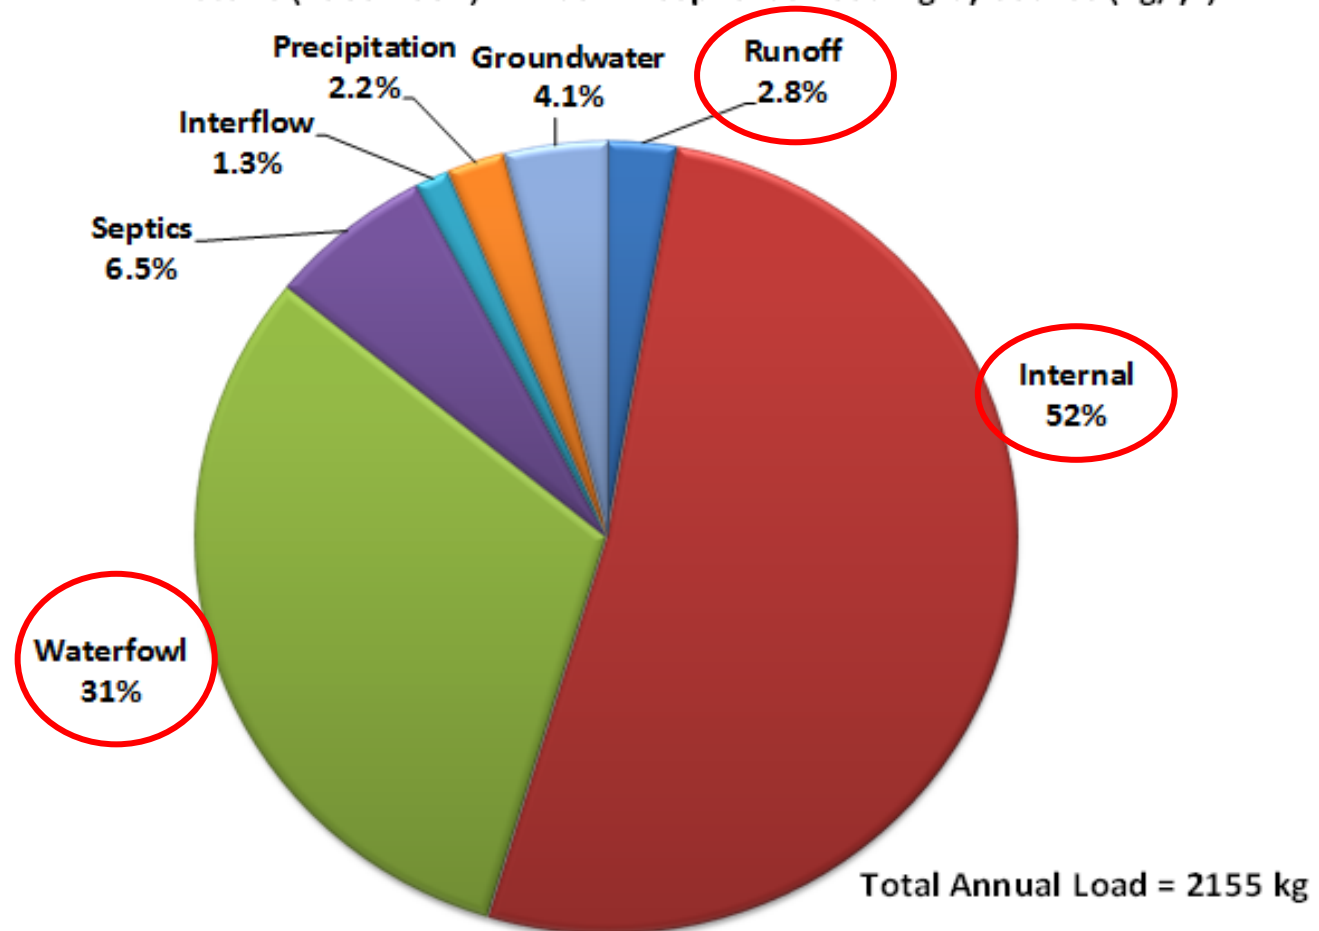
Historic (1986-1987) Annual Phosphorus Loading by Source (kg/yr)

Historic Sources of Phosphorus (1986-1987)

Internal loading mainly occurs when oxygen is low

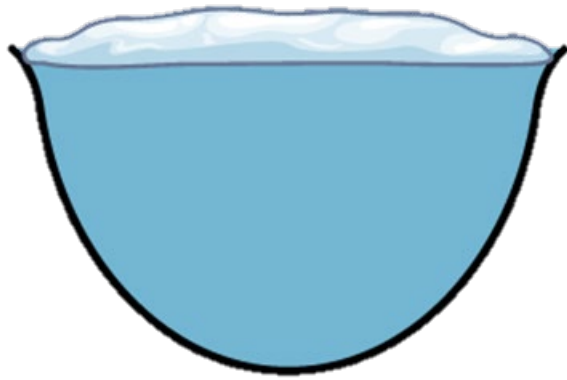
Winter

Seasonal Cycle of Lakes - Temperature

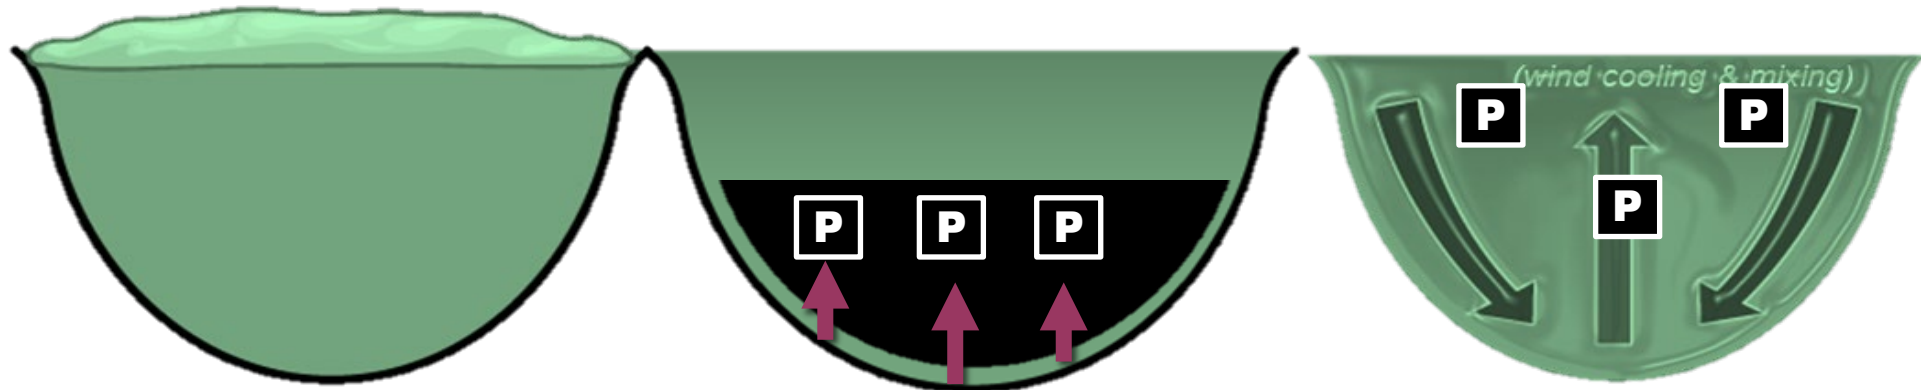
Dissolved Oxygen

Phosphorus **bound to iron** in lake sediments **is released** when **no oxygen**

When the lake mixes it is spread throughout the lake

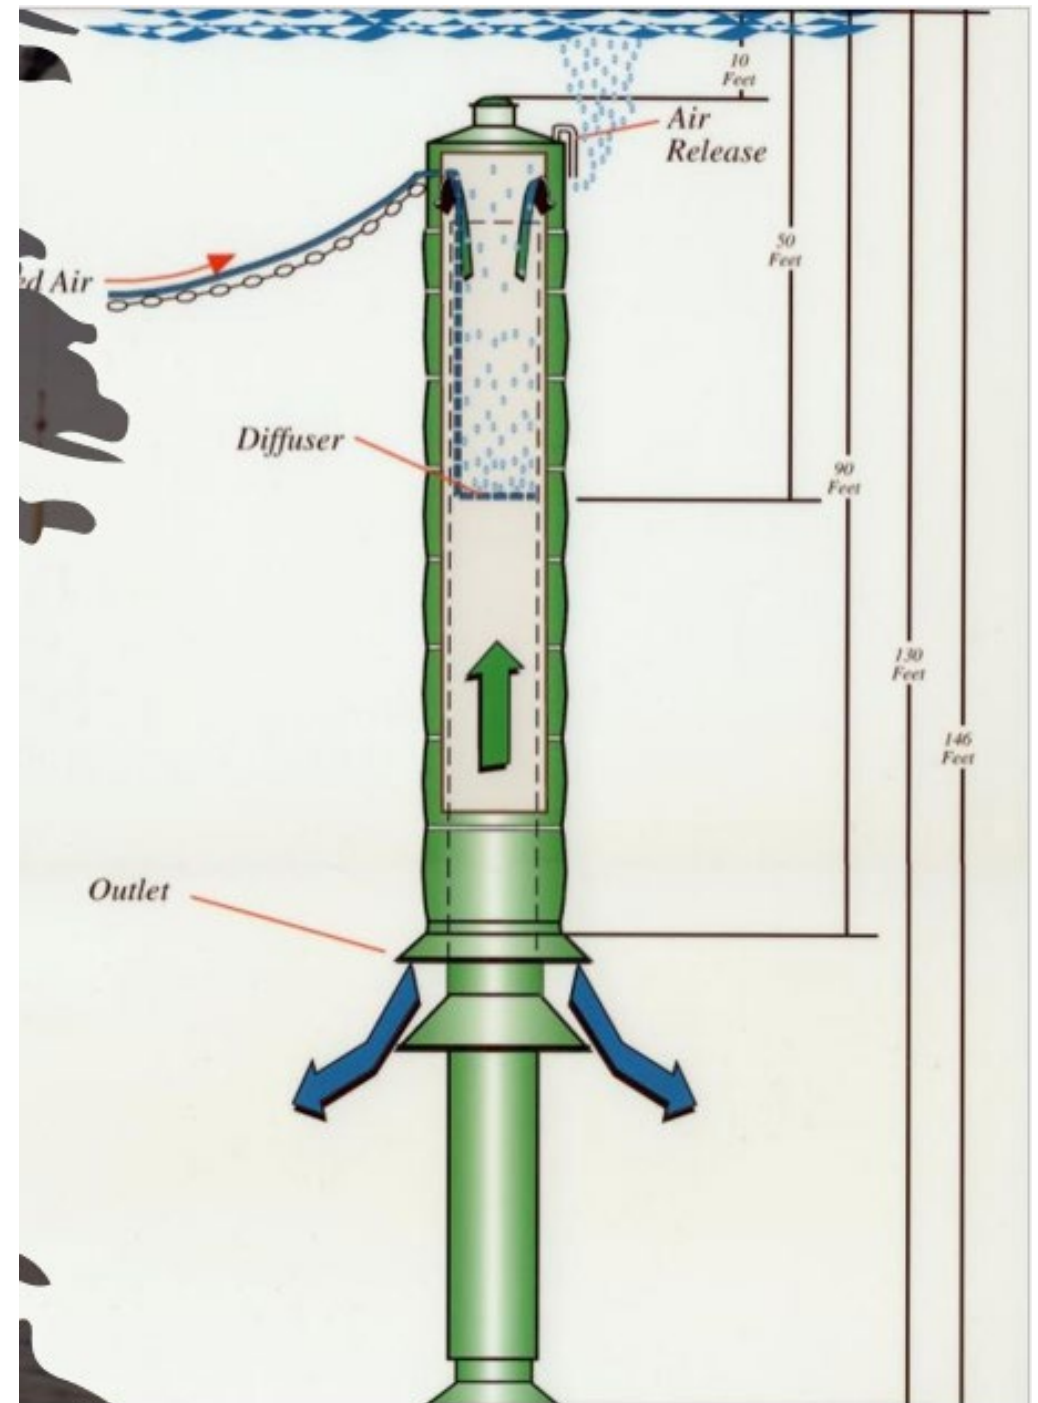
Lake Management Strategy #1 Aerator

- In 1994, a \$1.1 million hypolimnetic aeration system was installed
- The four aerators pull low-oxygen water from the lake bottom, mix it with air, and send the high-oxygen water back to the bottom.
- In the presence of oxygen, iron in the sediments stays bound and holds phosphorus
- Operational 1994- 2012

- 2009 sediment study completed
- Finding - Depletion of iron needed to bind all the phosphorus

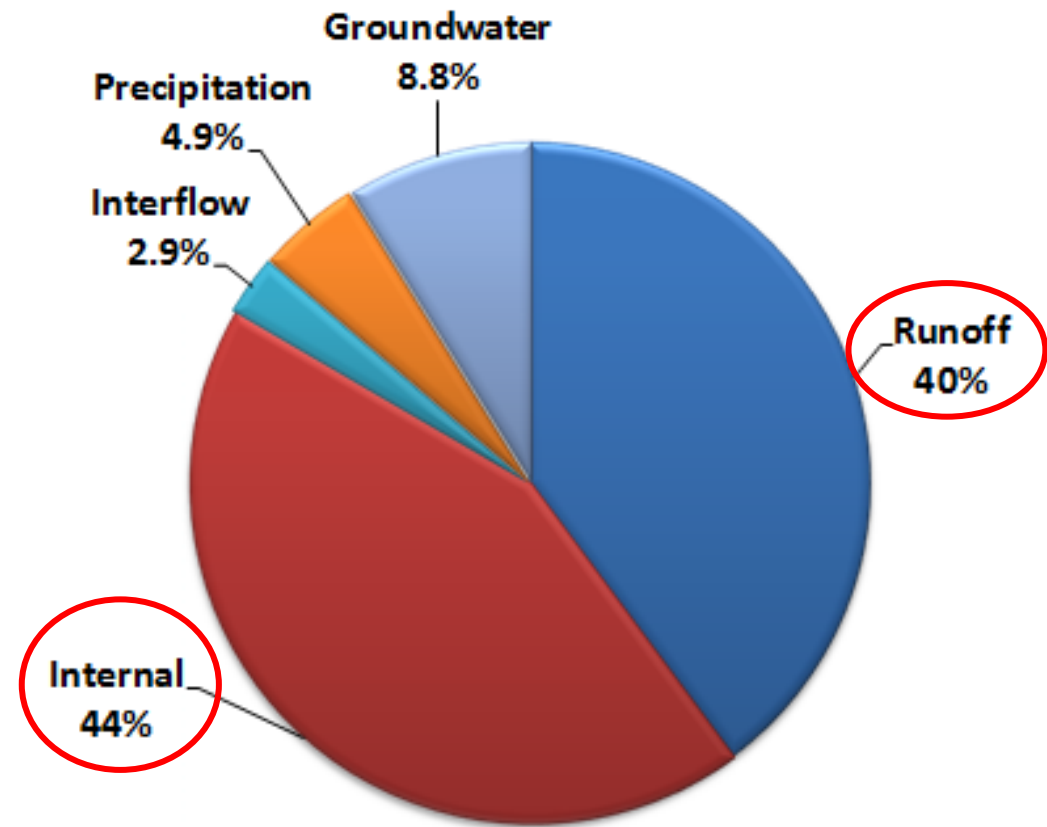
2011 Study

Total Annual Load = 992 kg

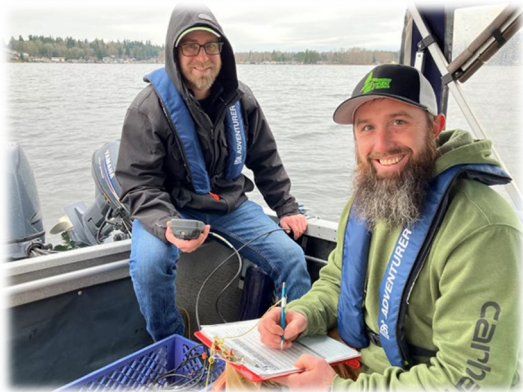
Sonde Reading

WATER QUALITY MONITORING

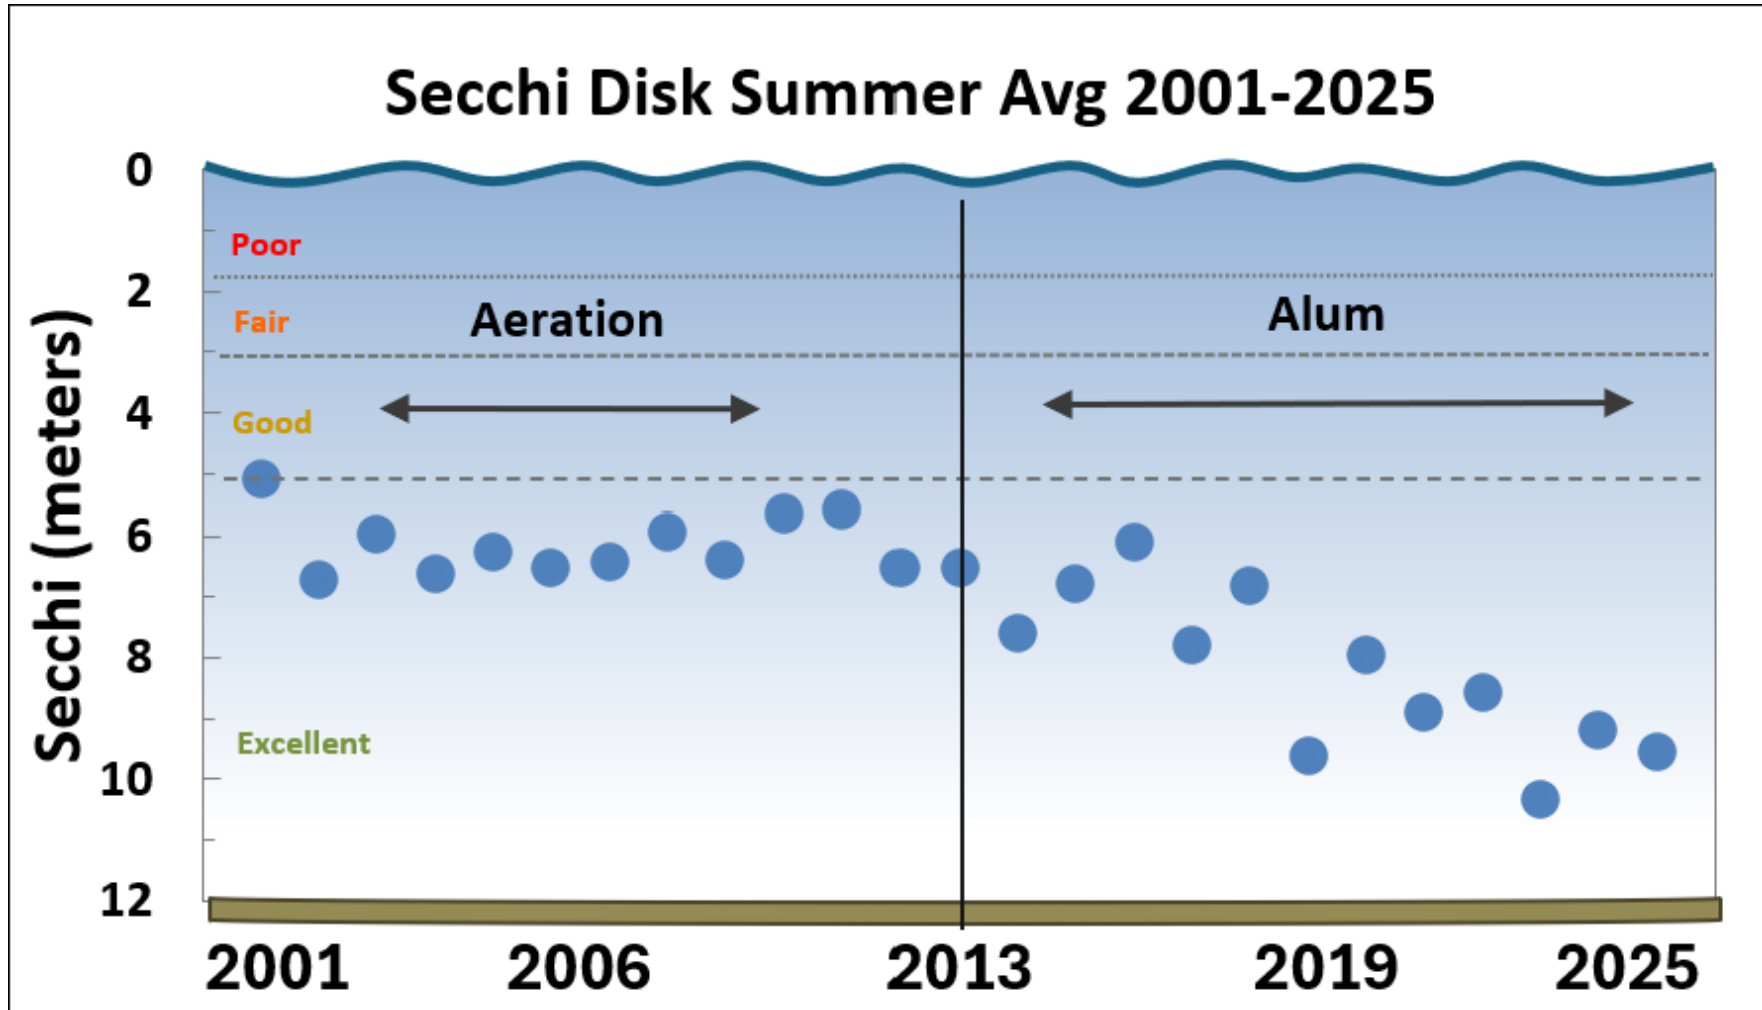
Water Clarity

EXCELLENT

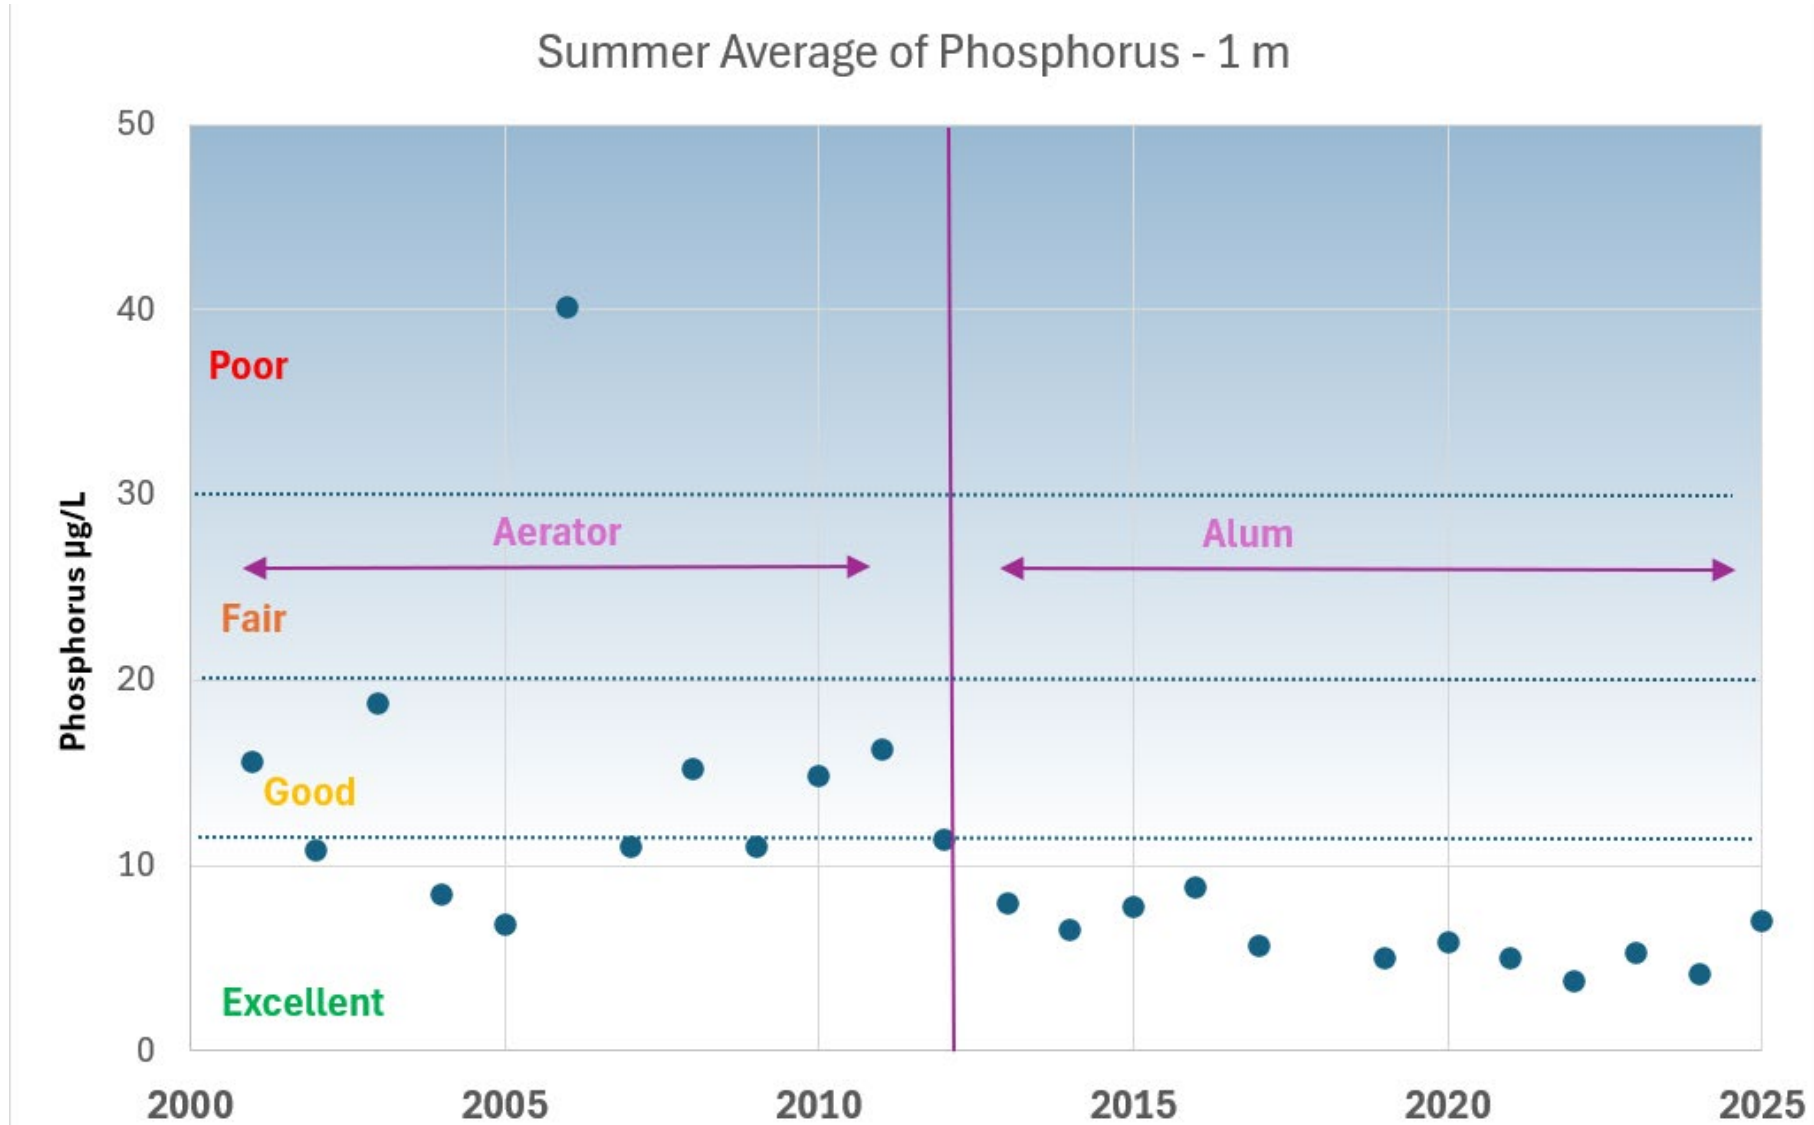
Phosphorus

EXCELLENT

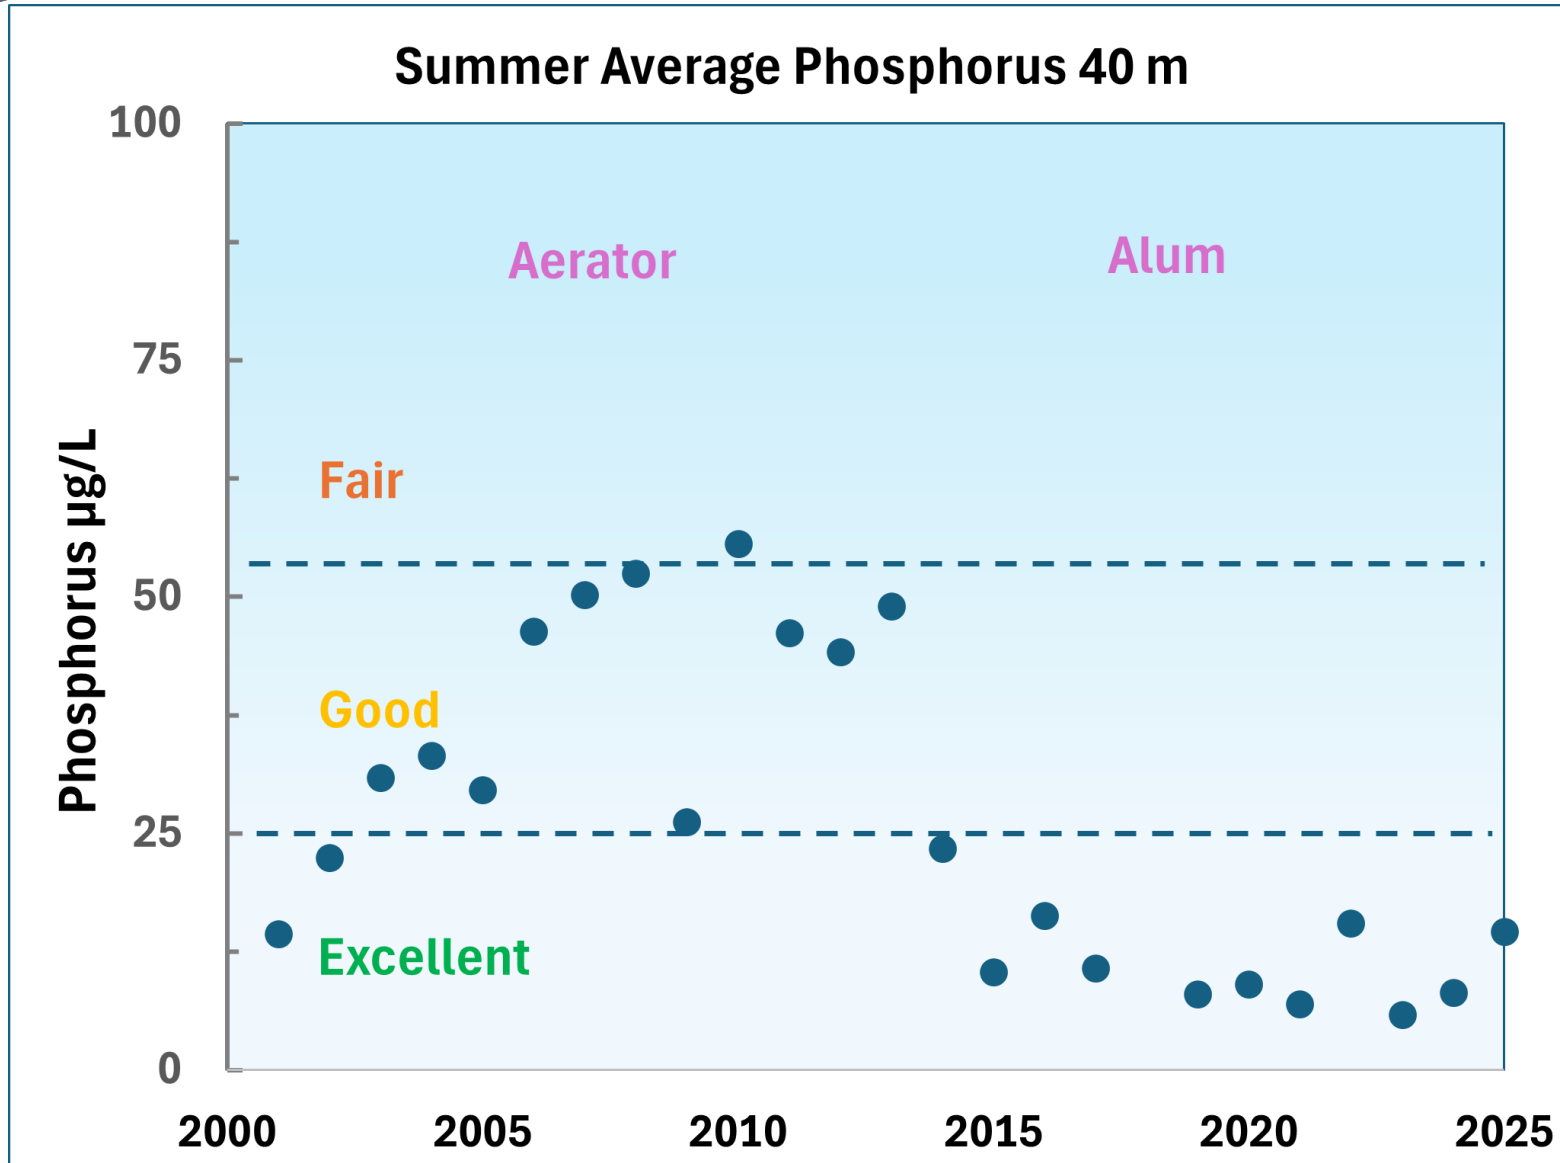
Phosphorus

EXCELLENT

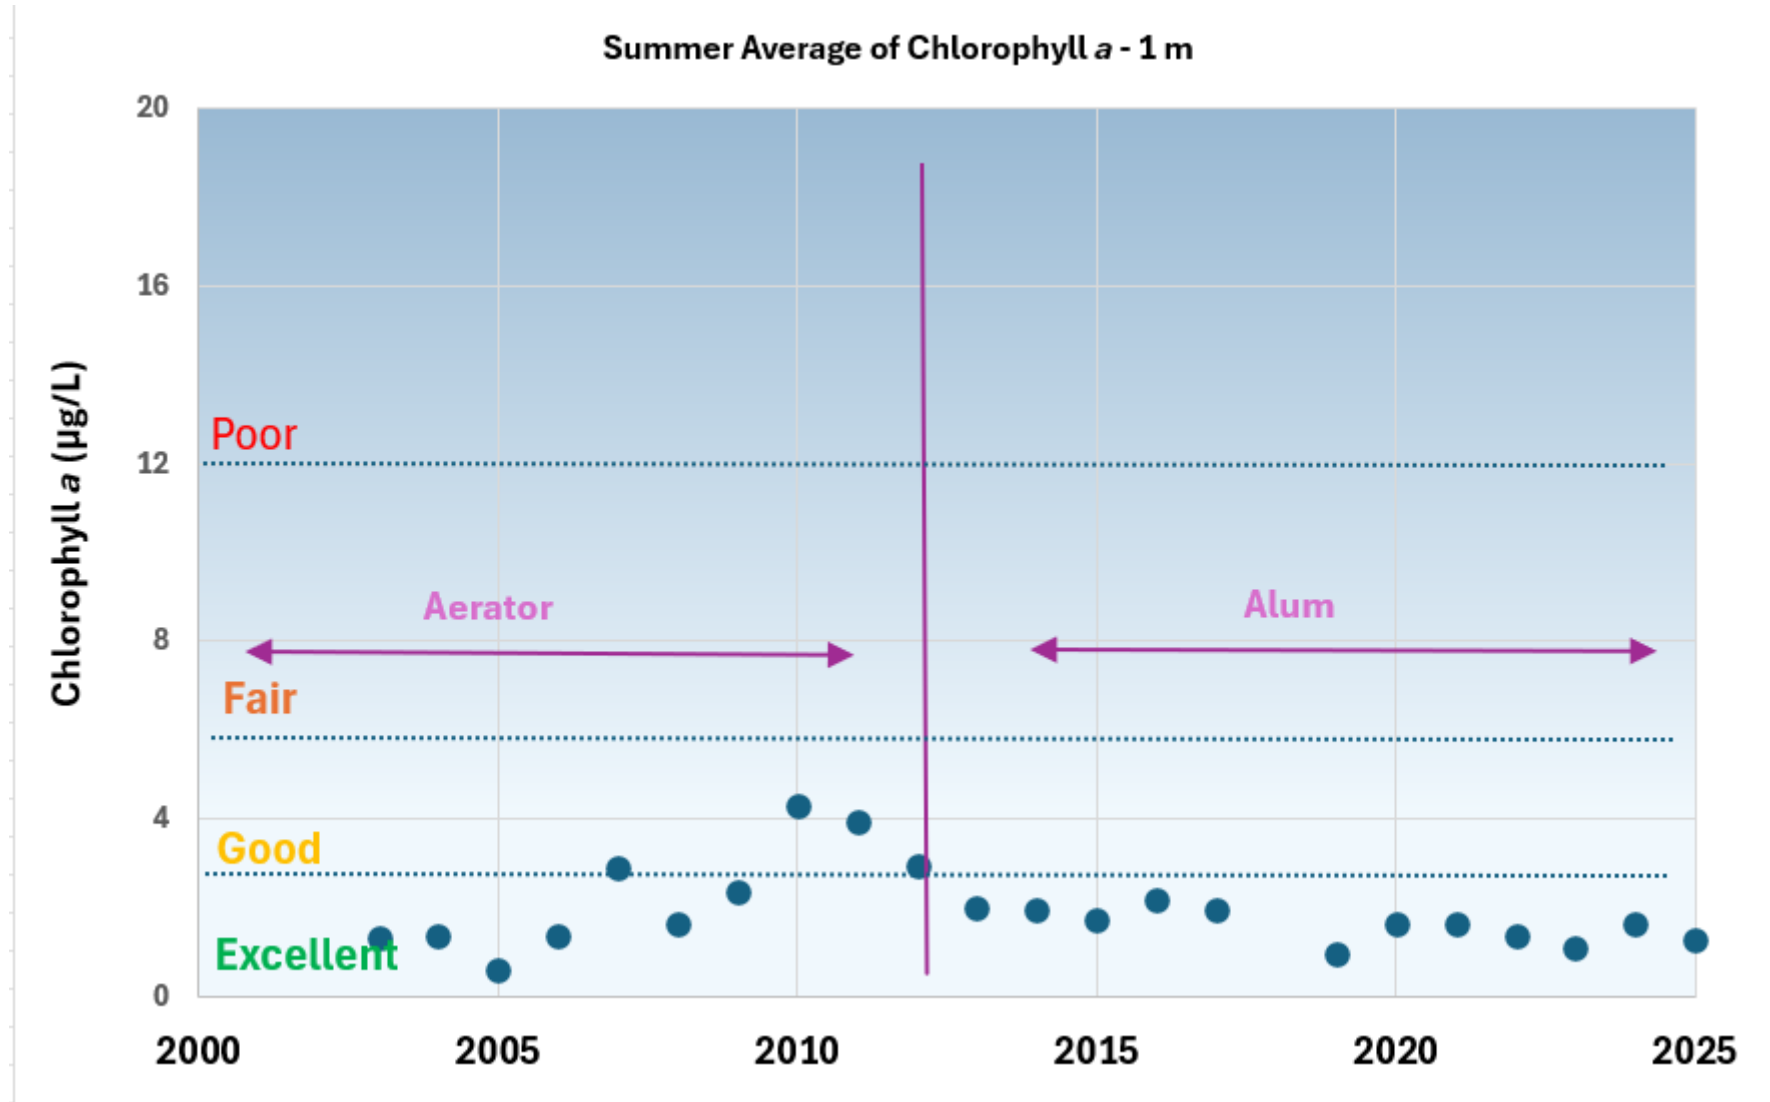
Chlorophyll a

EXCELLENT

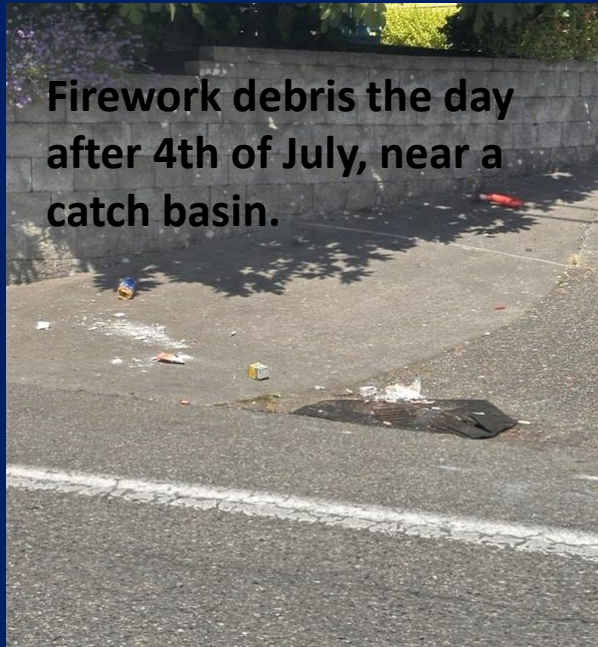
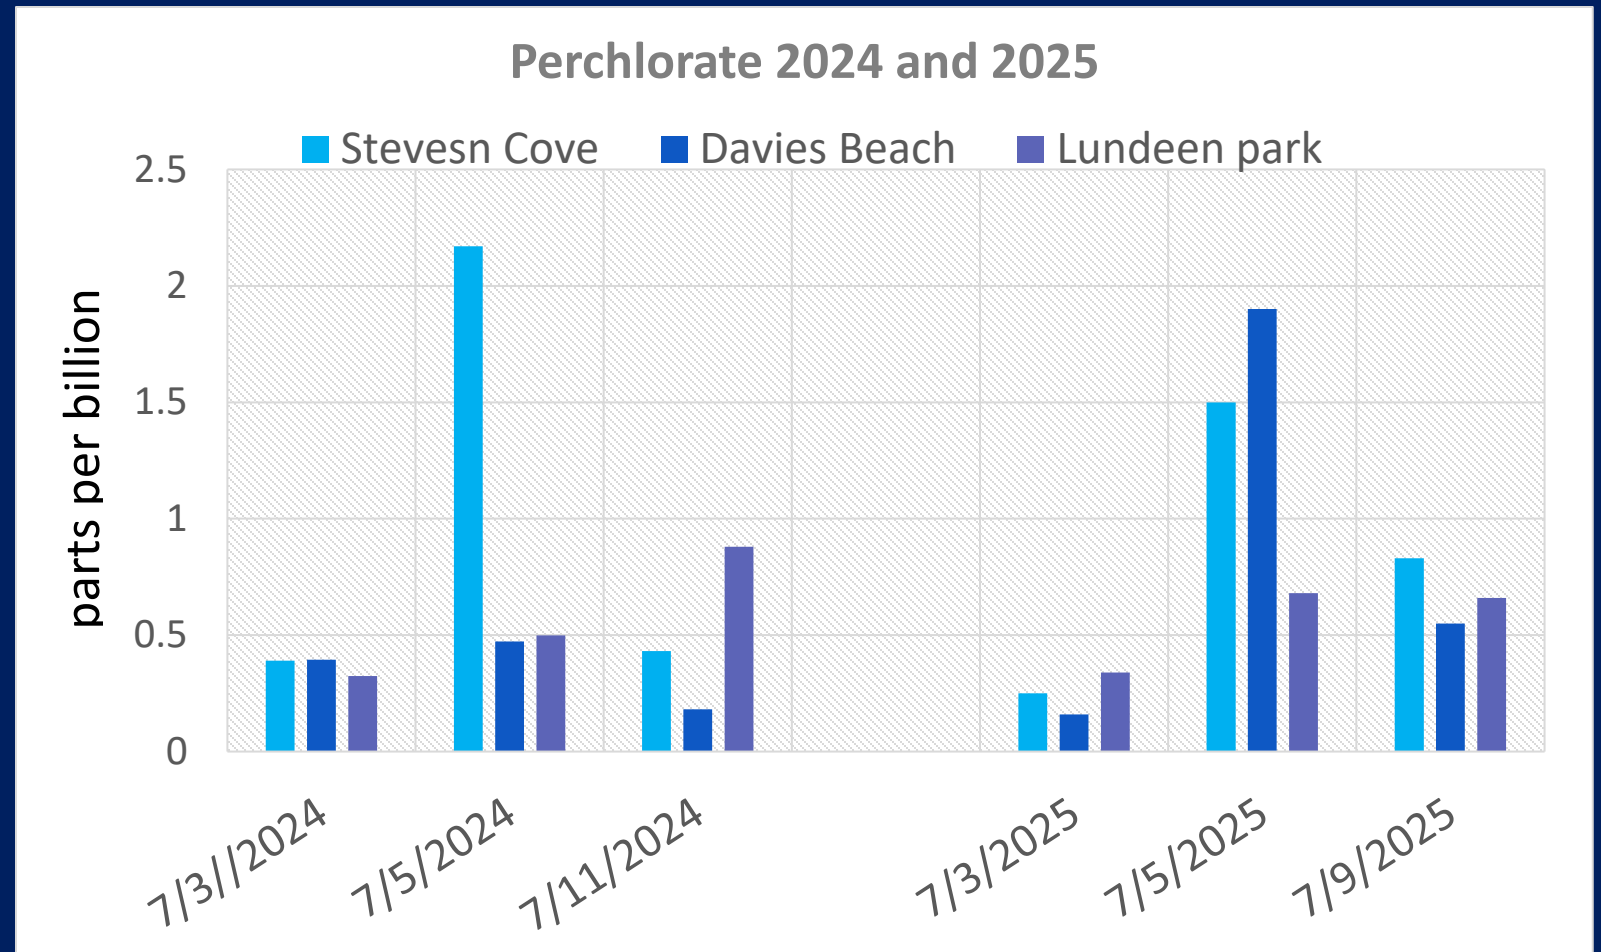
Perchlorate in Lake Stevens

- EPA drinking water maximum contaminant level goal: 20 ppb, effects are detectable at 1 ppb
- Goldfish study showed impacts on the thyroid at concentrations starting around 1,200 ppb
- Continued perchlorate testing: \$3,000 - \$4,000/year
- Our Recommendation: Sample every 3 – 5 years to establish and track long-term trends
