RE: White Lake Road Site
Environmental Impact Study

This Environmental Impact Study (EIS) assesses a proposed residential development in the southwest portion of the Town of Arnprior. The 14.7 hectare site is in the Madawaska River watershed, on the east side of White Lake Road, between Van Dusen Drive to the south and Bev Shaw Parkway to the north.

**White Lake Road Site
Arnprior, County of Renfrew**

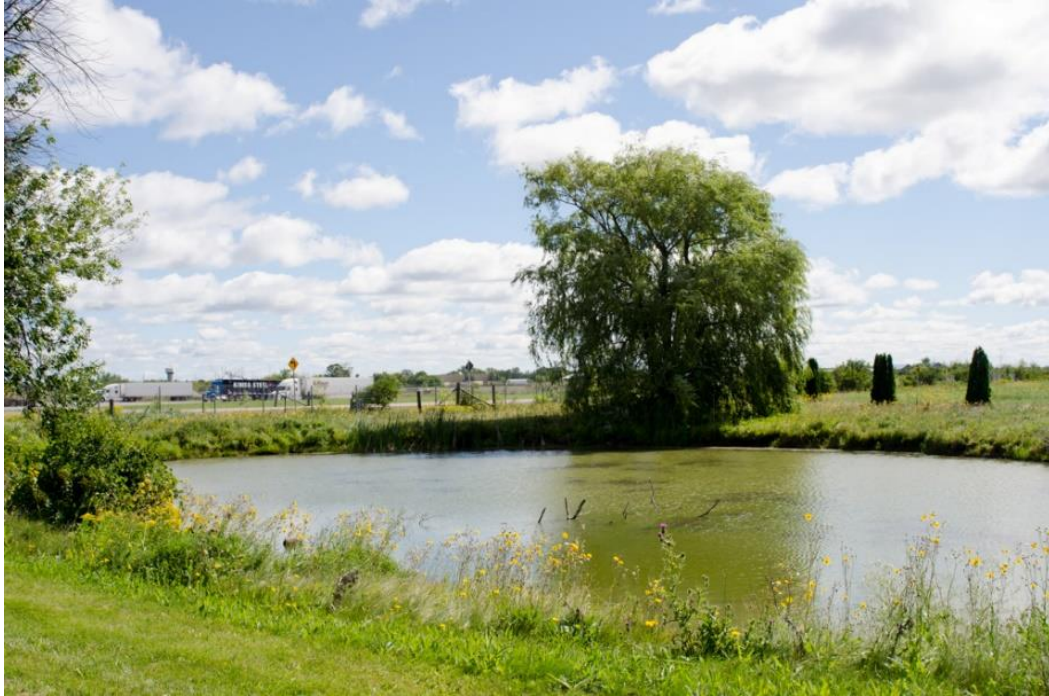
As indicated above, a pond is on the driving range lands east of the parking lot east of White Lake Road (Photo 1). The pond is approximately 110 metres in length, with an area of about 0.25 hectares and appears to be dug, with no obvious inlet or outlet.

*Photo 1 – Dug pond between the driving range and White Lake Road.
View looking northeast*

3. Prior to filling in the dug pond associated with the driving range, water is to be mostly drained from the pond and any fish, turtles or other sensitive wildlife in the pond relocated by qualified biologist to the Madawaska River corridor to the east. It is important that the screening on any dewatering pumps is fine enough to prevent fish from being sucked into the pumps. A fish collector's permit will be required from MNRF for the relocation of stranded fish. A minimum of three weeks should be allowed to obtain this permit;

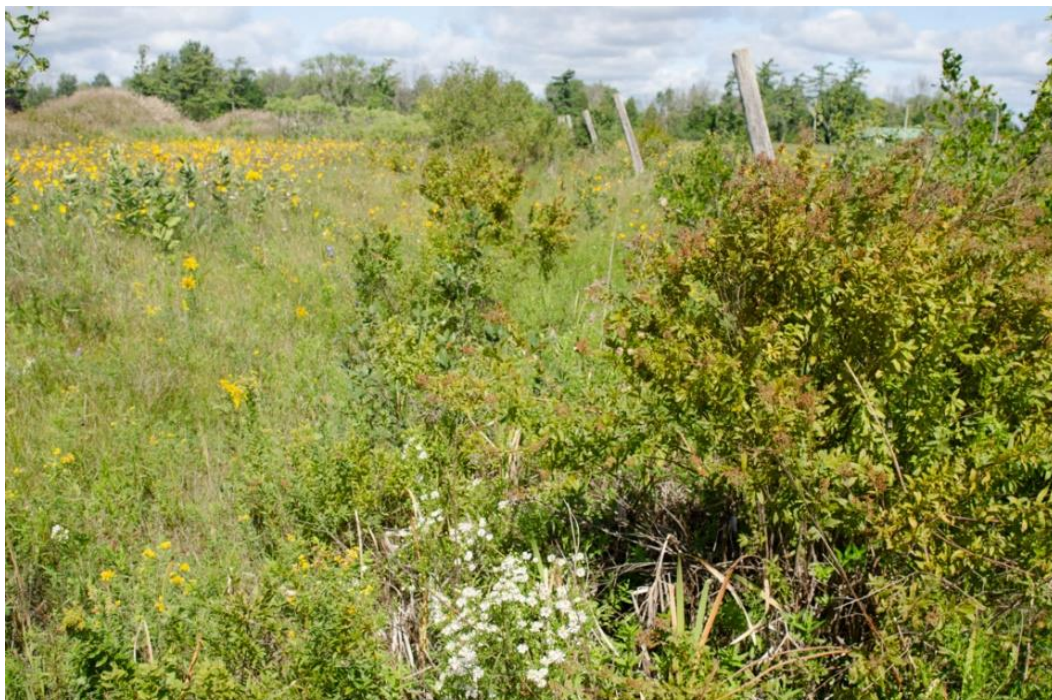
Potential swales supporting aquatic habitat were reviewed, including along the east edge and north site edges and an east-west channel between an agricultural field and the driving range (Photo 2). Some wetland vegetation (broad-leaved cattail, purple loosestrife, reed canary grass) was noted in the swales but the lack of a defined low flow channel or other aquatic habitat features and presence of woody vegetation and upland ground flora through the swales in areas indicates there is no direct aquatic habitat potential in the swales. Also, the east-west channel does not connect to the west-east roadside ditch on the east side of White Lake Road (Photo 3).

*Photo 2 - Swale between the driving range and the agricultural field.
View looking west*

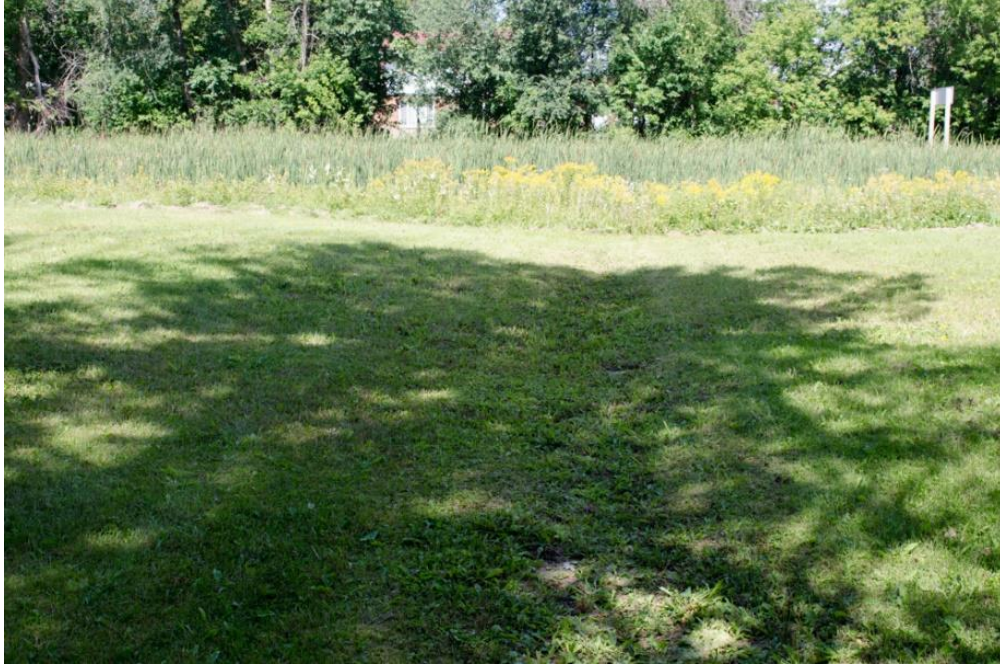
Photo 3 – No connection is present between the west edge of the central east-west swale and the roadside ditch on the east side of White Lake Road. View looking west to the road

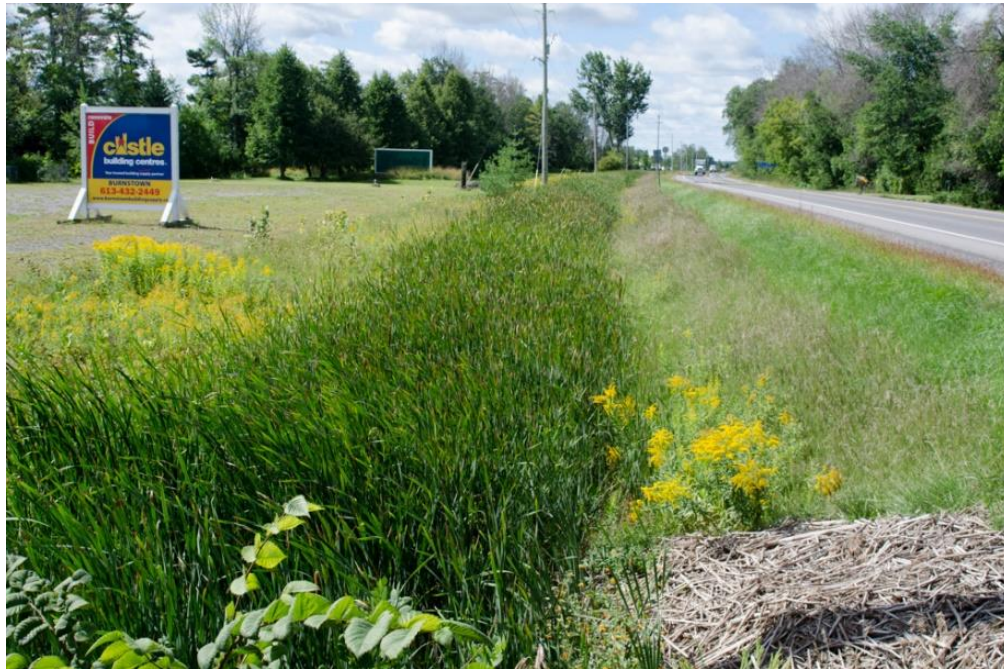
The roadside ditch on the east side of White Lake Road was thick with cattails in late August (Photo 4). Standing water was present in the ditch but no flow was noted and no well-defined low flow channel was observed. In the spring, flow in the ditch likely continues north towards the highway interchange but it does not appear to be connected to any aquatic features of note.

*Photo 4 –Roadside ditch on the west side of White Lake Road.
View looking south from the north access to the driving range parking lot*

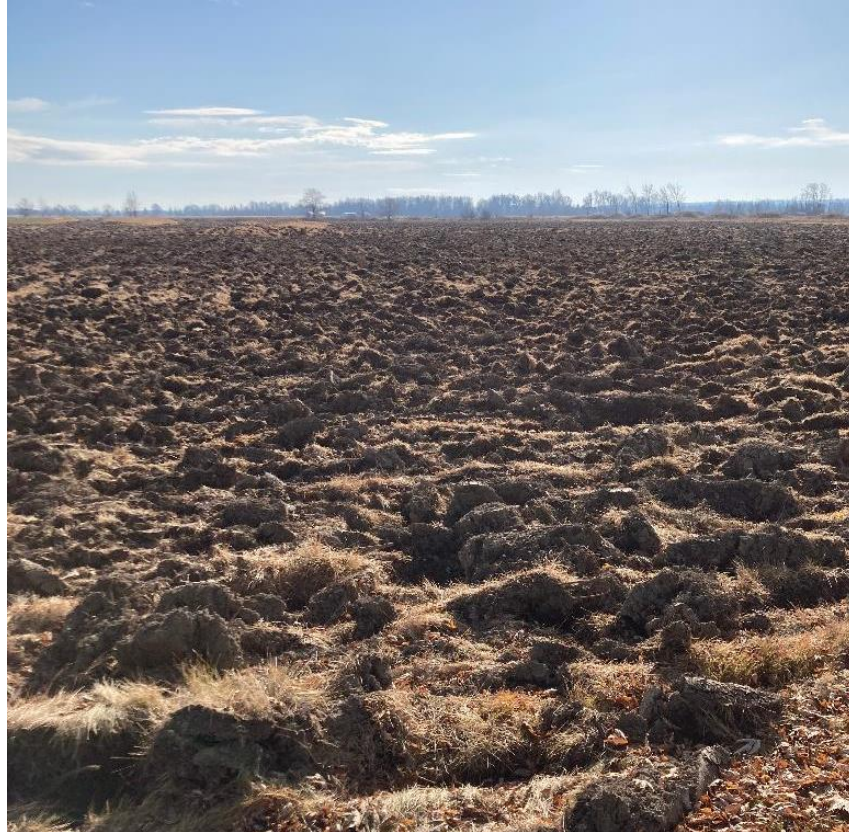
An approximately four-hectare agricultural field, ploughed in the fall of 2020 (Photo 5), dominates the south half of the site. Meadow vegetation along the field edges includes common brome grass, June meadow grass, yellow rocket, cow vetch, wild carrot, and white clover.

Photo 5 – Ploughed field in the south portion of the site. View looking northwest from the southeast corner of the field

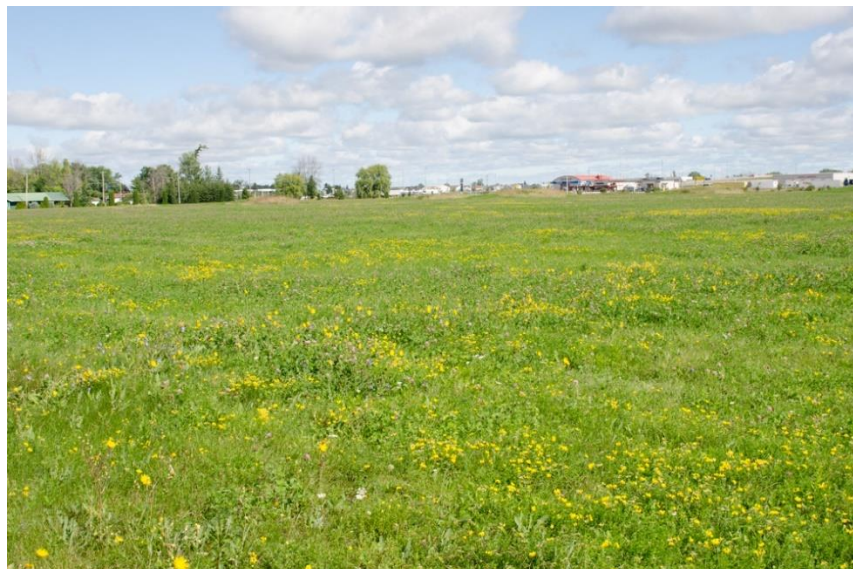
The driving range appears to be continued to be mowed (Photo 6), and is dominated by ground flora such as June meadow grass, bluegrass, red clover, chicory, common yarrow, tufted vetch, common ragweed, common dandelion, wild carrot, and field sow-thistle.

Photo 6 – Driving range in the north portion of the site. View looking northwest from the southeast portion of the driving range

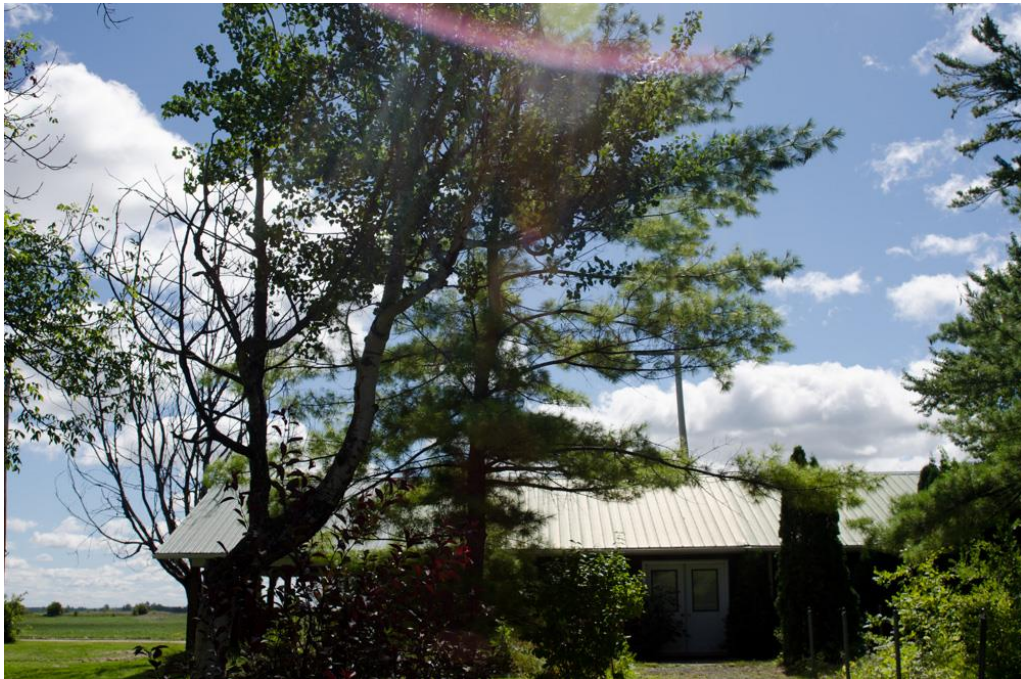
scattered around the closed driving range office (Photos 7 and 8), with smaller white spruce and Colorado spruce. Trees around the pond between the driving range field and parking lot south off White Lake Road include a mature weeping willow and smaller white ash, bur oak, Colorado spruce, and white pine. Many of the white ash were in poor condition with dead branches.

Photo 7 – A 55cm dbh white pine and smaller white spruce on the west side of the driving range office. View looking east

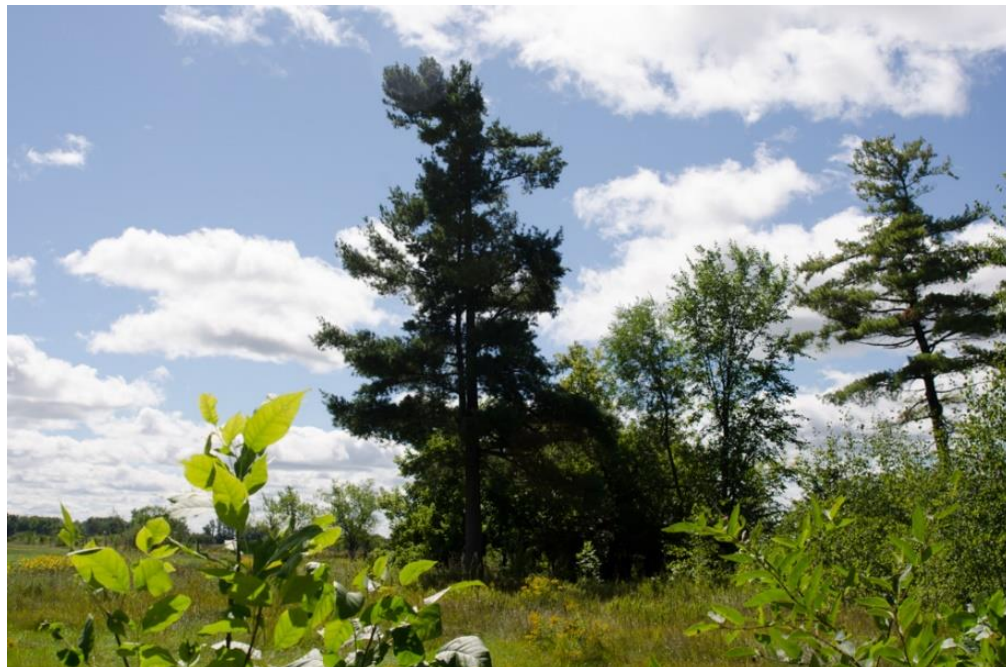
Photo 8 – A mature white pine in the west-central portion of the site. View looking east

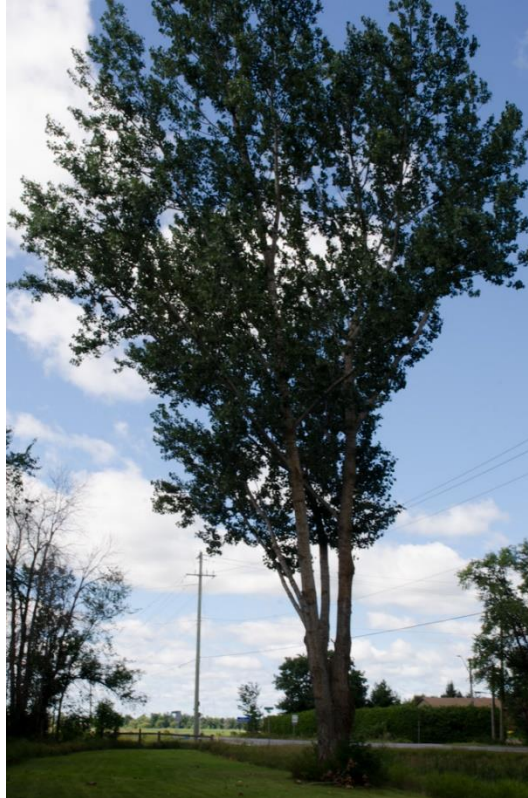
A mature (75cm dbh) eastern cottonwood (Photo 9) is in a mowed area between the north-south hedgerow described below and White Lake Road.

*Photo 9 – A mature (75cm dbh) eastern cottonwood in a mowed area east of White Lake Road.
View looking southwest*

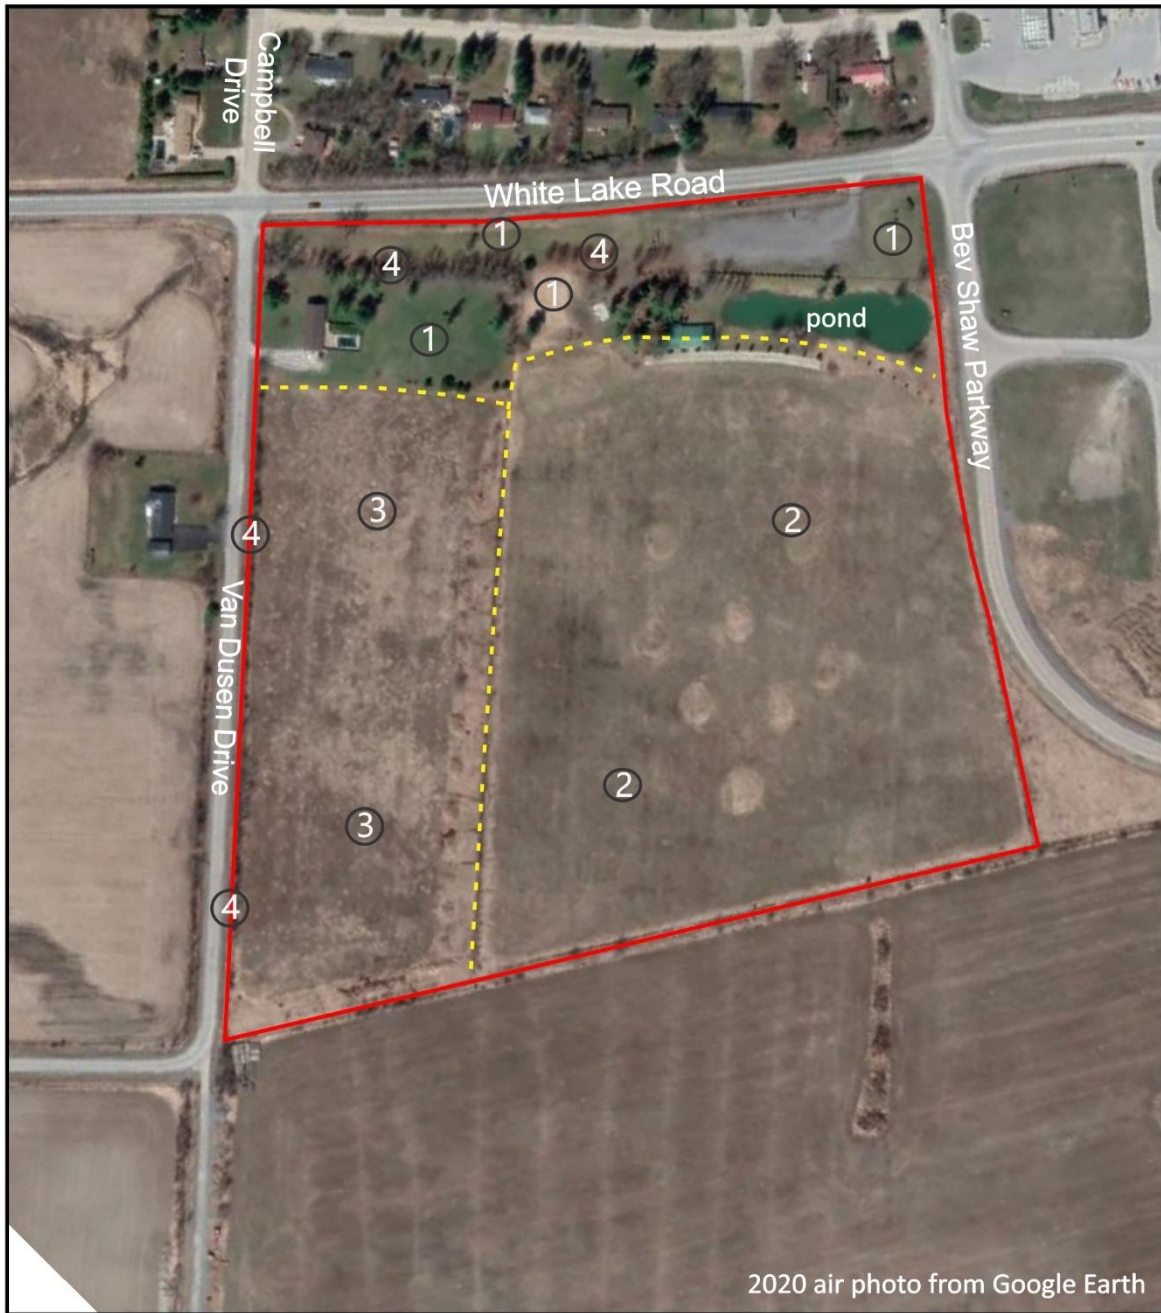
Figure 1

NATURAL ENVIRONMENT FEATURES

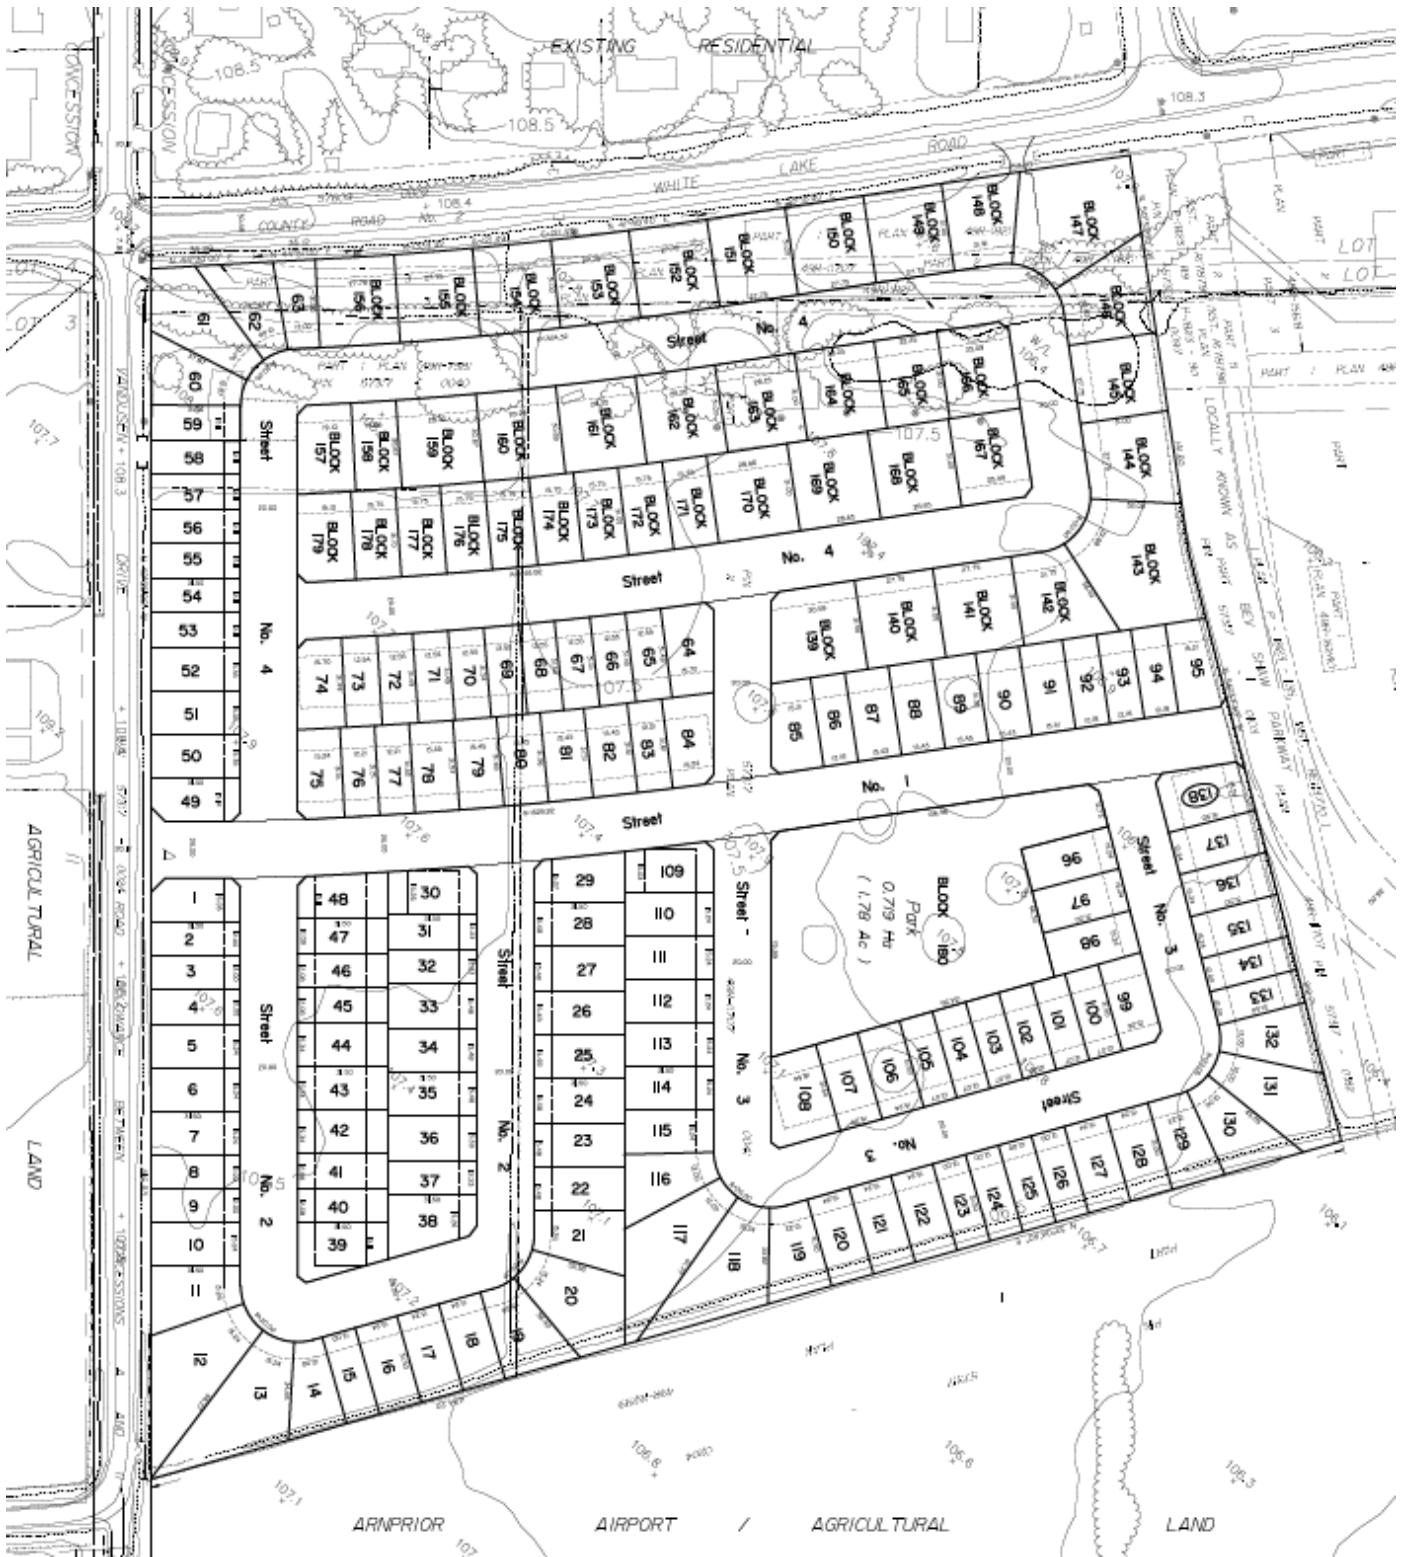
FIGURE 2 – DRAFT PLAN of SUBDIVISION

One-hundred and thirty-eight single detached residences, 22 semis, and 112 townhouses, for a total of 272 residential units, are proposed for the site. The detached residences will be in the central and east portions of the site, with townhomes and semi-detached units proposed for the west portion, east of White Lake Road (Figure 2). The detached lots have frontages between 12 and 15.5 metres, with depths in the range of 31.5 metres. A 0.7 hectare park is proposed for the northeast portion of the site. There will be no access off White Lake Road, with a new road connecting Van Dusen Drive and Bev Shaw Parkway and internal crescents off this new road (see Draft Plan of Subdivision, shown as Figure 2 at the end of this EIS). The development will
