Lake Stevens Aquatic Plant Management Year End Report 2025

Prepared for
City of Lake Stevens

**AquaTechnex,
LLC**

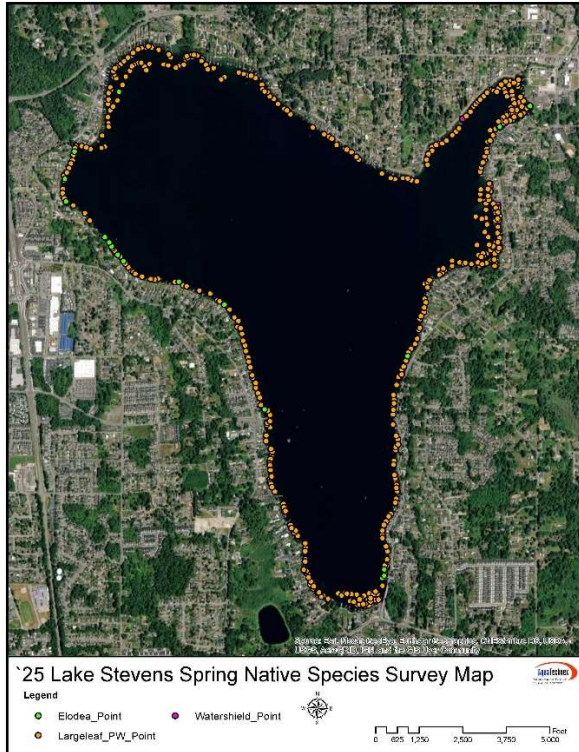
Figure 1: Spring Native Species Map

The lake's littoral zone has extensive areas where the native largeleaf pondweed (*Potamogeton amplifolius*) has established in the last few years. There are other *Potamogeton* species and *Elodea* mixed in as an understory to this plant. Note the Spring Native Species Survey Map below in Figure 1. In addition, invasive state listed Eurasian milfoil was noted in a few more locations than last year, several plants were observed at pioneering levels along the eastern shoreline and in the bay at the northeast corner of the main lake. Curly leaf pondweed continues to be observed as well. Fragrant water lilies are found in several locations around the lake. All recorded invasive species locations are noted in the Spring Invasive Species Map below in Figure 2.

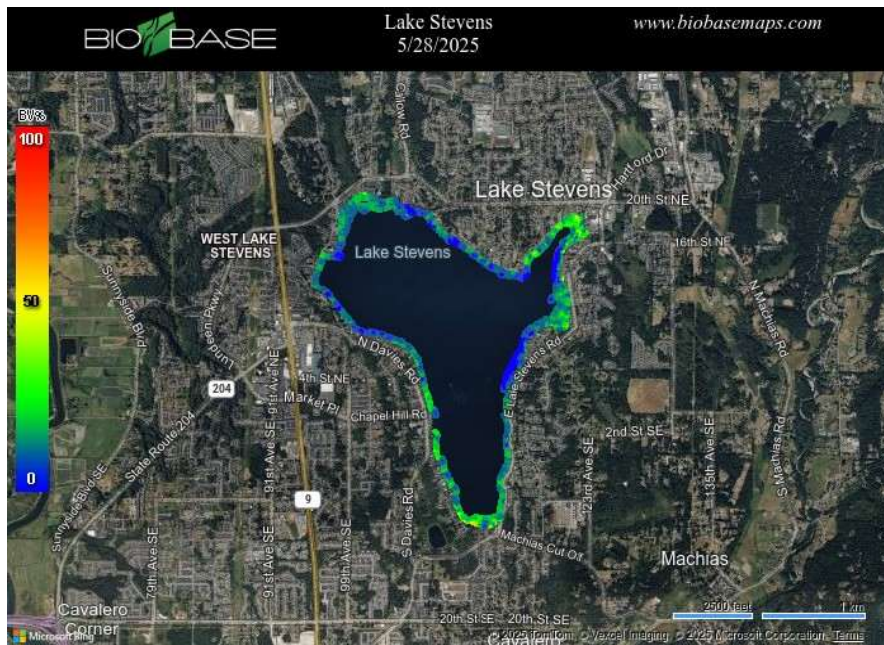
Figure 3: Lake Stevens BioBase Biovolume heat map.

Within the survey area, 66% of this zone supports aquatic plant growth. There are many areas of the littoral zone that are vegetation free. Much of the north shoreline of the lake does not support aquatic plant growth at this point. This can be attributed to the hard lake substrates that are naturally present in this area. Biovolume data is presented and can also be viewed as a “HEAT” map. The HEAT map, figure

3., has a color ramp that shows the percentage of the water column filled with vegetation where aquatic plants are present. The bottom of the HEAT ramp is blue and indicates no vegetation present. The top of the HEAT ramp is red and indicates that aquatic vegetation fills the entire water column at those locations. These plant communities can be viewed on the adjacent map.

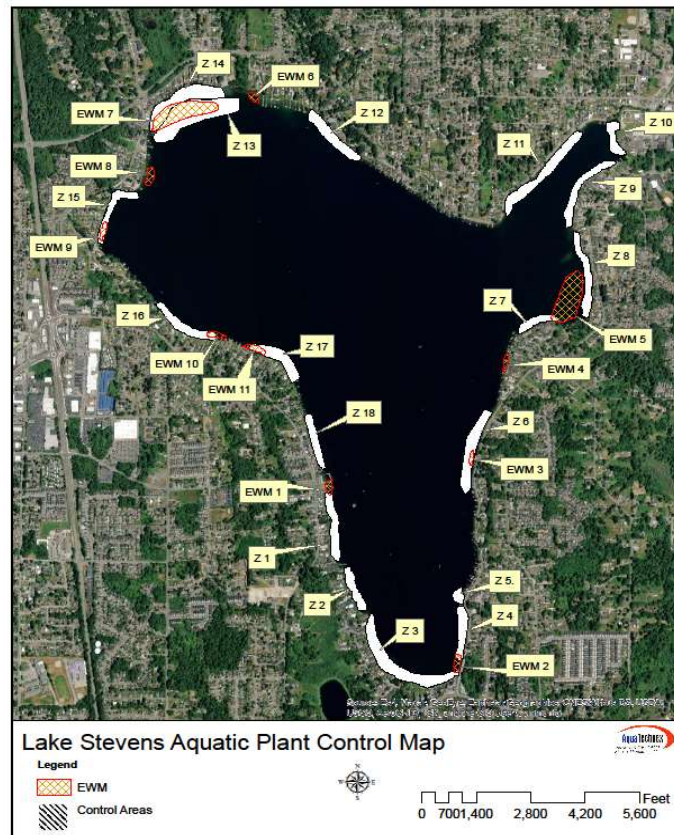
Figure 4: Control Map

The following proposed treatment map was developed based on the findings during the survey work. The state listed noxious aquatic weed Eurasian milfoil encompassed 19.14 acres. ProcellaCOR EC aquatic herbicide was recommended for each of the mapped zones to selectively target and remove the milfoil growth. ProcellaCOR EC herbicide is selective for only Eurasian milfoil and did not place any restriction on water use for potable supply, swimming or fishing. There was a 24-hour irrigation restriction on drawing water from the treatment area.

In addition, 4.74-acres of Curly leaf pondweed were delineated this summer. The main plots was located at the southernmost portion of the basin and in smaller sporadict locations around the lakes littoral area. Curly Leaf Pondweed has a unique growth habit and develops a hard reproductive

structures called turions which form at leaf axils and at the stem tips. Each plant can produce hundreds of these winter buds each year. These fall to the lake bottom in mid to late summer and sprout as new plants in the fall. The new plants overwinter and grow rapidly in the spring when day lengths increase often outcompeting native vegetation. One of the keys to controlling this plant is to complete plant control before turion production in the spring. There were also many areas where the Largeleaf Pondweed was present at nuisance level warranting control. Total area of nuisance aquatic plant control areas mapped totaled 88.04 acres.

Our first step prior to treatment is meeting permit compliance and to deliver a 10-day notice to the lake residents adjacent to a treatment area and for a quarter mile in each direction from the treatment zone. The day prior to treatment our teams posted the lake shoreline with the permit required signage. The team then mobilized four treatment and support boats to get the treatment completed early in the day prior to maximum boat traffic and to limit the impact of treatment work on the lake users. Milfoil zones were treated with ProcallaCOR EC herbicide. Curly leaf and native aquatic plant zones were treated with a combination of Diquat and Aquathol herbicides. This work was performed on July 22nd after the treatment window opened on the lake.

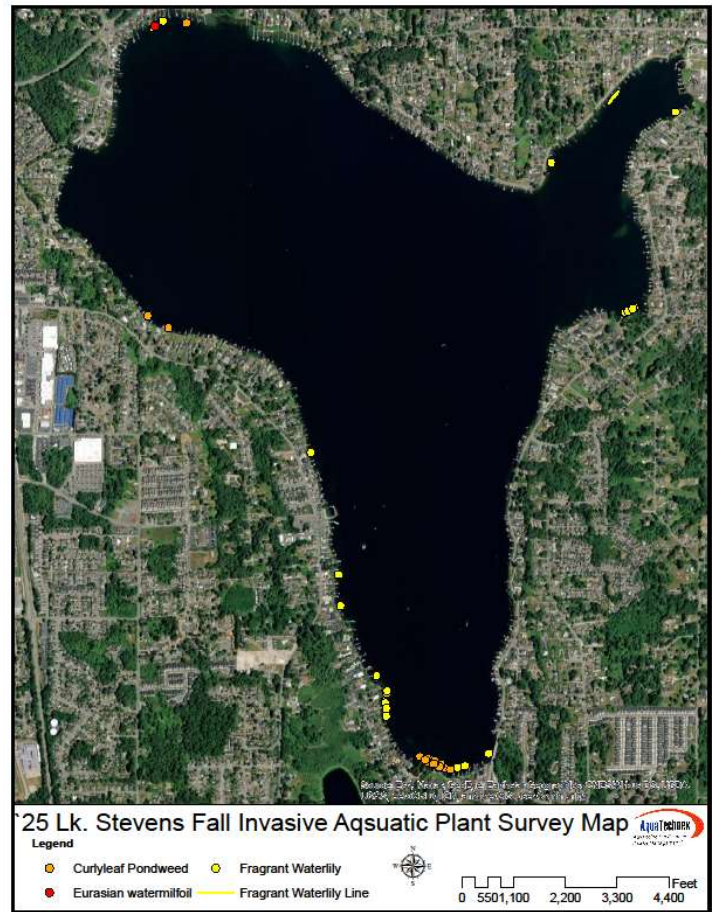
Figure 5: Invasive Plant Map

One Eurasian watermilfoil location was recorded at the northwest end of the lake. Three zones of Curlyleaf pondweed were recorded at the northwest, eastern side and south end of the lake. This new growth was from germinated turion from the seed bank. Fragrant water lilies were recorded sporadically around the lake near shore areas.

Eurasian Milfoil was found in more locations and was more widespread around the lake's littoral areas this Spring. While greatly reduced and only one location found during the fall survey, this plant has the probability to be found in multiple locations in the Spring. Curly leaf pondweed appears to be reduced, but the number of winter buds that germinated won't be known until Spring. Two surveys are recommended to focus on all aquatic plant species. A spring survey in late April or early May should be performed to catch the Curly leaf plants prior to turion production. Treatments for Eurasian milfoil and curly leaf can be performed with herbicides that are not subject to the fish timing windows. Treatments should then be followed with post-treatment surveys to monitor and determine next management steps. Fragrant water lily is a state listed noxious weed and should be managed to prevent expansion with a goal of eradication over time. Continued nuisance aquatic plant control should continue where warranted around the lake next season.

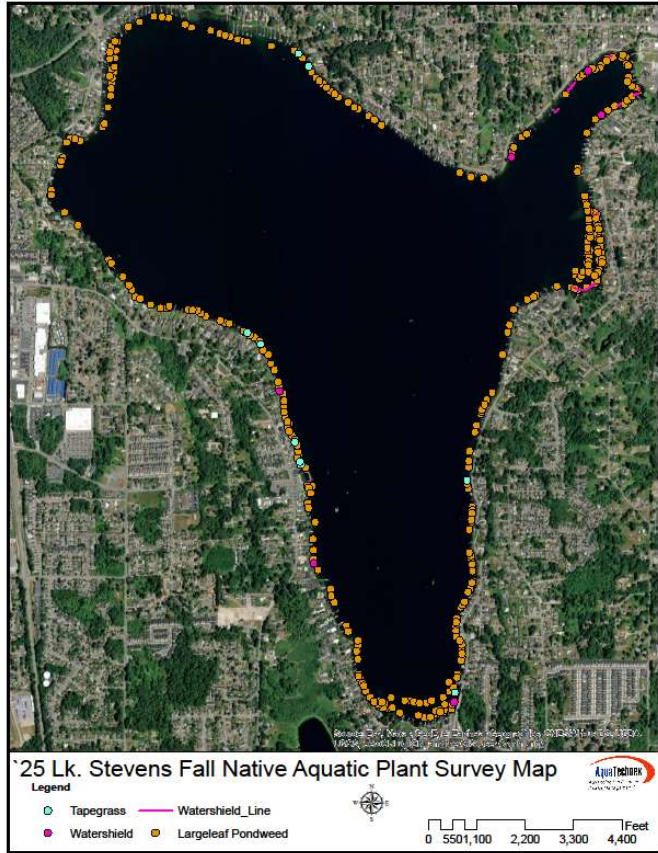
Figure 6: Native Plant Survey Map

The more dominating Large-leaf pondweed remains in reduced densities around the lake. This plant was treated with contact aquatic herbicides to provide seasonal control. These products control the biomass in the water column, does not kill the roots, and plants have the ability to return late season and the following year. The map, Figure 6. below, provides native plant locations around the lake which notes Watershield, Tapegrass, and Largeleaf pondweed. The Fall Biobase map, Figure 7., following the Native Aquatic Plant Survey map shows overall biomass reductions of nuisance plants within the 2025 control areas compared to the Spring Biobase Map.
