Middle Street, Brockham Collision Data Analysis

(Recorded 10yr period between 2012 – 2022 at time of initial research and conception of scheme)

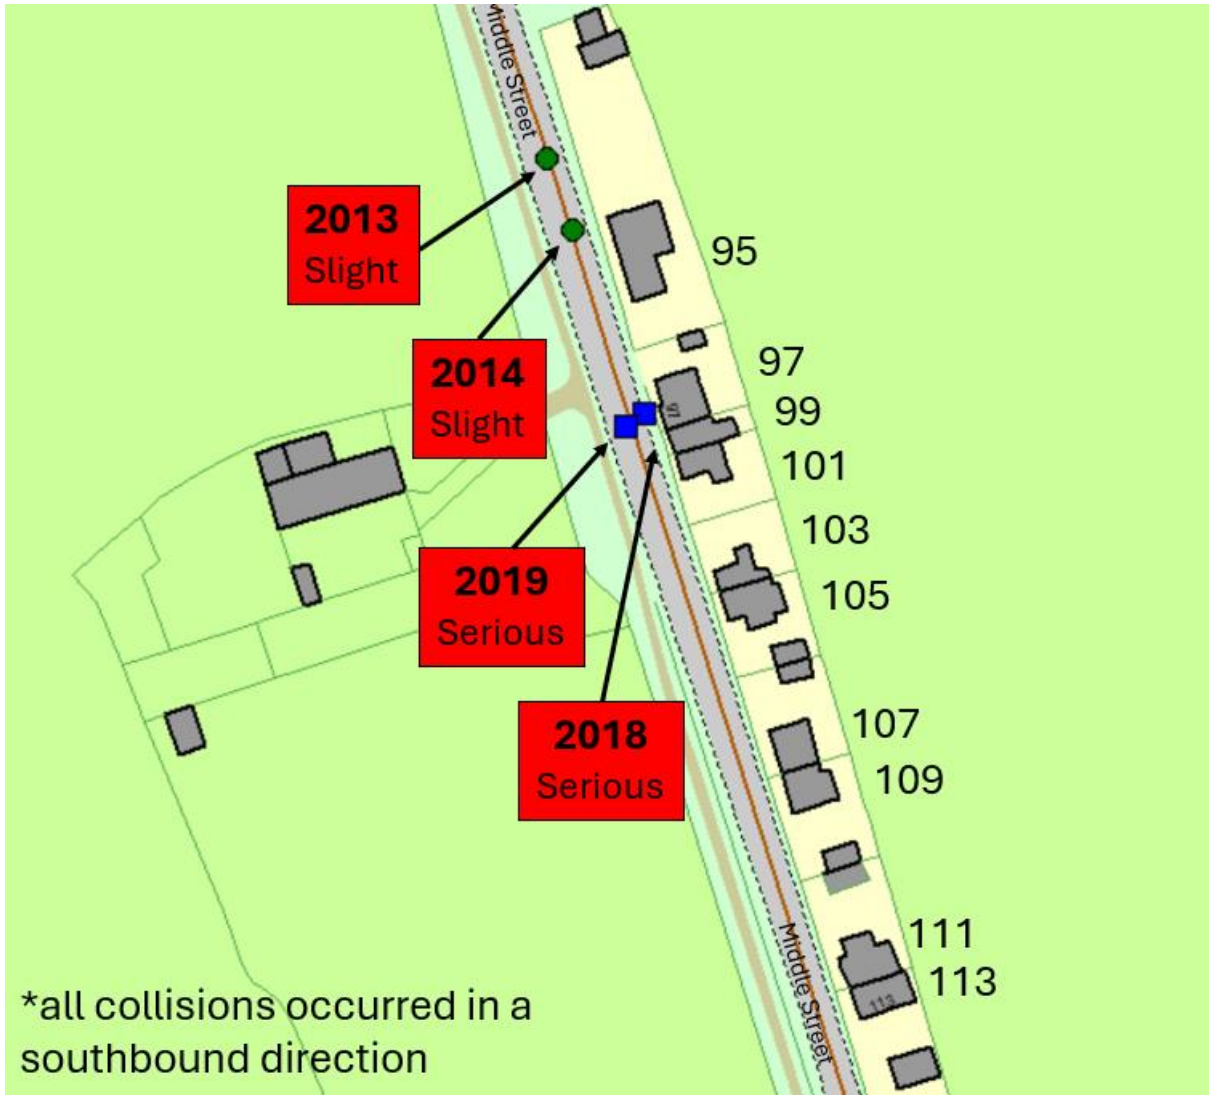
October 2013 – outside cottages

Shunt collision into rear of parked vehicle during the day (10:02am)

Recorded collision: Slight

STATS19 Police report:
V2 PARKED. V1 HIT V2 IN THE REAR.

March 2014 – outside cottages

Loss of control collision into rear of parked vehicle during the day (12:15pm)

STATS19 Police report:
V1 LOST CONTROL LEFT CARRIAGEWAY TO NS COLLIDING WITH ROADSIDE FURNITURE AND GATE TO 95 MIDDLE STREET.

Note: It is thought that there must have been an obstruction (parked vehicle or a manoeuvring vehicle) in the southbound running lane. Driver may have been attempting to pass the obstruction and misjudged the distance of oncoming northbound traffic and has had to take avoiding action, resulting in a loss of control collision and conflicting with roadside street furniture. This cannot be confirmed, although it is unusual for a vehicle to suddenly lose control of a vehicle on a straight road with good visibility.

July 2018 – outside cottages

Shunt collision into rear of parked vehicle during the hours of darkness (licenced taxi driver) (00:25am)

Recorded collision: Serious

STATS19 Police report:
V1 TRAVELLING SOUTH ON MIDDLE STREET. FOR AN UNKNOWN REASON V1 HAS HIT V2 WHICH WAS PARKED ON NEARSIDE. V1 HAS LOST CONTROL AND HIT THE OFFSIDE KERB WHERE IT STOPPED. V2 HAS SPUN AND HIT METAL RAILINGS.
