Final Technical Memorandum

Lake Stevens Outlet Study

Indicator Engineering PLLC

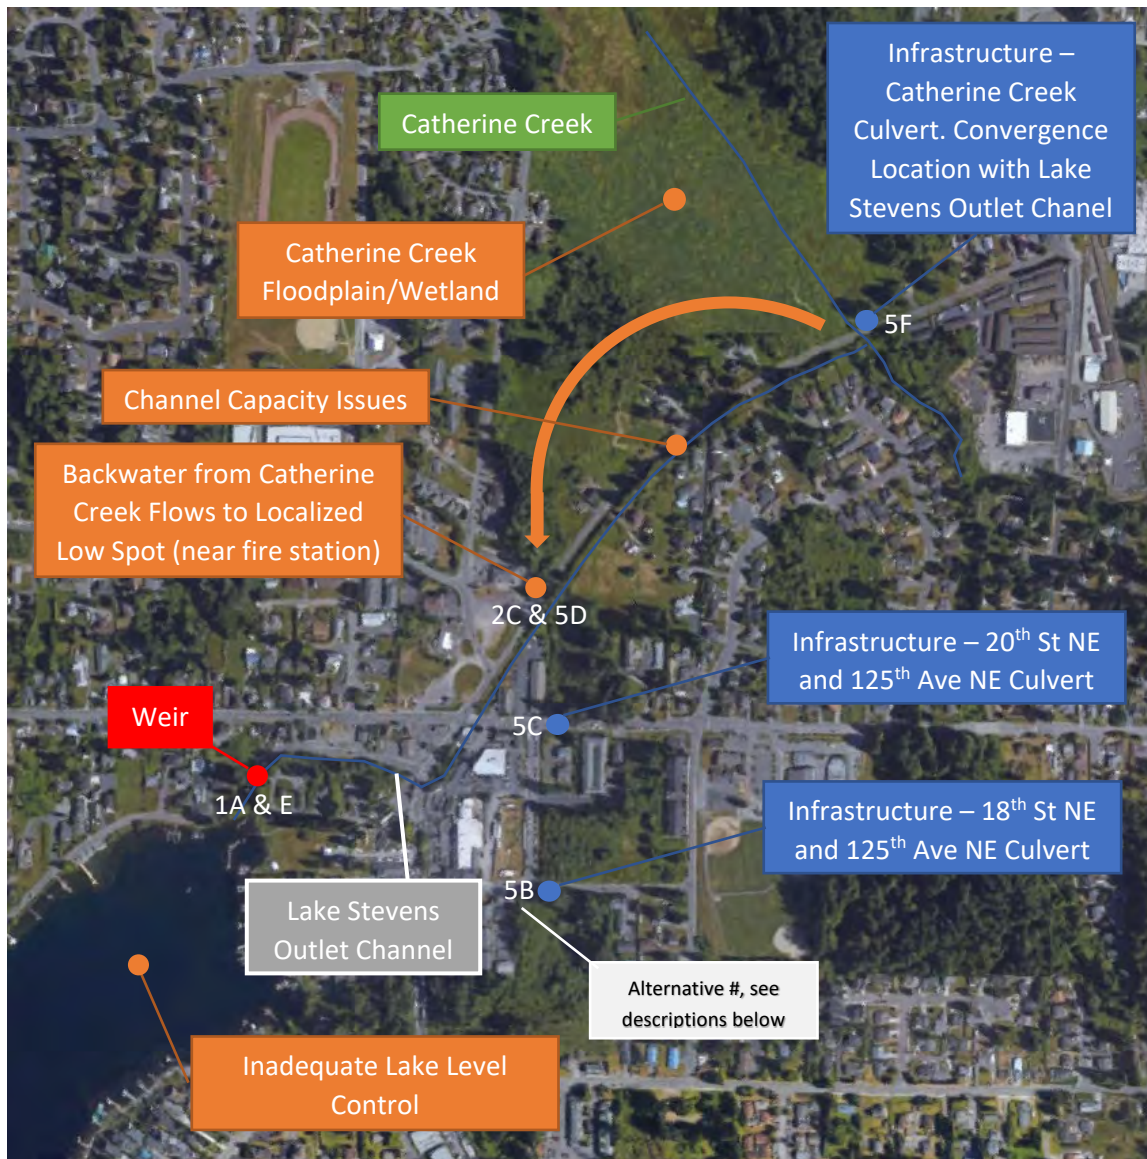
Figure ES-1. Lake Stevens Outlet Channel existing conditions

The City of Lake Stevens frequently experiences flooding in the low-lying areas north and east of Lake Stevens with some roads being overtopped by flood waters several times a year. Flood management has been an ongoing issue for the City, but other related issues are also important including lake level management, stream health and protection of aquatic species. This study was conducted to identify and assess existing hydrologic issues then develop and evaluate alternatives to address the identified issues. Figure ES-1 below, shows the location of existing infrastructure and some of the identified flooding issues.

During intense rain events the outlet channel along Hartford Drive lacks capacity to accommodate high flows. This is further exacerbated by the lack of outlet control at the weir during the wet season and potentially a backwater issue from the Catherine Creek floodplain/wetland north of the fire station. In addition, inadequate hydraulic diversity (pools and riffles) and lack of large woody debris does not support aquatic species (salmonids).

Low-lying areas where transportation and conveyance infrastructure intersect, specifically at 18th Ave NE and 20th Ave NE, the roadways tend to flood during intense rainfall events. Causes included inadequate culvert sizes, sags or broken conveyances, and low roadway elevations. Additionally, the Catherine Creek culverts crossing Hartford Drive are inadequately sized and constrict the flow from the Creek which contribute to the backwatering north of the fire station (described above). The Catherine Creek culvert replacement project is in preliminary design by another organization so was not included as an alternative considered in this Study.

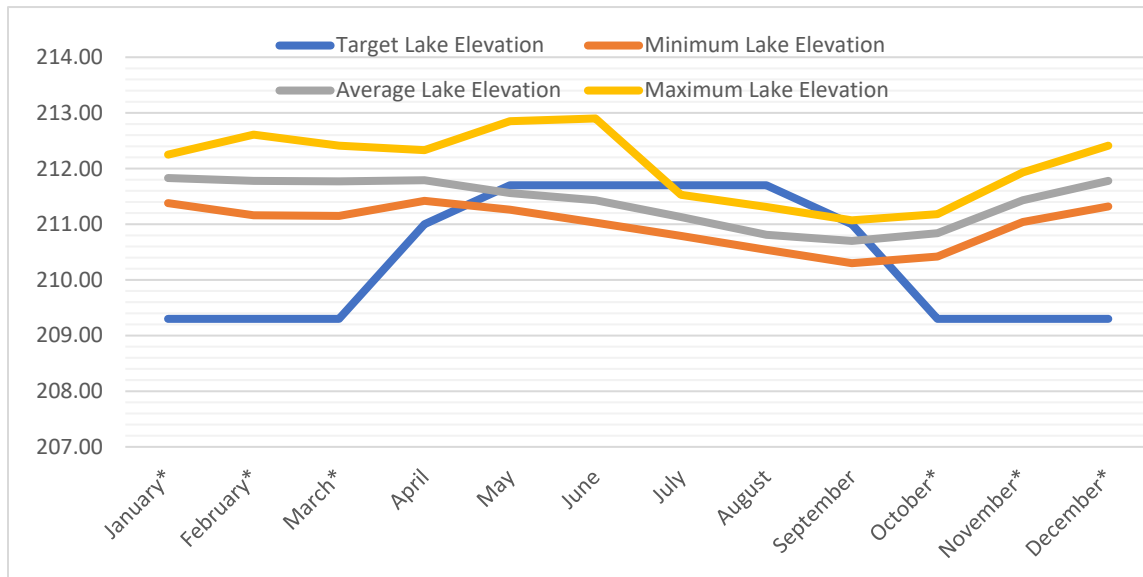
Figure ES-2. Graph of Tabulated Lake Elevations Relative to Targeted Elevations (2008 through 2019).

The existing weir does not provide hydraulic control of the lake level during the wet season months, October through May. Instead, the stream channel configuration (width/height/slope etc.) is the control during the wet season. During the dry season (May through September), lake levels often drop below the bottom of the weir not allowing control or maintenance of low flows in the lake outlet and Catherine Creek. Despite the City's Public Works Crew's programmatic management of the weir to control the lake level the limitations of the weir make it impossible to manage level for much of the year.

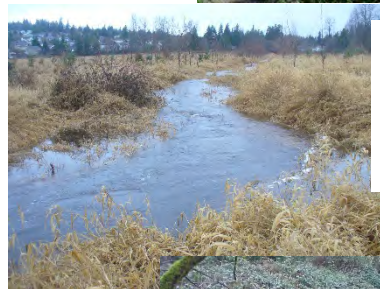
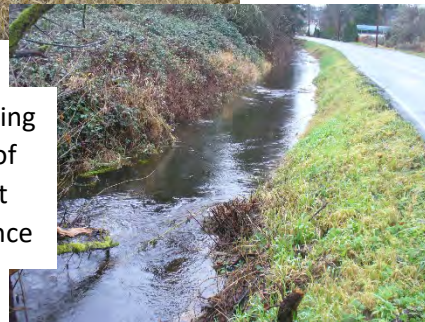
Additional modeling and analysis is necessary to understand the interaction of the lake outlet stream at its confluence with Catherine Creek, the backwater condition from the wetland north of the Fire Station and the impact on Hartford Drive residences and roadway.

Photo looking upstream of Catherine Creek at confluence

Photo looking upstream of Lake Outlet at confluence

-Cost of additional study is \$100K.

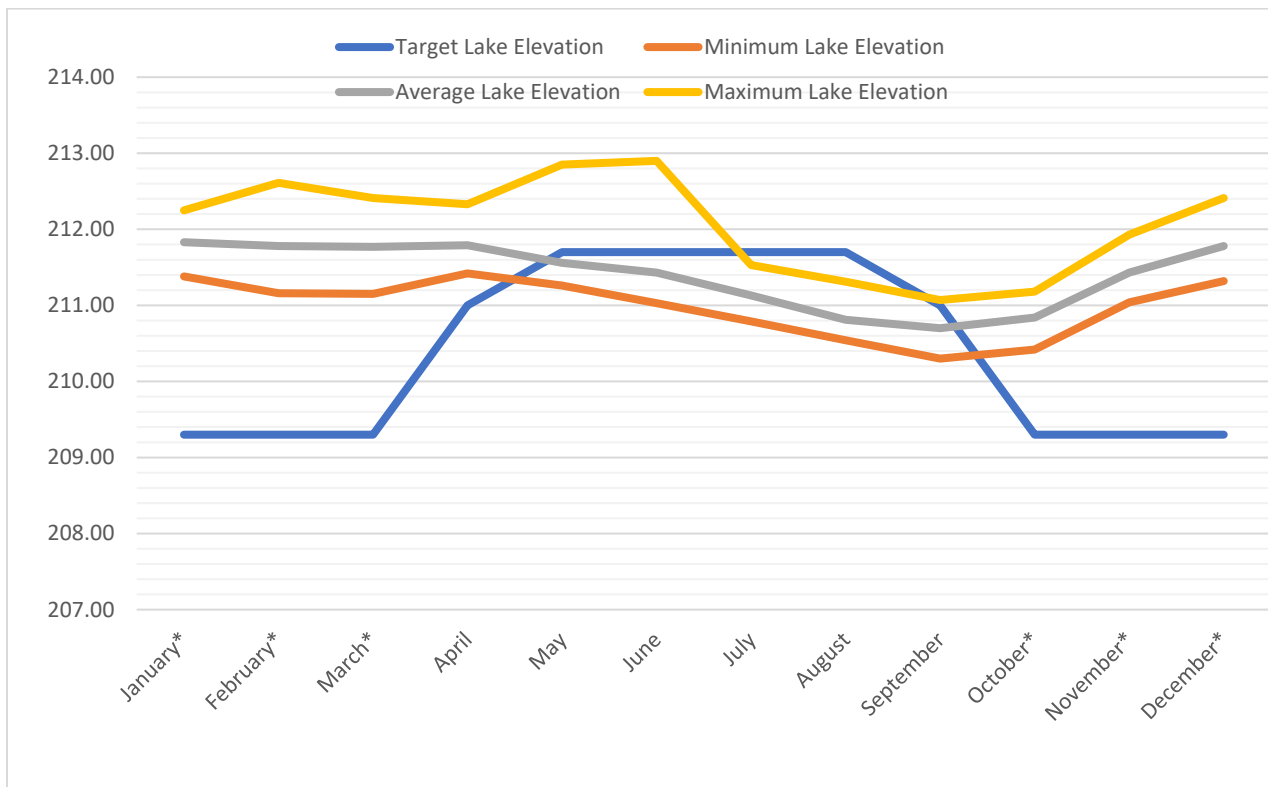
Figure 8. Graph of Tabulated Lake Elevations Relative to Targeted Elevations (2008 through 2019).

Monthly average lake levels between 2008 and 2019 were evaluated to determine the range of lake elevations observed relative to the targeted lake elevations. Table 4 shows the monthly averages, minimum and maximum lake elevations for each month. Figure 8 depicts the data graphically.

A preliminary evaluation of the lake elevation and existing weir indicates that the weir might not be operating as intended. This needs to be confirmed. Preliminary modeling shows that the weir could be actively managed between February and October to continually release 1 or 2 cfs which would be sufficient to provide minimum flows for aquatic species. This would result in slightly higher lake levels (green lines in Figure 16) than currently modeled with the existing outlet (red line in Figure 16). The observed lake levels (blue line in Figure 16) indicate that the weir is not providing the intended function, since it does not match the red line.

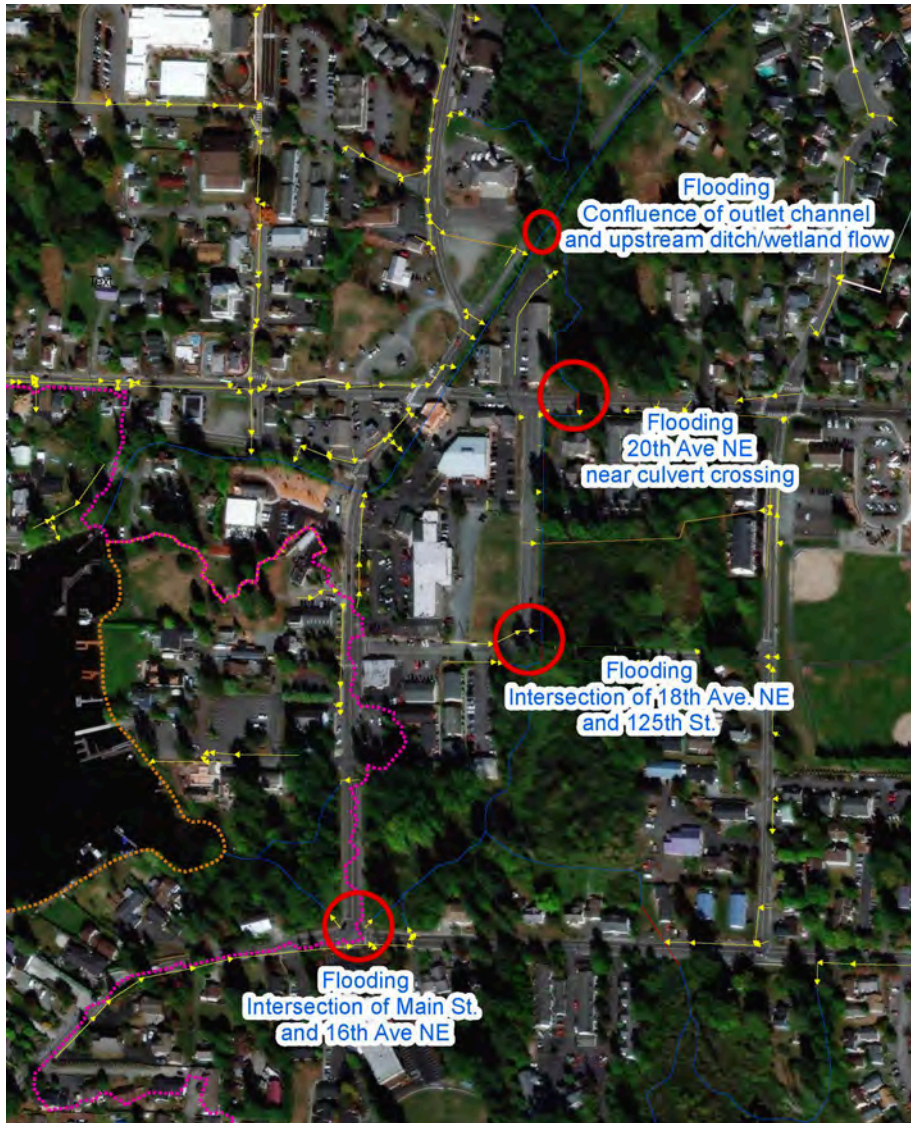
Figure 9. Known Flooding Areas where Infrastructure Conditions were Evaluated.

Conveyance infrastructure including catch basins, pipes, outfalls and ditches were evaluated in the field on September 25, 2019. A photo log of the infrastructure evaluation is available in Attachment A. Special attention was paid to infrastructure in the vicinity of known flooding issues shown on Figure 9. Observed conditions during the February 2020 flooding event are described for the locations evaluated. Below are descriptions of infrastructure in the vicinity of each location. Additionally, descriptions of other infrastructure issues or potential issues noted during the field evaluation are provided below.

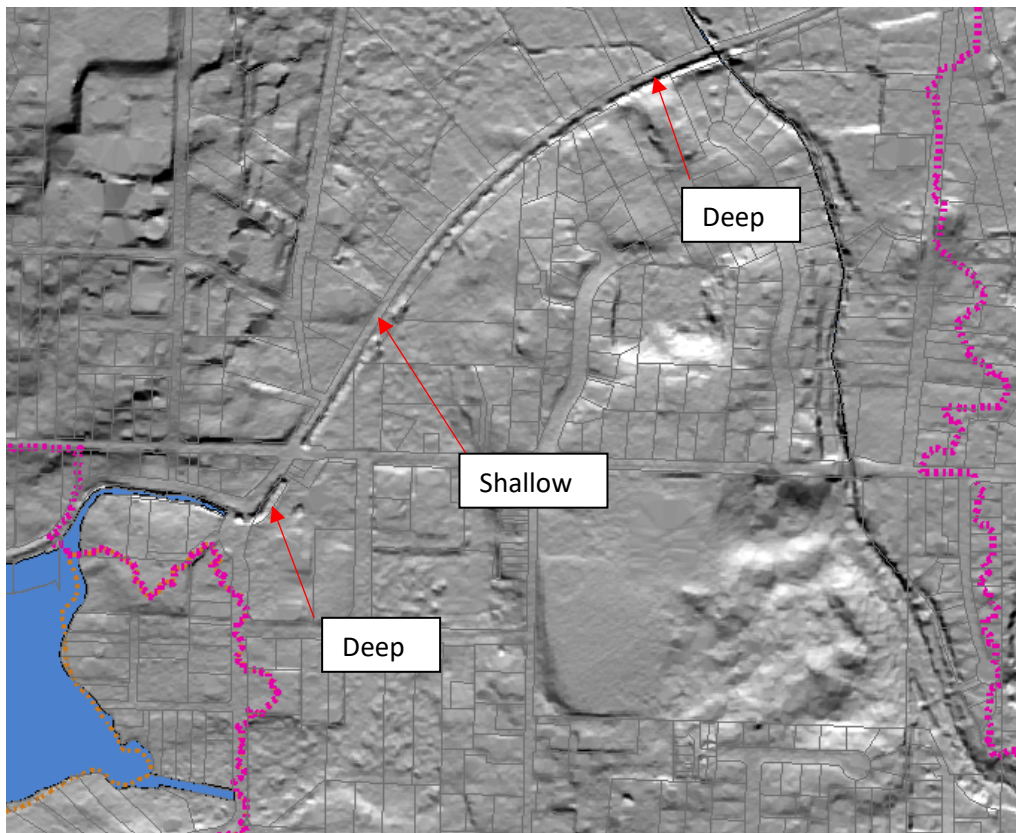
Figure 10. LiDAR imagery with deep and shallow locations indicated in the outlet channel. Darker contrast indicates greater relief; lighter contrast indicates less relief.

Geomorphic evaluation of the stream channel included observations of channel planform, dimensions, and substrate during a field visit on October 3, 2019. The outlet channel was walked to observe physical and biological characteristics (biological conditions are described in Section 8) and photographic documentation is provided in Attachment B. As described in Historical Documentation Section 3, the outlet channel is not natural and was created around 1908 in association with the Rucker Lumber Mill located on the northeast side of Lake Stevens, near the current City Hall. The channel has consistent dimensions from upstream at the lake outlet to downstream at the confluence of Catherine Creek, ranging from 12 to 18 feet in width, and banks of 4.5 to 8 feet high. The channel length is approximately 3,160 feet (0.6 miles). The LiDAR image in Figure 10 illustrates the channel depth relative to the surrounding landscape. The shallow location is near the confluence of the historic channel. At this location the bank height is only 4.5 feet compared to an average bank height of 7.5 for the remainder of the channel. Water depth ranged from 0.3 to 1.2 feet on the day of our site visit. Because the channel is artificial, it has an artificial planform as well. It is relatively straight and ditch-like, confined to the south side of Hartford Drive for most of its length with no floodplain connection except in the location of the confluence where banks are low and the road overtops and floods during heavy precipitation (see Photo 14).

Nearly all the channel length consists of relatively deep, ditch-like channel sections along North Lakeshore Drive, Main Street, and Hartford Drive (see LiDAR imagery in Figure 10).

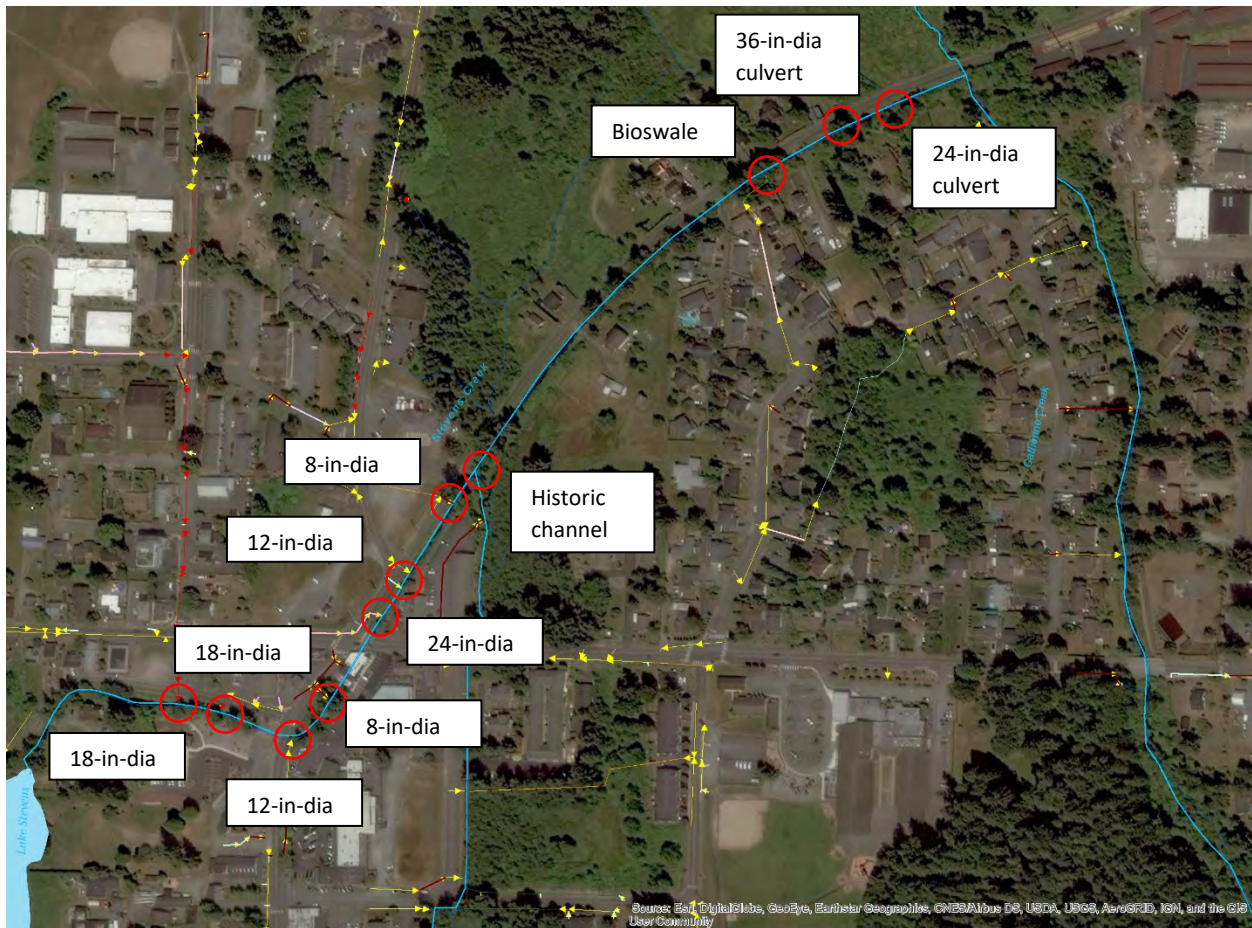
Figure 11. Location of surface water inputs to outlet channel.

Sources of sediment in the outlet channel include the channel banks, bed, and surface water inputs that transport and deposit material to the channel. Surface water flow inputs into the outlet channel are shown in Figure 11 and include the following:

- Lake Stevens;
- Seven outfalls conveying stormwater from the north side of the outlet channel and one outfall conveying stormwater from the south side of the outlet channel;
- A bioswale conveying stormwater from the south side of the channel upstream of the Catherine Creek confluence;
- Historic outlet channel; and
- Two culverts conveying stream flow from the north side of Hartford Drive.

Transport and deposition of fine sediment in the channel is likely from all of the surface water inputs, however, coarser materials are unlikely to be transported from the lake environment or the historic outlet channel due to the low gradient environment and large extensive wetlands that are present prior to reaching the outlet channel. Large storms that create high energy flow situations could transport large gravel from upstream ditches and stormwater catchment areas to outfalls that eventually reach the outlet channel.

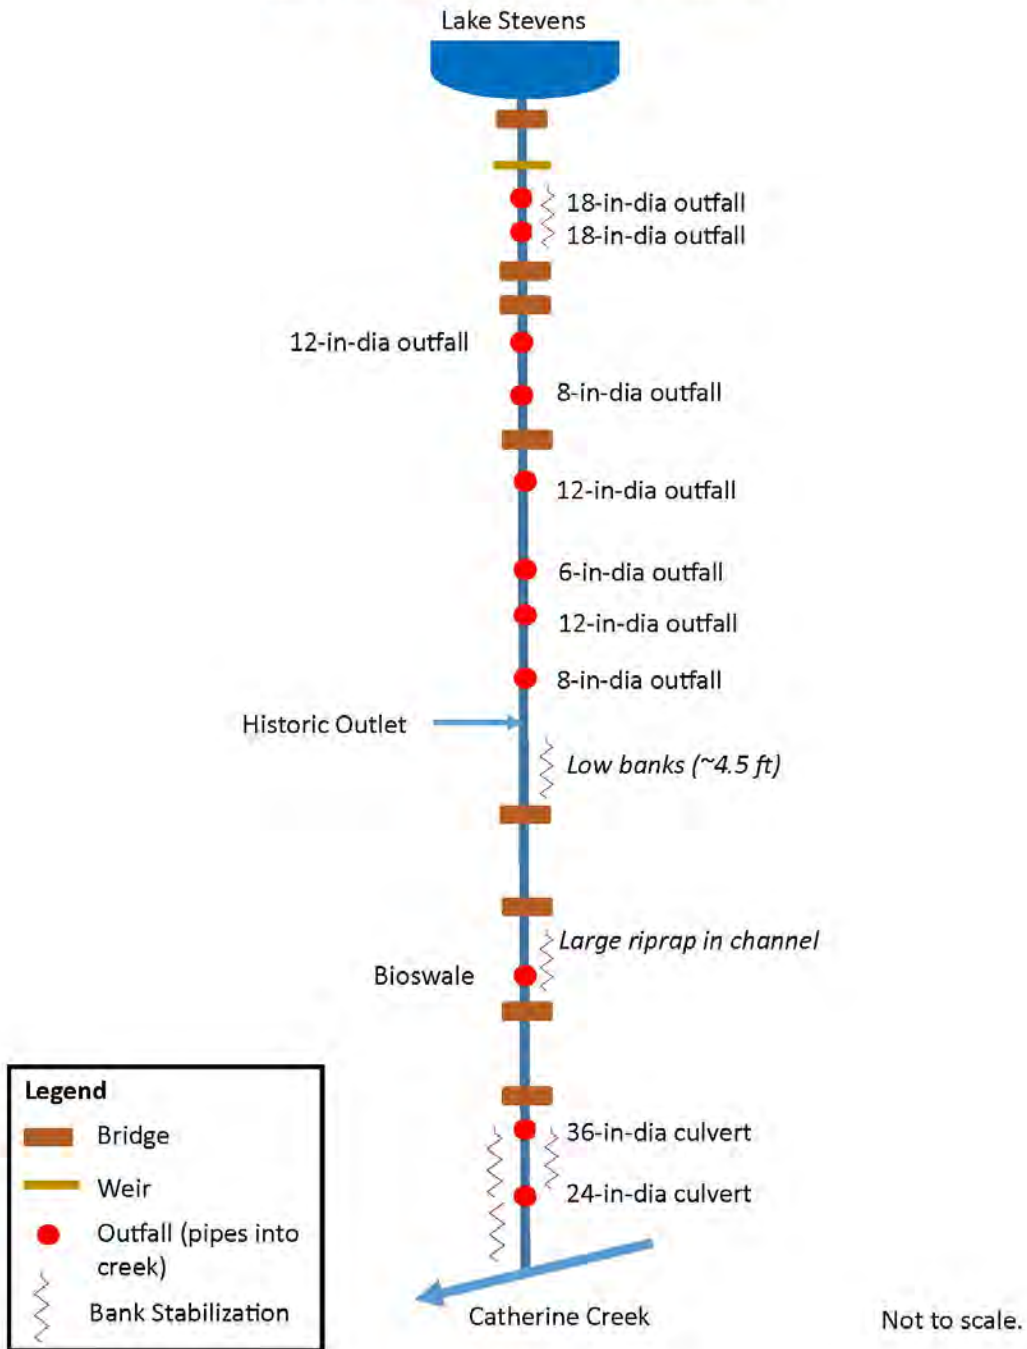
Figure 12. Lake Stevens Outlet Channel Schematic

The banks of the outlet channel have been hardened with various materials, including solid concrete, concrete blocks, timber walls, and large riprap at several locations between the historic outlet channel and the Catherine Creek confluence. Most of these bank stabilization efforts are in the vicinity of private bridges or outfalls conveying flow from the ditches on the north side of Hartford Drive. Many of the timber crib walls appeared to be in poor condition and attempts have been made to repair them. The solid concrete walls appeared to be stable but were generally covered with vegetation and difficult to observe.

A schematic of the outlet channel showing general locations of bridges, outfalls, notable channel conditions, and significant bank stabilization is shown in Figure 12.

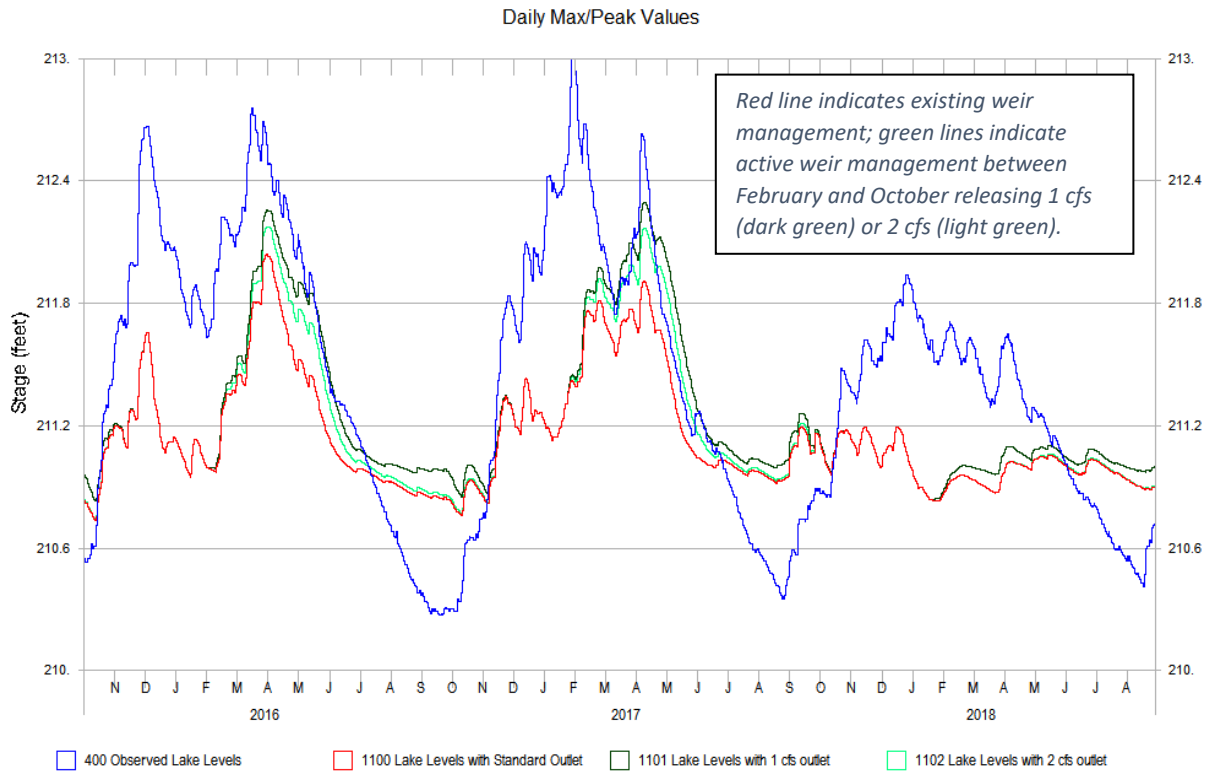
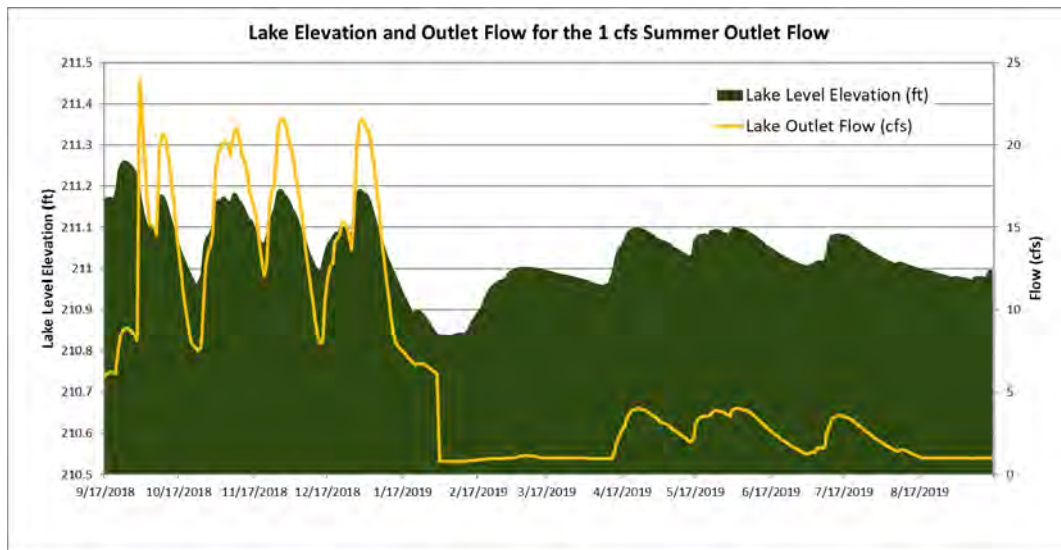
Figure 16. Modeled Lake Elevations with Different Weir Management and Lake Elevations with Outlet Flow for One of the Scenarios (1cfs outlet flow in summer).

Note in Figure 16 in the lower graph for the scenario managing lake level outlet flow to 1cfs in the summer, the weir is raised in February to increase the lake level/storage to achieve higher lake levels and a minimum of 1cfs outlet flow in the Summer.

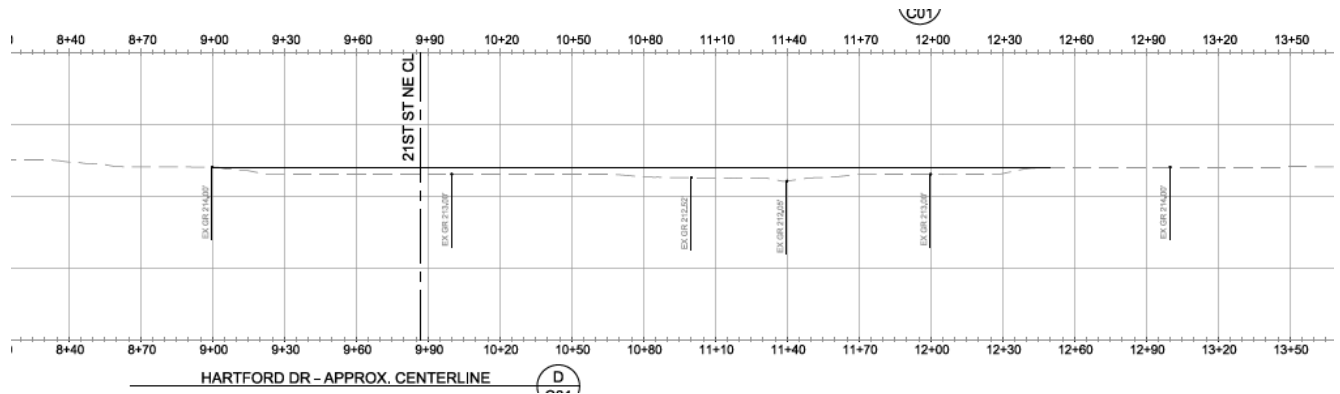
Figure 17. Hartford Dr. preliminary existing road profile in vicinity of historic channel confluence which is approximately at station 11+00. Grid lines on the y-axis represent 10-ft elevation intervals.

A preliminary analysis of the road profile shows Hartford Drive is lower in the vicinity of the historic channel confluence (Figure 17). The plan and profile for Hartford Drive and other roads evaluated in this analysis are provided in Attachment C.

Channel improvements in this reach would focus on improving hydraulics so that fine sediment does not accumulate and reduce channel capacity in the vicinity of Hartford Drive. Additional evaluation will be needed to determine appropriate site-specific solutions because there are a number of factors that could be contributing to channel conditions in the vicinity of Hartford Drive that are not fully understood, including the nature and volume of stormwater inputs from the north, and the historic outlet channel from the south.
