FORT GORGES CASEMATE STABILIZATION AND WESTERN VIEWING AREA ACCESS IMPROVEMENTS

ASSESSMENT REPORT AND COST OPINIONS

PERFORMED FOR
CITY OF PORTLAND, MAINE PLANNING DEPARTMENT
389 CONGRESS STREET
PORTLAND, ME 04101

SEPTEMBER 26, 2017

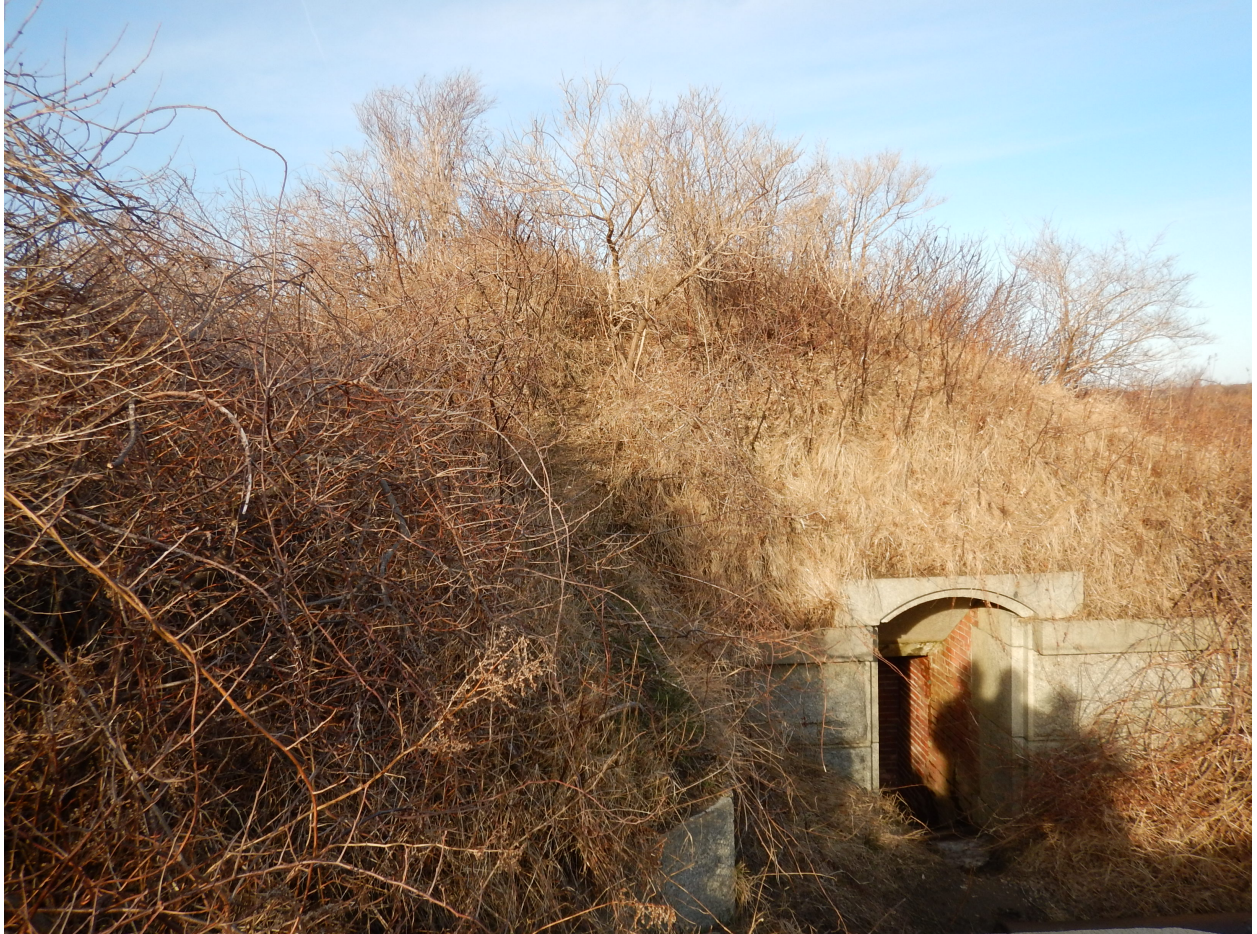
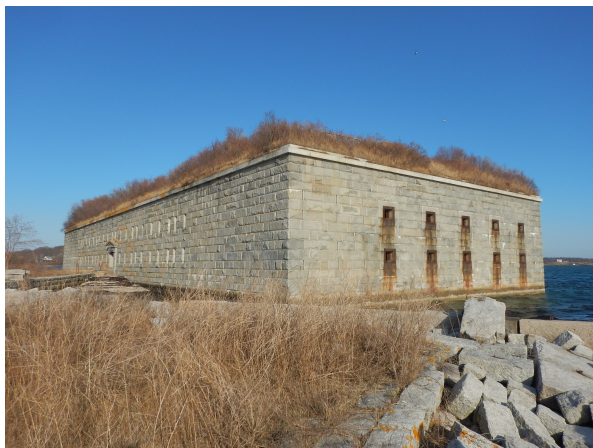
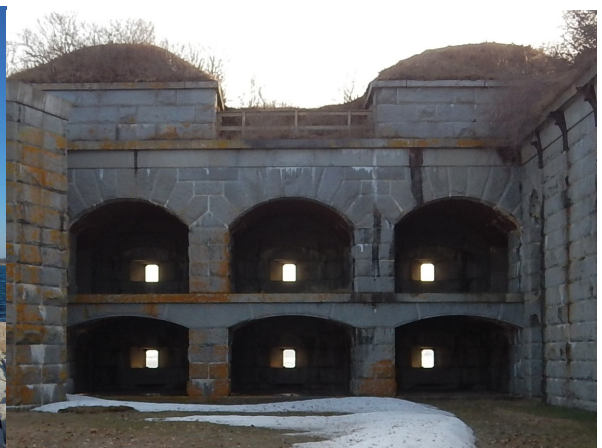
Above: Barbette Tier, Built-up berms (parados) over passageways to Barbette Tier powder magazines.
Below: Scrub foliage reduces and obscures the visibility of parados (left), an important historical feature of the fort. More visible contours are viewed from parade ground (right)

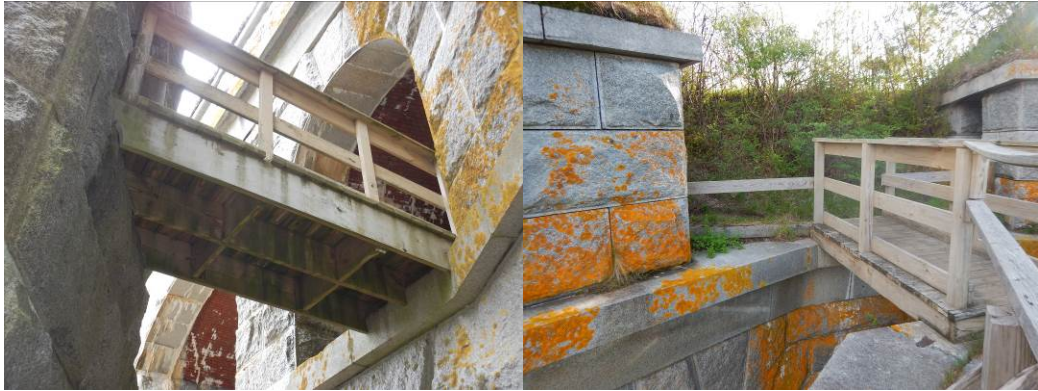
Photo 4.1 and Photo 4.2: Tier 2 (left) and Barbette Tier (right) bridges

- Existing bridges consist of pressure-treated lumber beams, decking, and handrails. The Tier 2 bridge spans from casemate 246 and lands at a skew to the south tower. The Barbette Tier bridge spans orthogonally between the tower and the parade wall intersection of Face IV and V. Both bridges bear directly on granite at each end.
- The Drawing labeled Drawer 13, Sheet 3 indicates that iron bridges with iron railings may have been intended originally. We have observed the type of "X" railing pattern on other Third System Fort railings, such as at Fort Warren on Georges Island in Boston Harbor.

- Replace the bridges. While general replication of the existing bridges, with improved wooden railings, is feasible, we recommend replacement with galvanized steel structures with galvanized floor grating and rails to generally match the Army Corps Work.

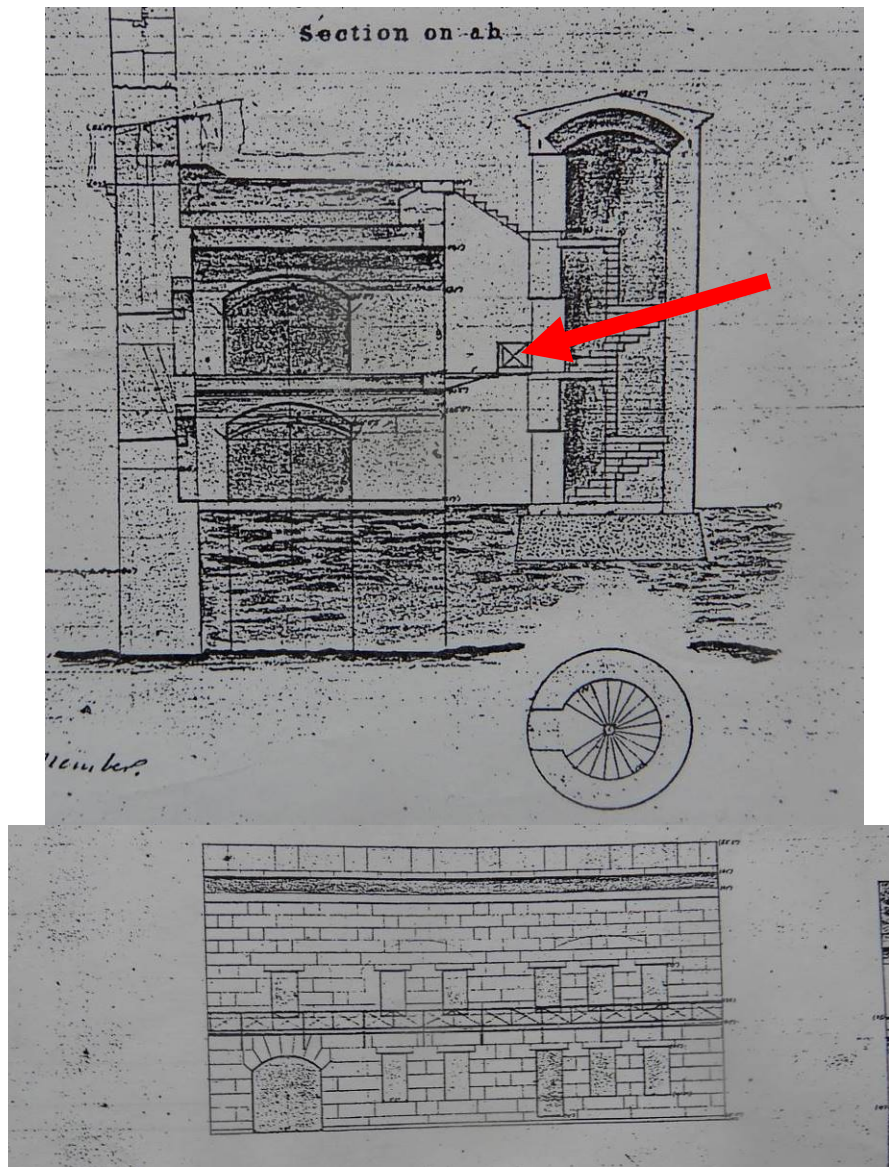
Photo 4.6: Iron bridge suggested on design drawings (arrow). Note also that the tower was originally conceived to be a cylindrical structure, and that the finished Barbette Tier elevation was to be several feet higher! Early design drawings also show three towers, located at the centers of faces I, III, and IV. It appears that the later addition of the massive powder magazine inboard of Face I required the reduction to two towers. Further research is necessary to determine if any evidence exists of towers at different locations.

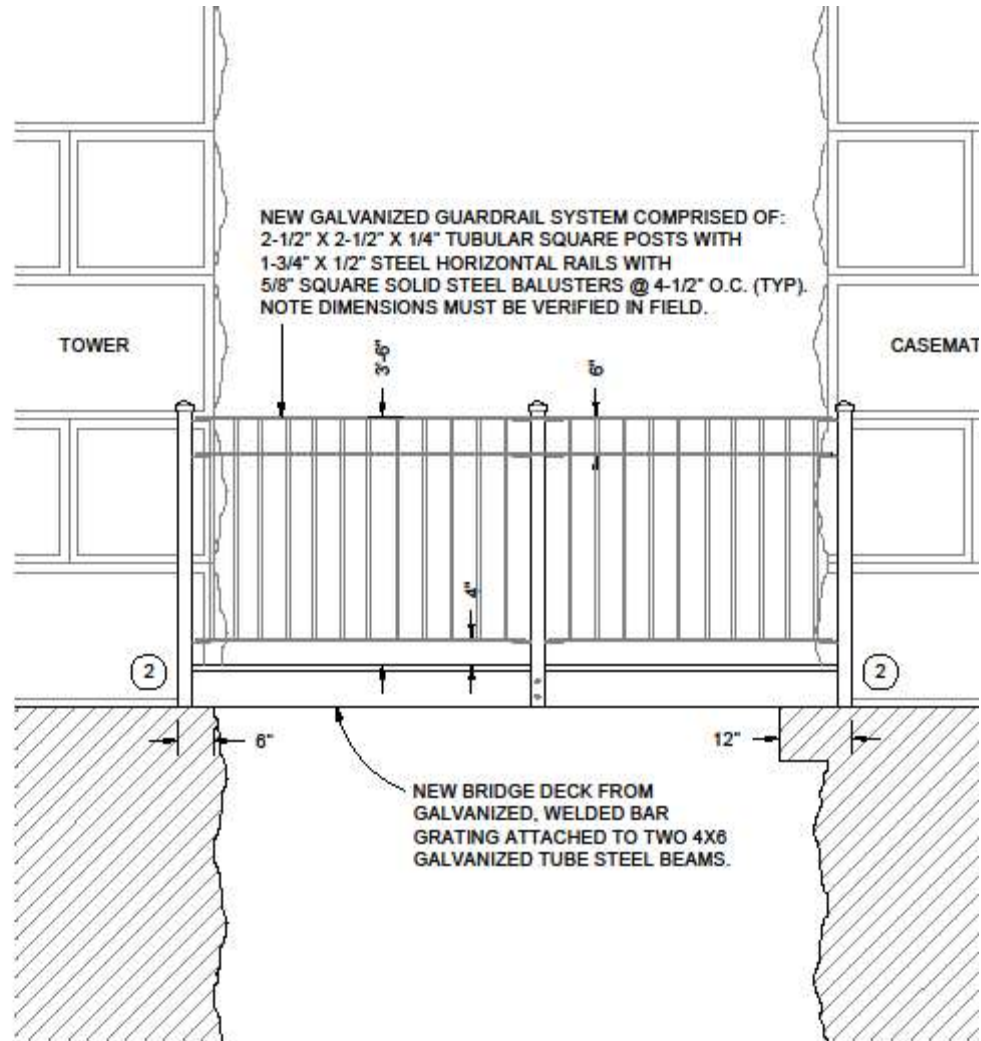
1 ELEVATION AT SECOND TIER BRIDGE
A2.6 1/2" = 1'-0"

Photo 4.9: Elevation of Second Tier Bridge, showing rail system similar to that installed by the Army Corps of Engineers in summer 2017.
