Centre Region MS4 Partners
(College Township, Ferguson Township, Harris Township, Patton Township,
The Pennsylvania State University – University Park Campus, Borough of State
College)

POLLUTANT REDUCTION PLAN

November 15, 2017
Revised August 30, 2019

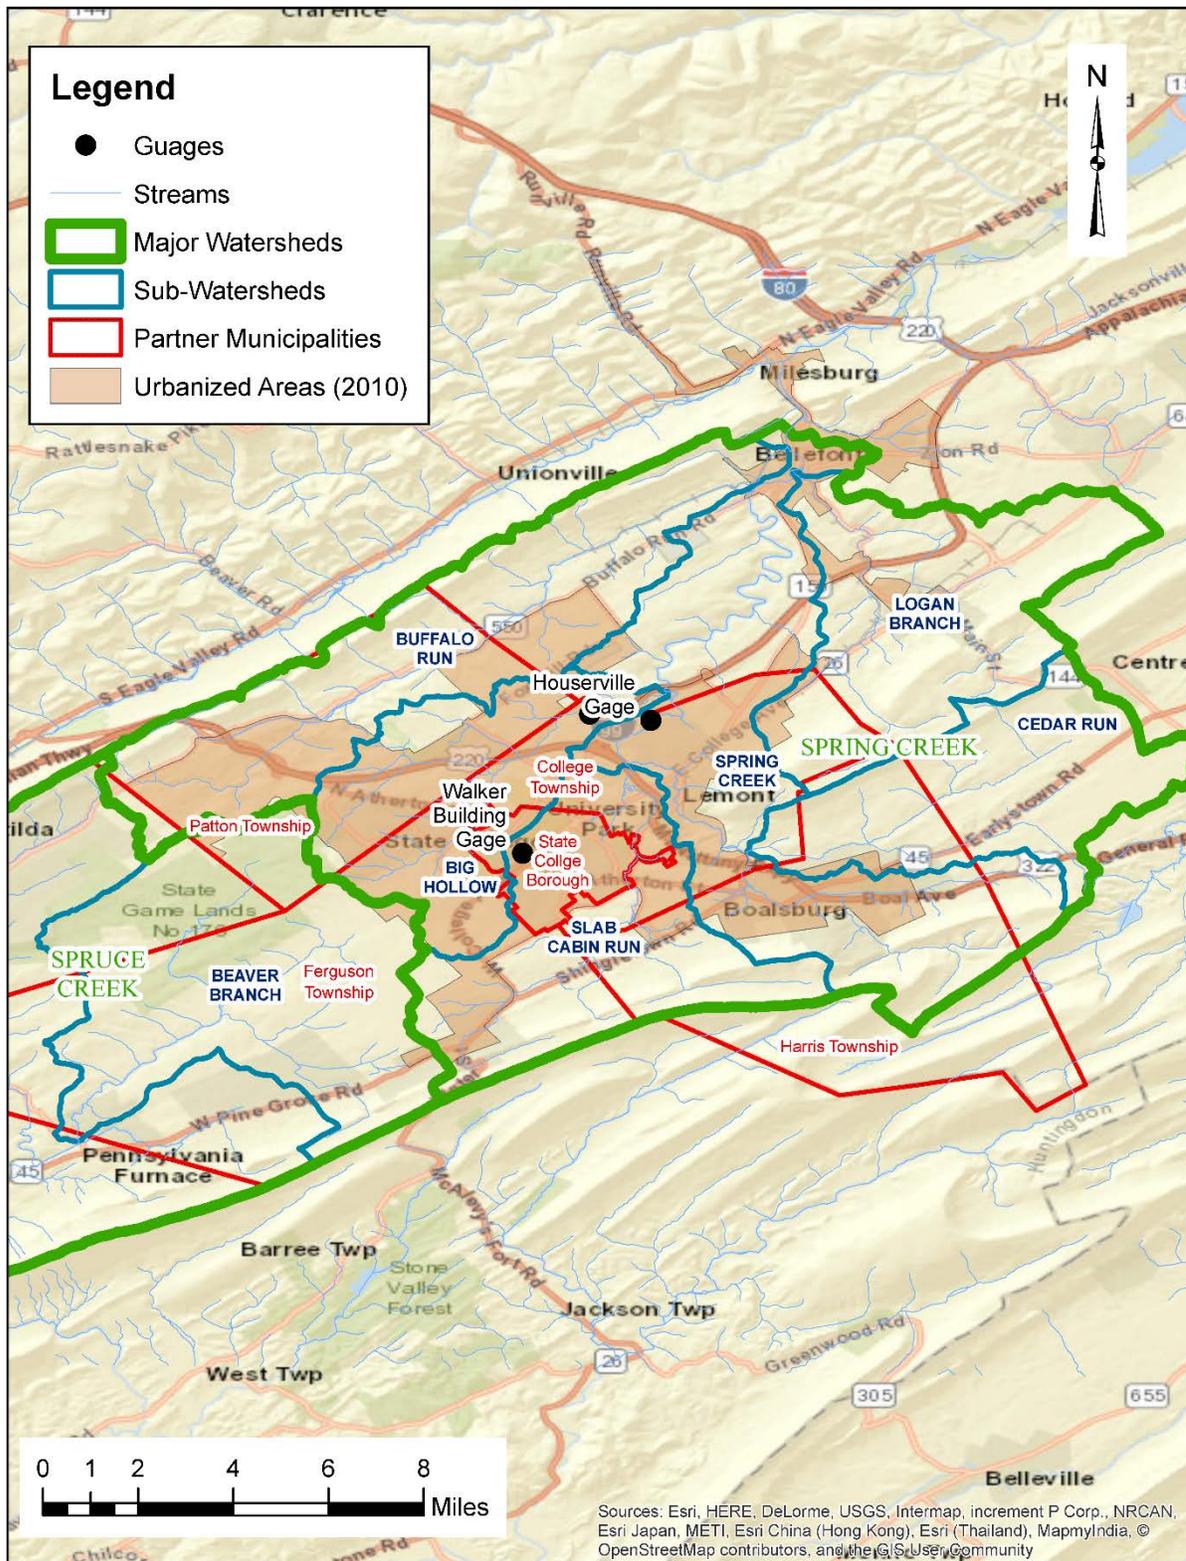
Figure 1. Centre Region Study Area

Although listed in **Table 1**, Logan Branch will not be addressed further in this PRP. As illustrated in **Figure 1**, a small headwaters portion of Logan Branch is located in eastern College Township. However, College Township does not have any regulated MS4 elements that discharge to Logan Branch or its tributaries. As such, Logan Branch is not in the planning area of the Partners.

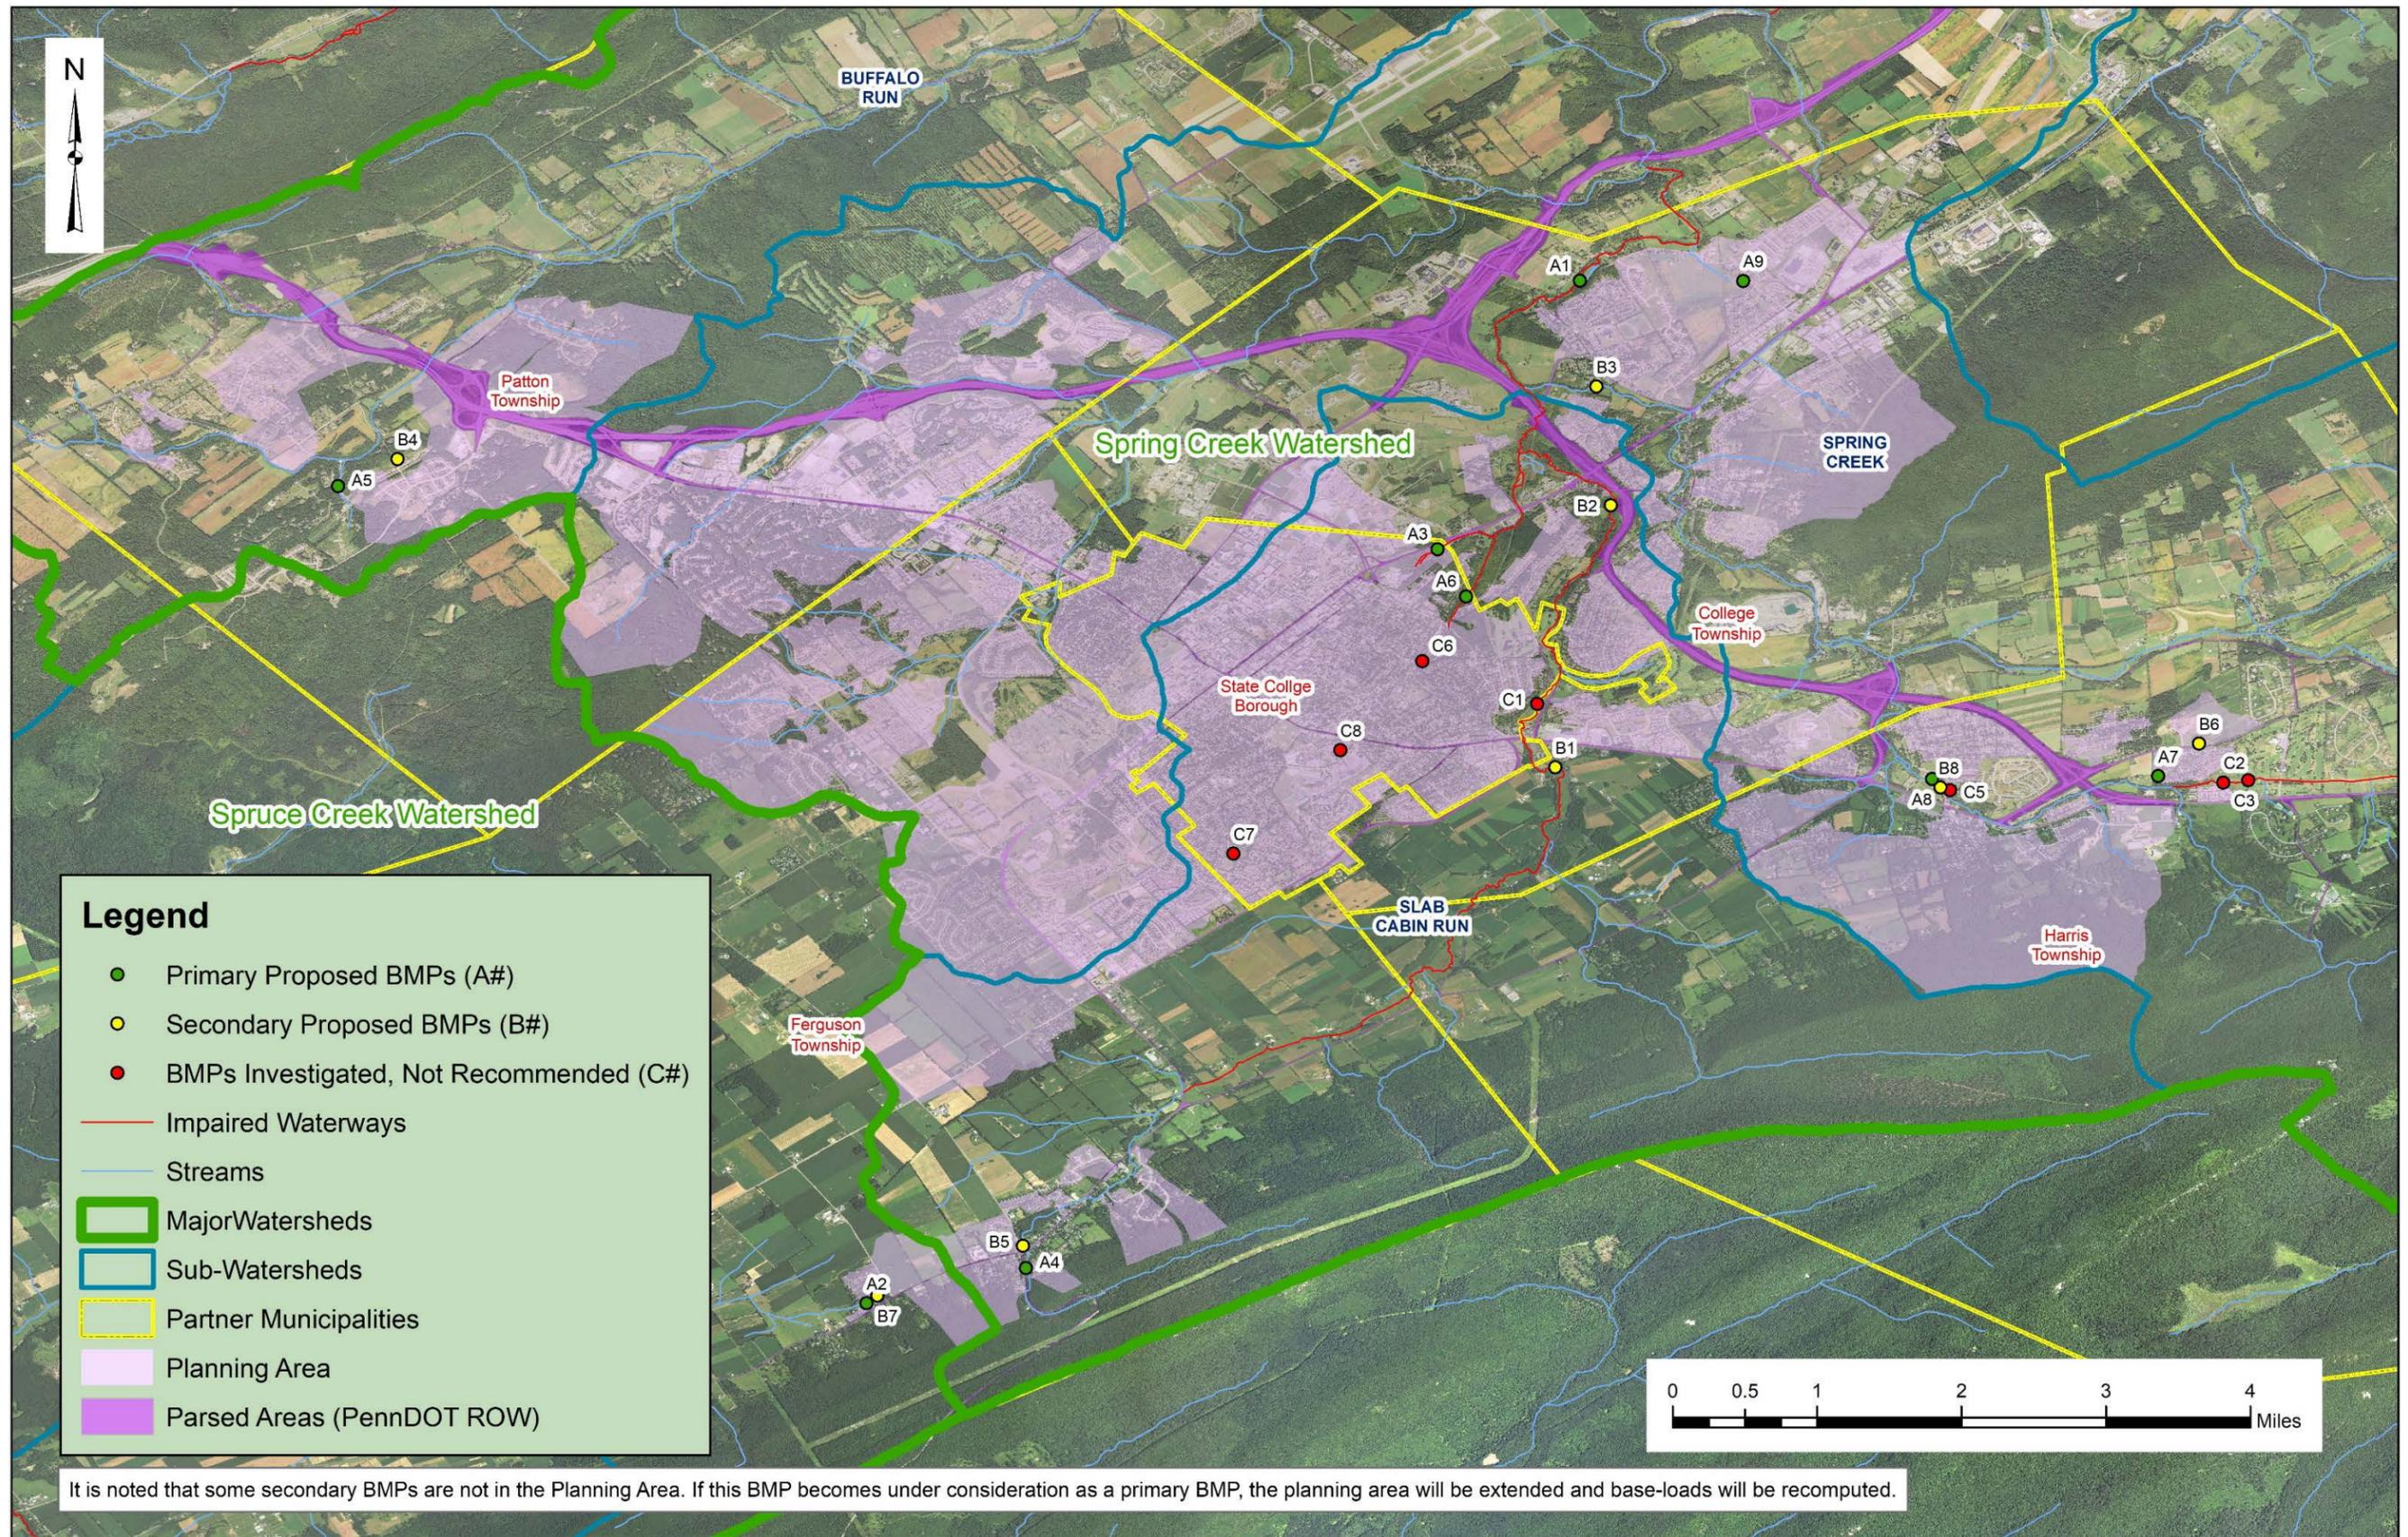
Figure 2. Planning Area Map

BMPs evaluated for pollutant load reduction include 1) stream restoration, 2) basin retrofits, and 3) street sweeping. Except for street sweeping, the locations of evaluated BMPs are illustrated in **Figure 2**. The PA DEP recommends that BMP effectiveness values published in PA DEP document 3800-PM-BWC0100m or Chesapeake Bay Program expert panel reports be consulted to compute BMP treatment capacity in pounds per year (lb./yr.).

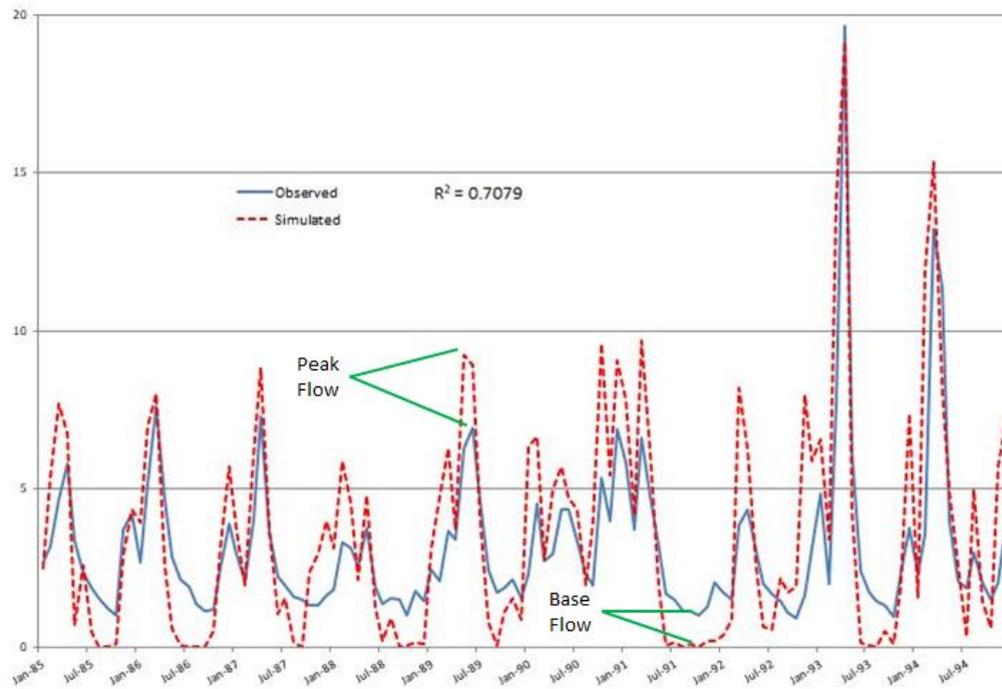
Figure 3. Pre-Calibration Observed and Simulated Houserville Stream Gage Flow Data (stream flows are in units of water depth [cm] over the watershed)

Available historic streamflow data from the Houserville USGS stream gage (USGS 01546400 - see **Figure 1**) was used to calibrate the hydrologic model in GWLFE. As illustrated in **Figure 3**, prior to calibration GWLFE simulated base flows were depressed and peak flows were accentuated relative to observed stream flows.

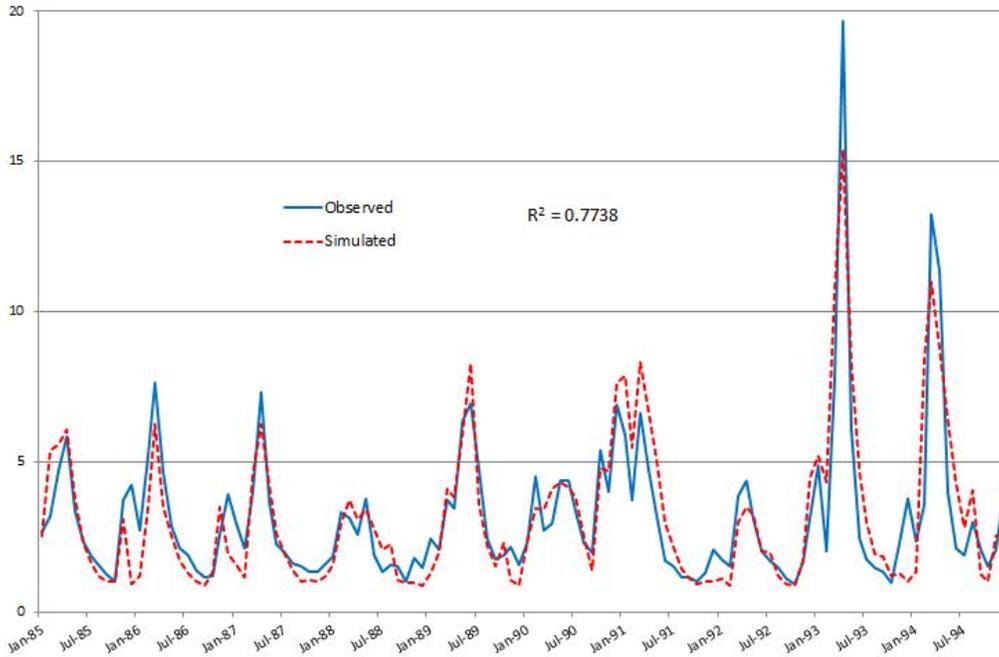
Figure 4. Post-Calibration Observed and Simulated Houserville Stream Gage Flow Data (stream flows are in units of water depth [cm] over the watershed)

To improve simulated stream flow conditions, adjustments were made to various model parameters including minor adjustments to point source discharge coefficients, evapotranspiration rates, and groundwater recession rates. As illustrated in **Figure 4**, these adjustments increased base flows, decreased peak flows, and increased the correlation coefficient (R^2) from 0.71 to 0.77.

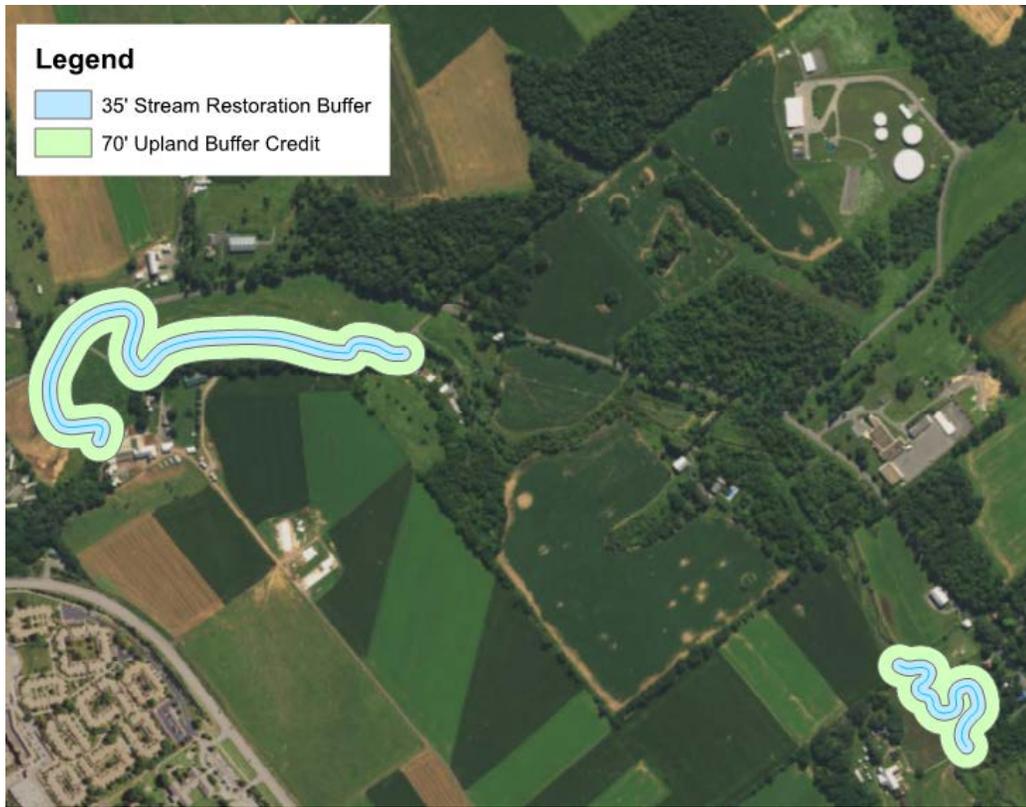
Figure 6. Location of Buffer and Adjacent Upland Credit Area.

The land-use conversion analysis was performed in *MapShed* (GWLFE). The GWLFE output indicates that the current sediment load in the non-forested riparian buffer is 5,684 lb./yr. Given that forest buffers are effective at reducing the sediment load by 40%, the TSS load reduction for the project is estimated to be 2,274 lb./yr. The first 34% of this load reduction (773 lb./yr.) is to be allocated to meet the Agricultural Component of the Phase II WIP. The remaining 1,501 lb. can be allocated to the Partners.

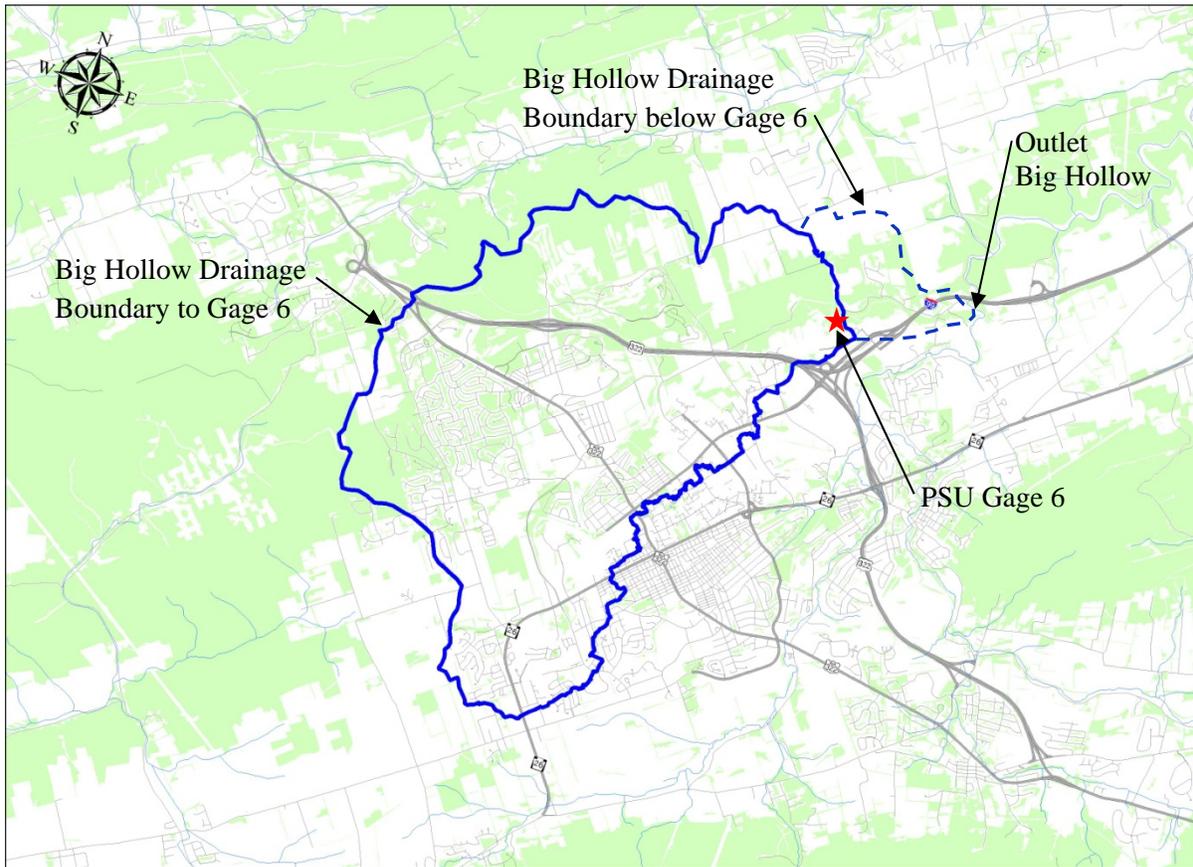
Figure 1. Map of PSU Big Hollow Gage 6 Drainage Area (15.8 sq mi, includes 2.5 sq mi imperviousness)

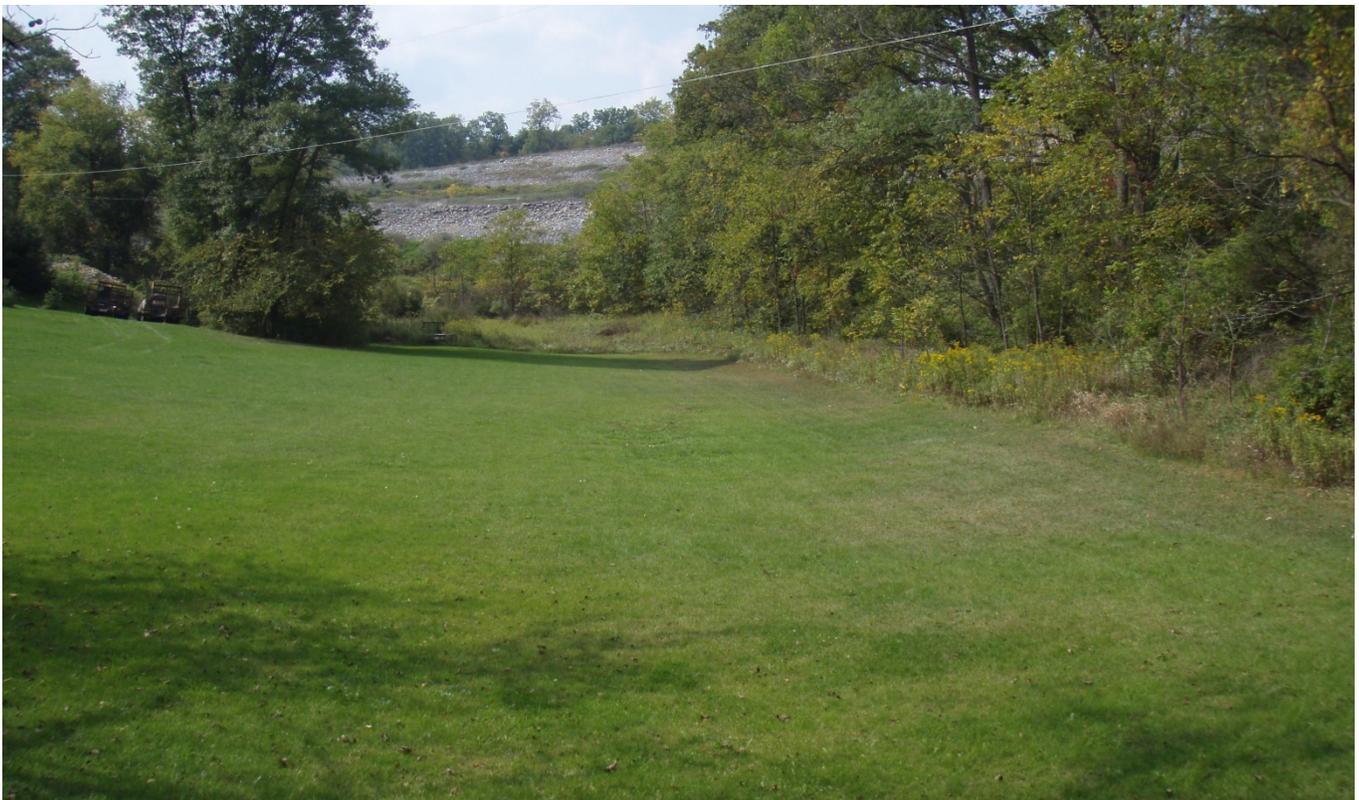
Figure 2. Big Hollow at Outlet (17.2 sq mi) has no Channel or Bed and Banks

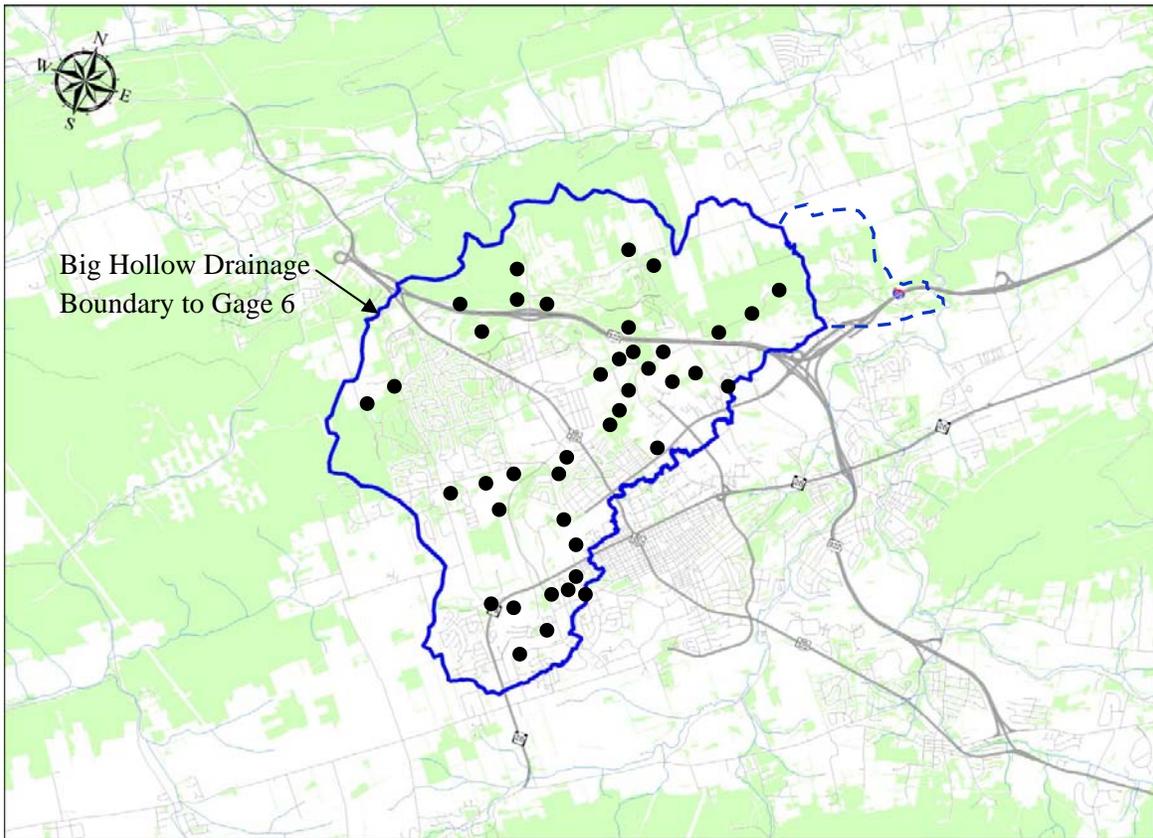
Figure 3. Map of Some of the Significant Sinkholes and Recharge Areas in the Big Hollow

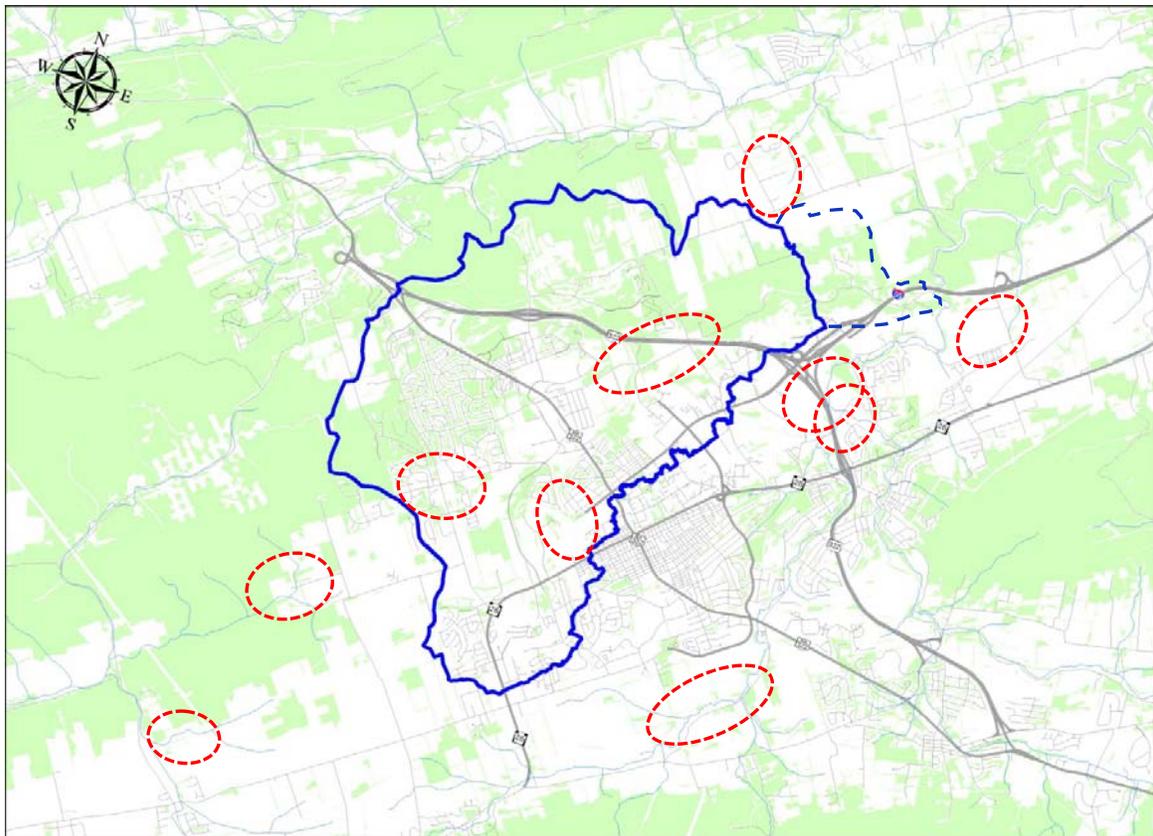
Figure 4. Public Water Wellfields within and around the Big Hollow

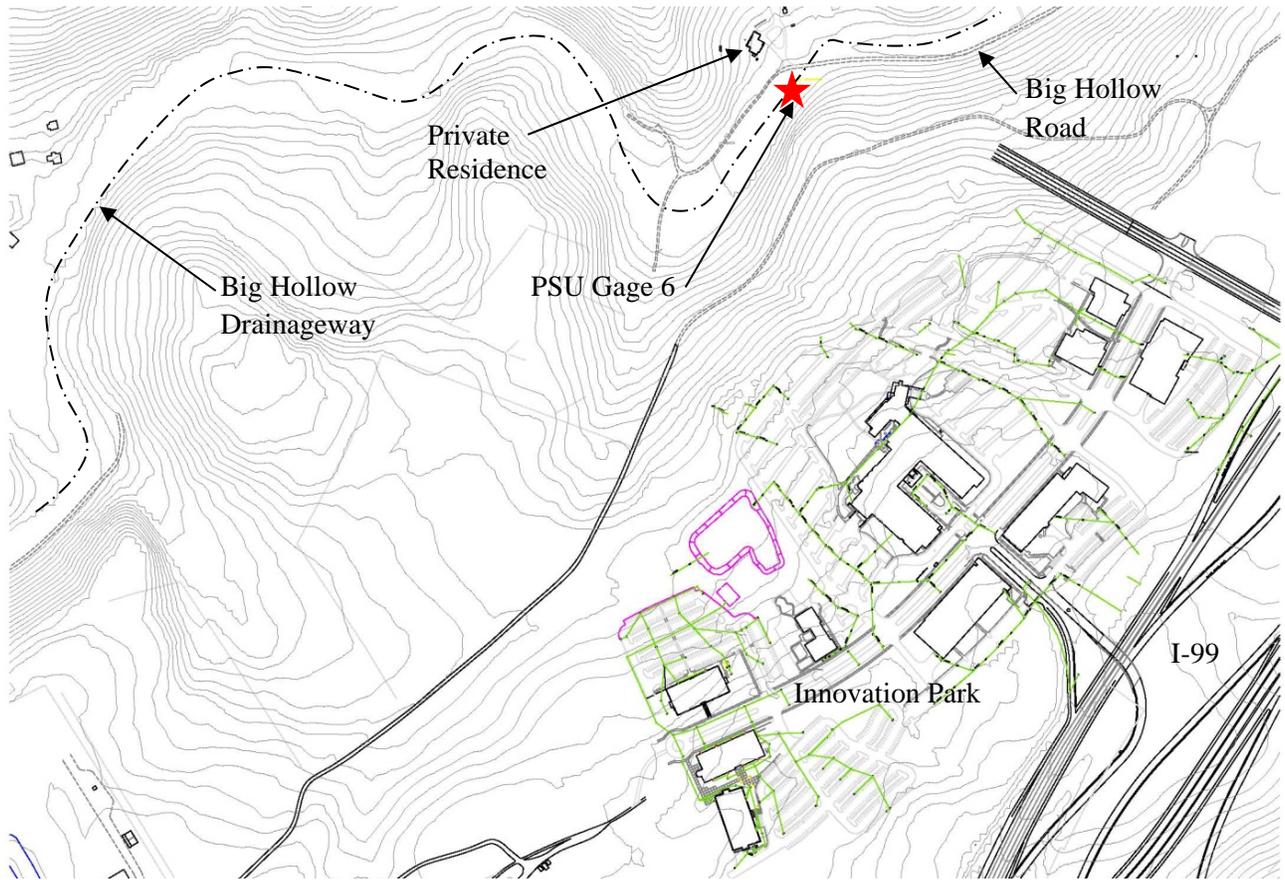
Figure 5. PSU Big Hollow Gage 6 in Relation to Innovation Park

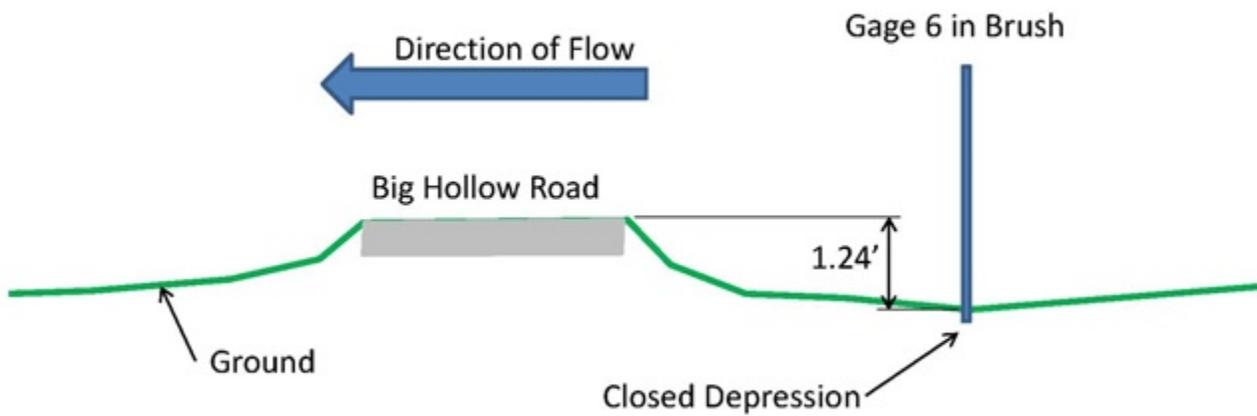
Figure 6. How Gage 6 sits in Relation to the Big Hollow Roadway

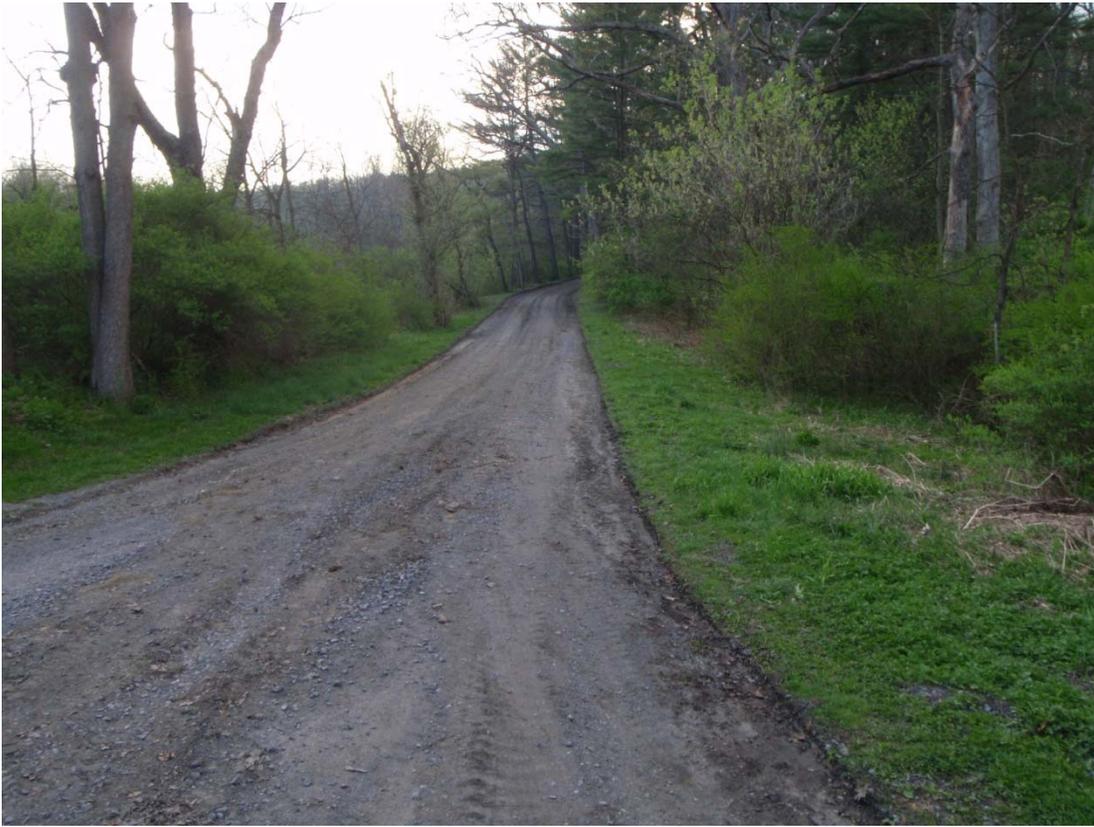
Figure 7. Photograph of Roadway Across Big Hollow with No Culvert (Gage 6 is located on the right side)

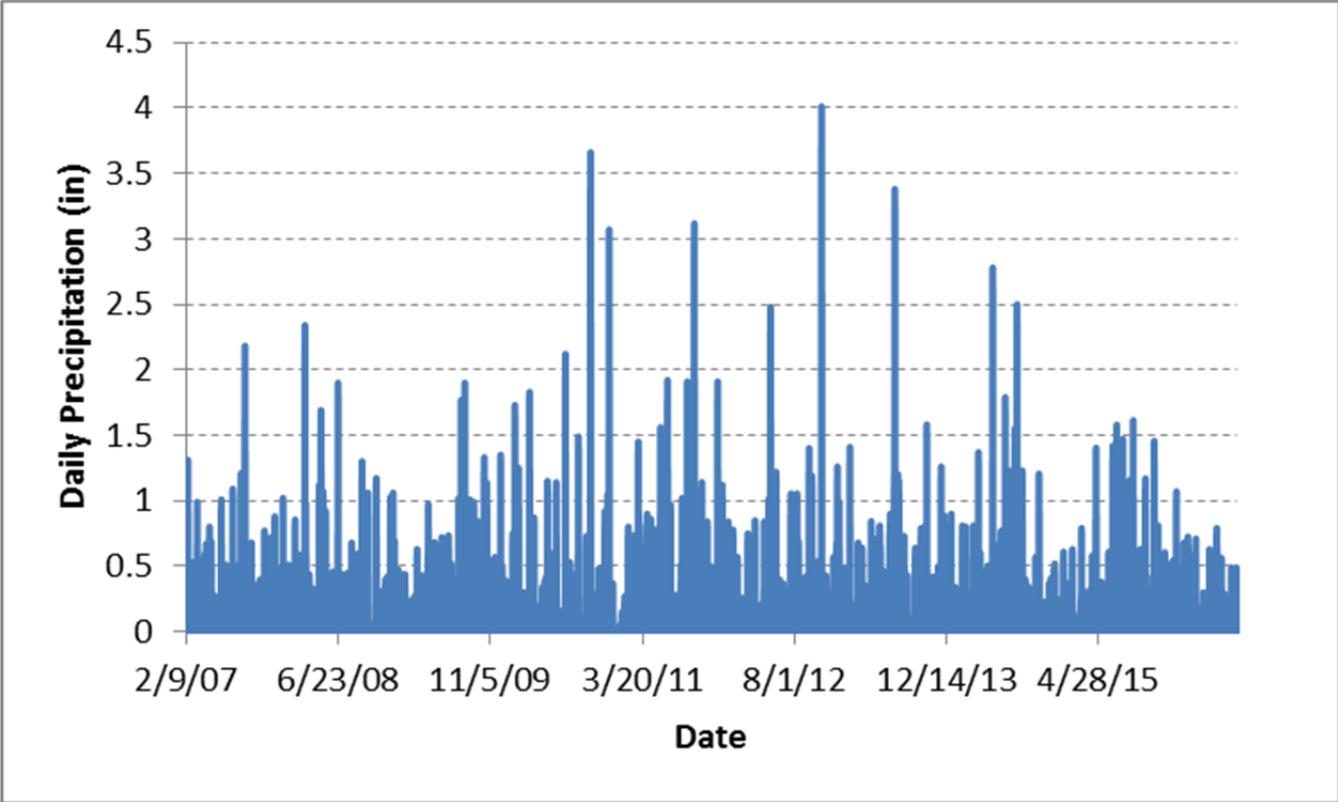
Figure 8. PSU Walker Building Daily Precipitation Data from 2/9/2007 to 7/29/2016

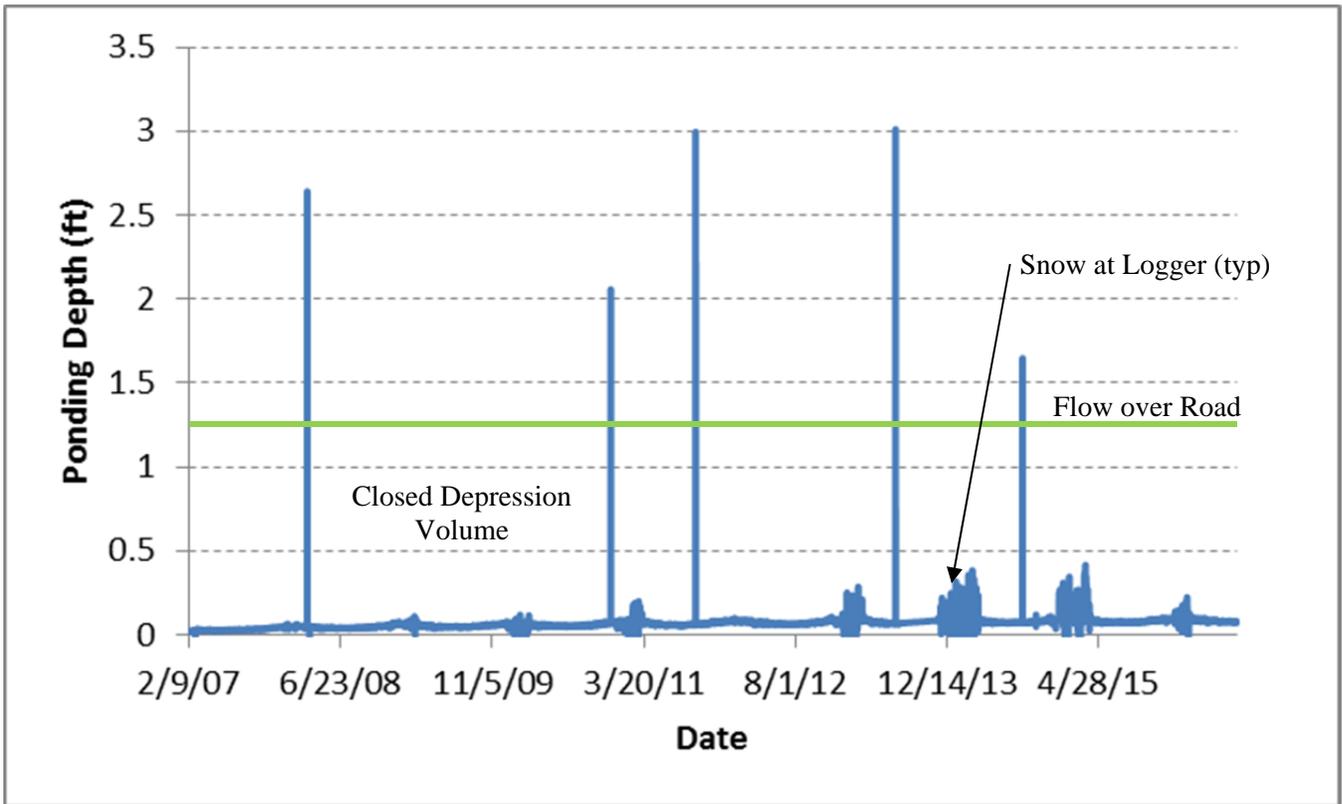
Figure 9. Gage 6 Runoff Data from 2/9/2007 through 7/29/2016

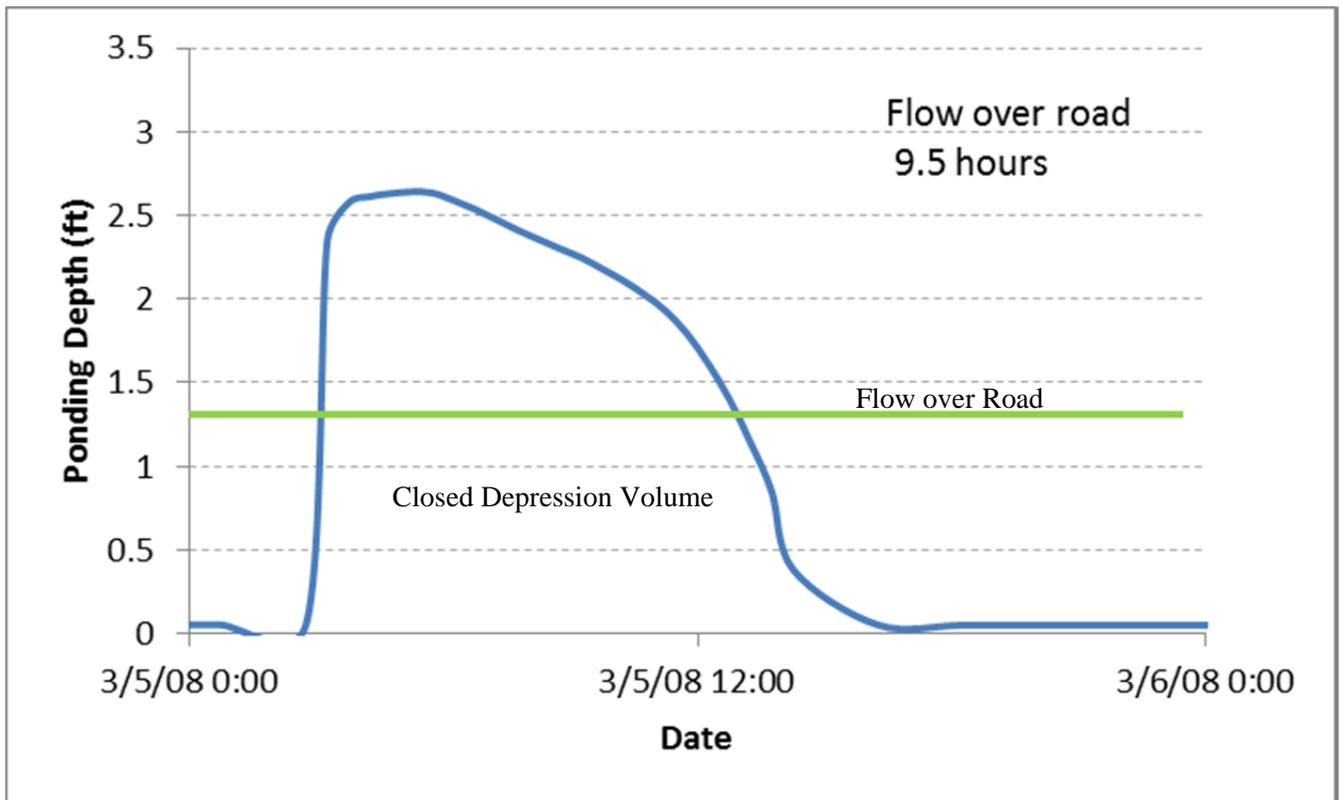
Figure 10. Runoff of March 5, 2008 (2.34" of Rainfall on a 5" snowpack)

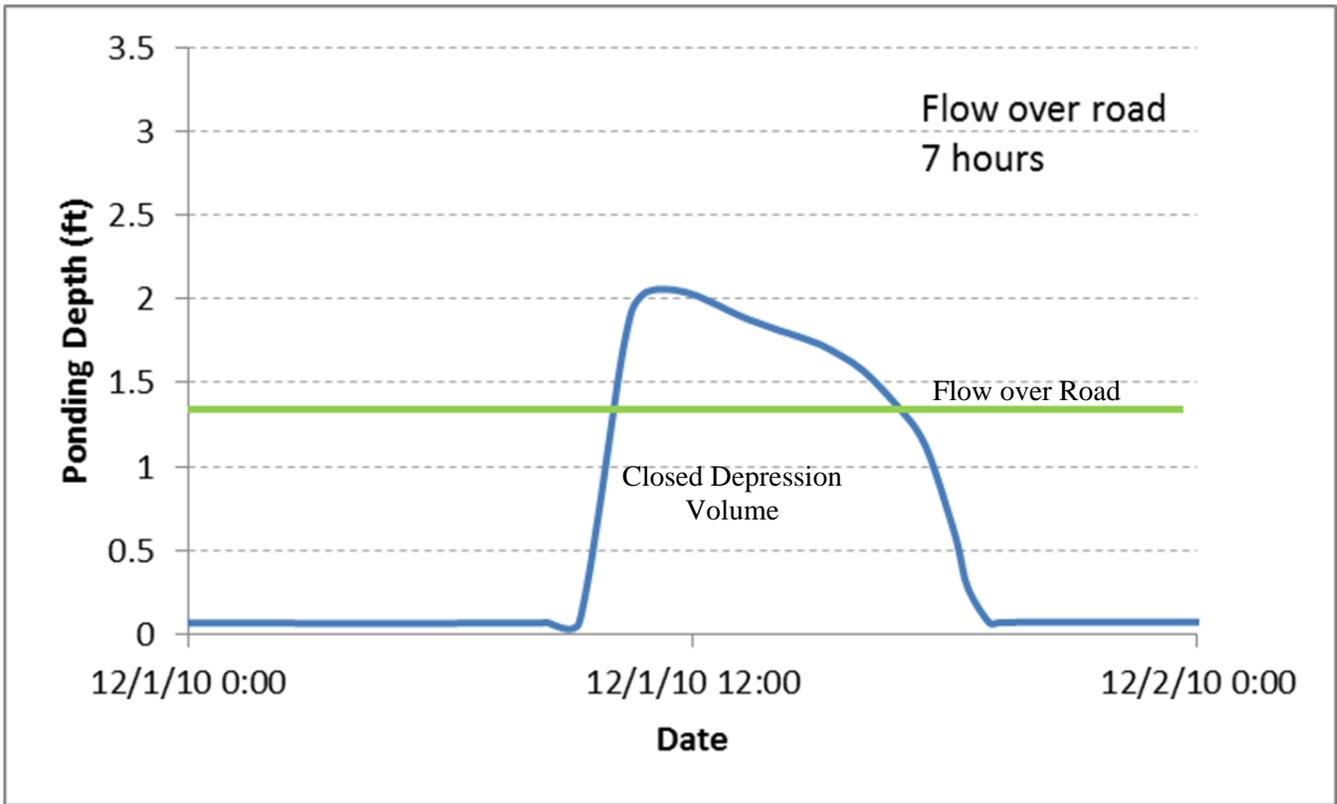
Figure 11. Runoff of December 1, 2010 (3.07" of Rainfall)

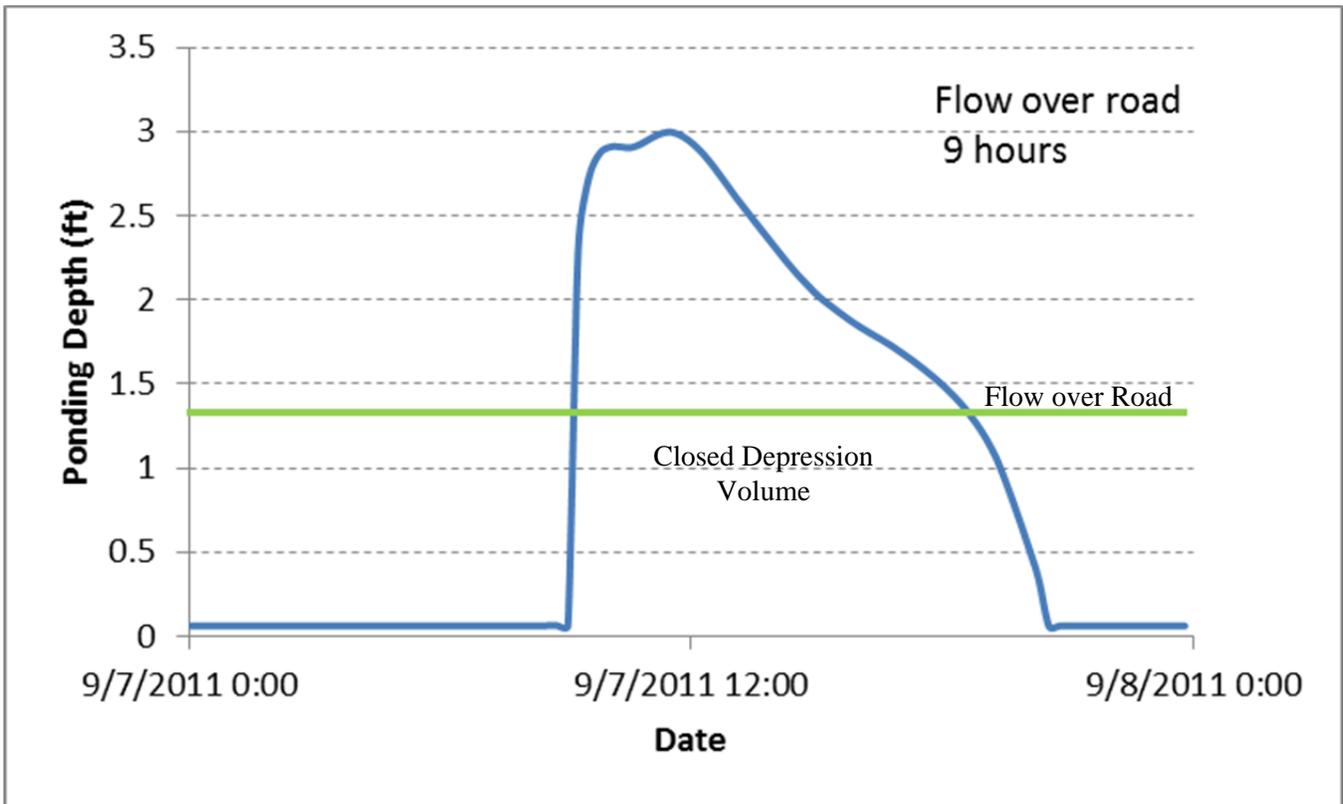
Figure 12. Runoff of September 7, 2011 (3.11" of Rainfall)

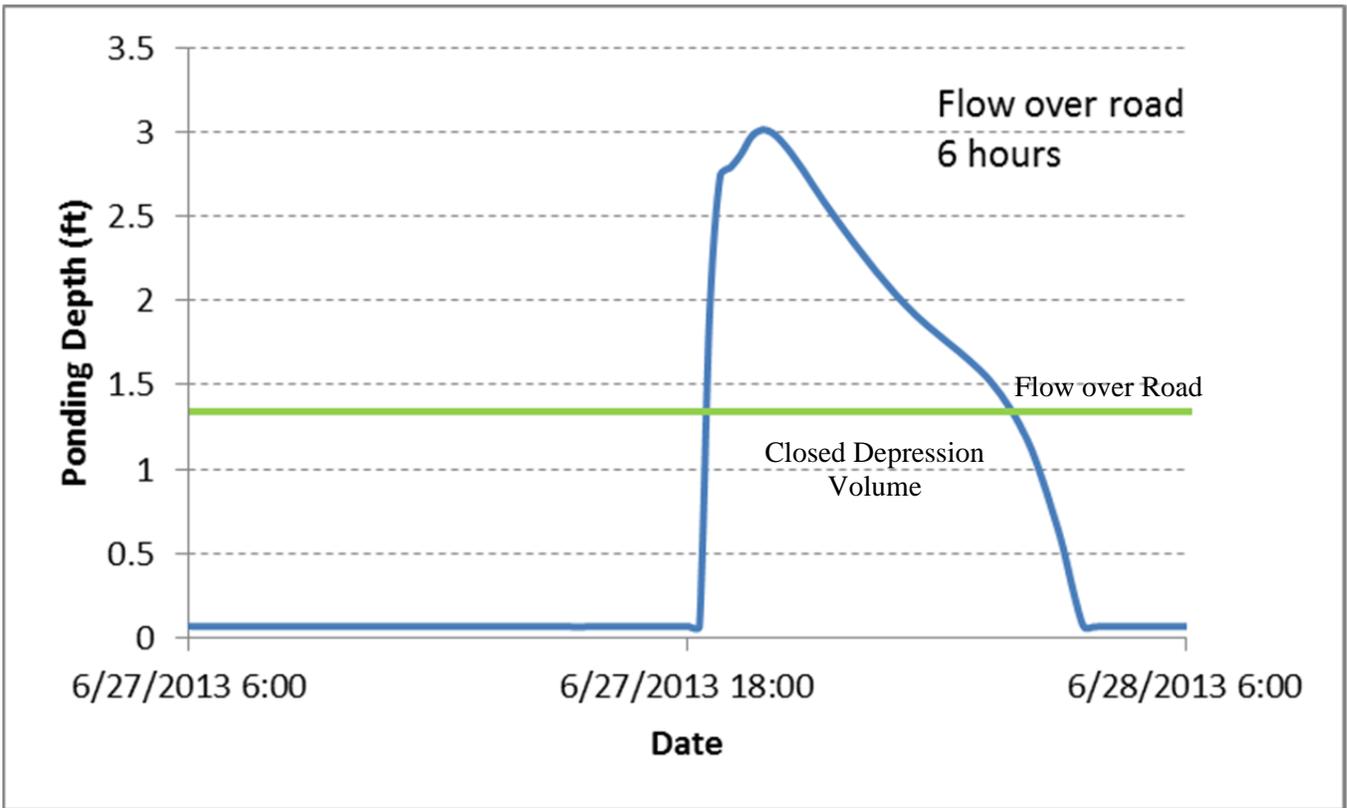
Figure 13. Runoff of June 27, 2013 (3.38" of Rainfall)

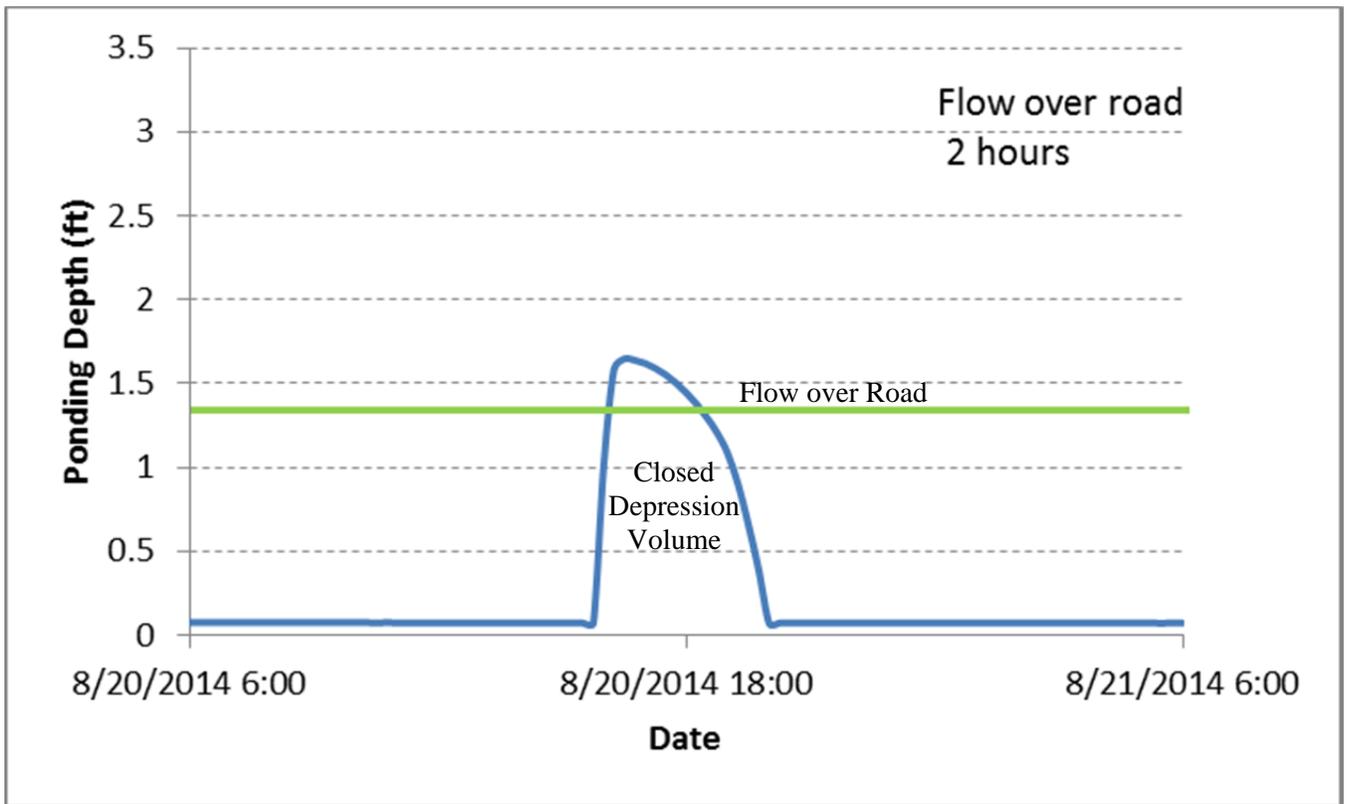
Figure 14. Runoff of August 20, 2014 (1.23" of Rainfall)
