Centre Region MS4 Partners
(College Township, Ferguson Township, Harris Township, Patton Township,
The Pennsylvania State University – University Park Campus, Borough of State
College)

POLLUTANT REDUCTION PLAN

November 15, 2017
Revised August 30, 2019

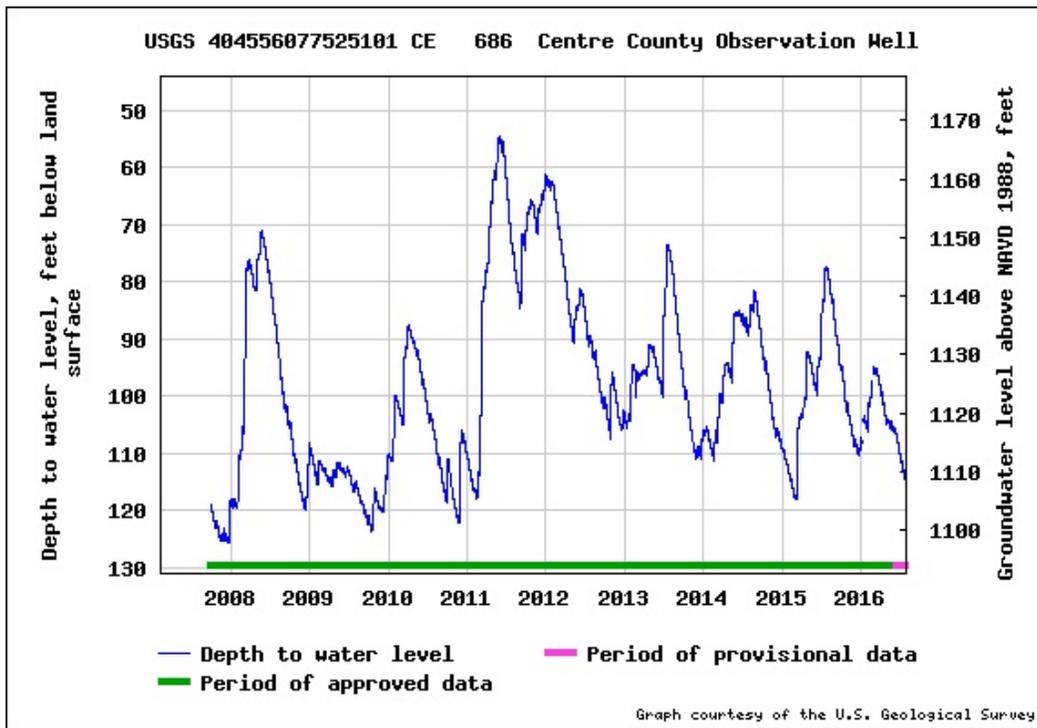
Figure 15. USGS 404556077525101 CE 686 Centre County Observation Well, Ground Elevation 1222.6 ft Located in the Upper Portion of the Big Hollow

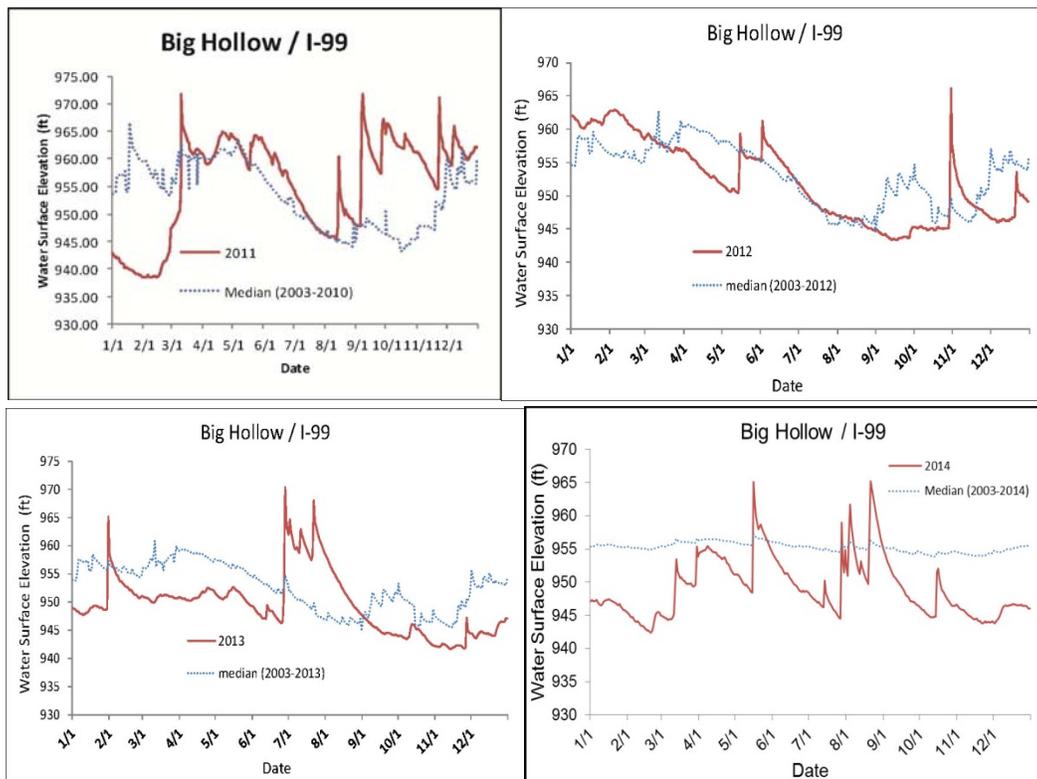
Figure 16. Big Hollow/I-99 Observation Well Collected by the WRMP, Ground Elevation 1010 ft Located in the Lower Portion of the Big Hollow (Data available from 2003)

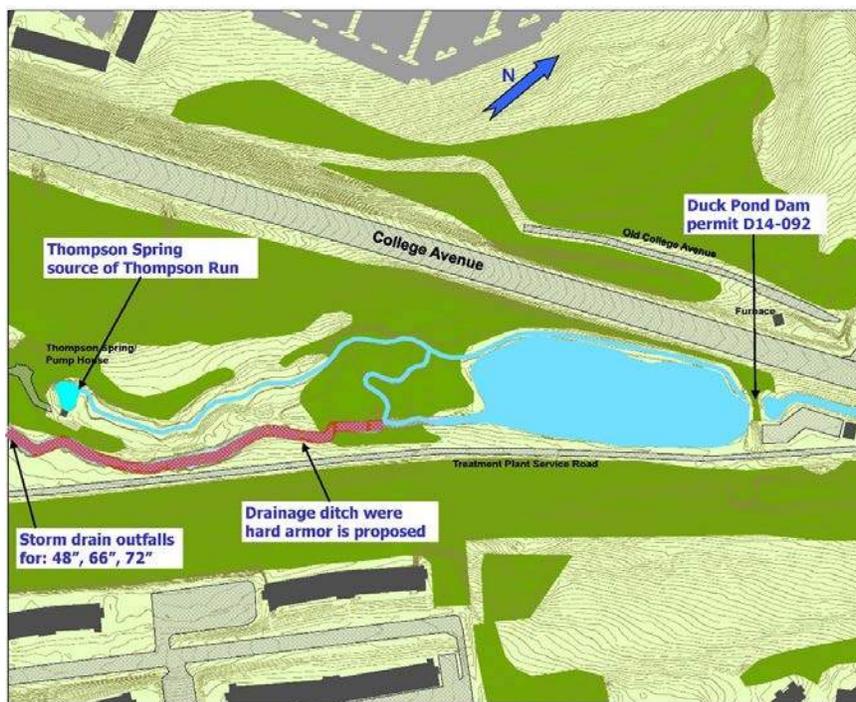
Figure 1. Schematic of the section of Thompson Run where the stream restoration project is proposed

Stream restoration, via hard armoring, will be conducted along approximately 1,000 ft. of the Duck Pond Inflow Channel. The Duck Pond Inflow Channel is identified on eMapPA as an unnamed tributary (UNT) to Slab Cabin Run. Locally it is considered an UNT to Thompson Run which is tributary to Slab Cabin Run. This project will result in 115,000 lb./yr. of TSS reduction based on applying the 115 lb./LF credit allowed. The channel is within Penn State University's MS4 permit Urban Area. Thompson Run and its tributaries are defined as impaired due to sediment. The Chapter 93 classification of Thompson Run is as a high quality cold water fishery (HQ-CWF). As discussed below, past experience and analysis dictate that hard armor is required to control scour and erosion in this channel reach. The drainage area to the subject reach is 867 acres (1.35 sq. mi.) and is approximately 50% impervious.

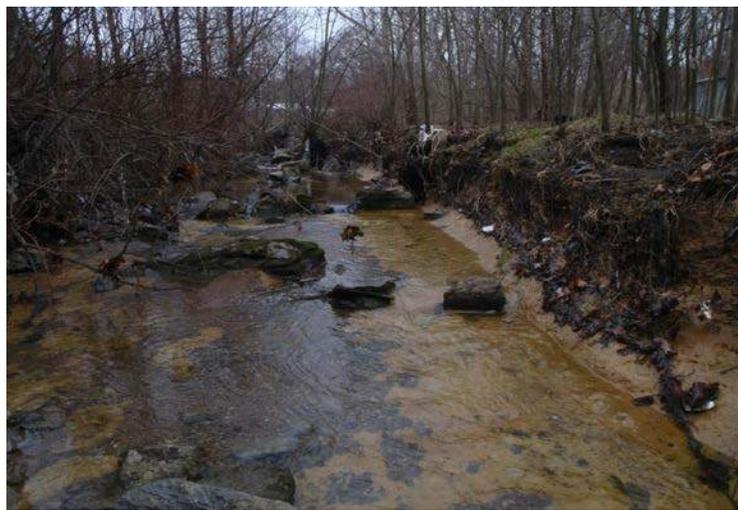
Photograph 1. Duck pond channel following bioengineered stabilization

The duck pond inflow channel has been actively eroding for the last two decades. As mentioned above, the floods of 1996 resulted in significant erosion to the streambank. Bioengineering efforts in 2002 failed to stabilize the stream reach. Based on surveyed channel geometry before the bioengineering project and current surveyed conditions and an assumed bulk density of 2.0 g/cm^3 , it is estimated that bank is currently eroding at a rate of 102 lb./yr.

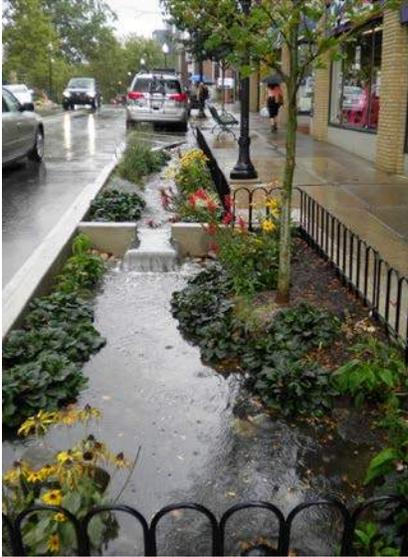
Photograph 2. One of two rain garden retrofit projects installed at the corner of Allen Street and Beaver Ave in the Borough of State College

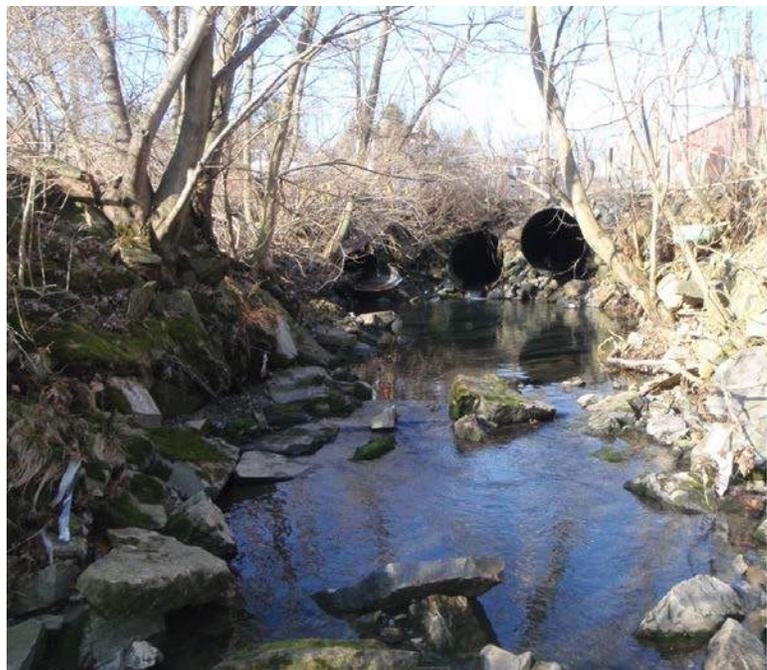
Photograph 3. Stormwater discharge pipes at the beginning of the project reach

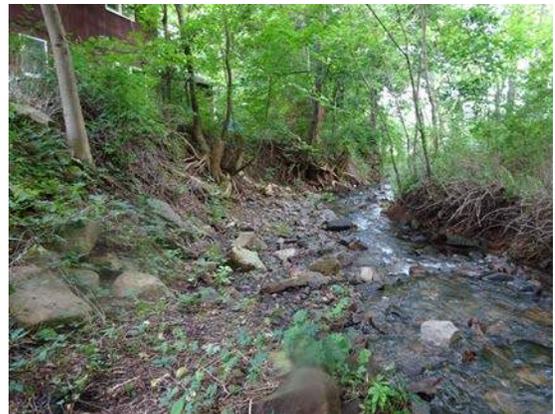
Photograph 2. Actively eroding section of Slab Cabin Run, located along Route 26 in the village of Pine Grove Mills (Ferguson Twp.)

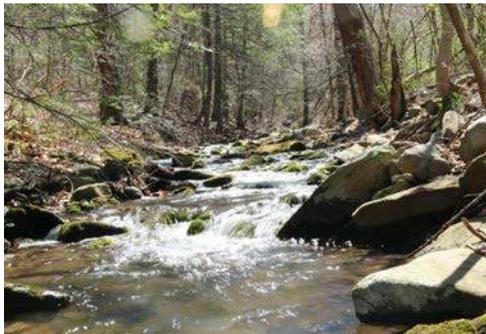
Photograph 4. Stable reach immediately upstream of the proposed project.

Significant floodplain connection is not a characteristic of natural mountain streams (see **Photograph 4**). Minor floodplain benching, similar to that illustrated in **Figure 1** will be included in the project.

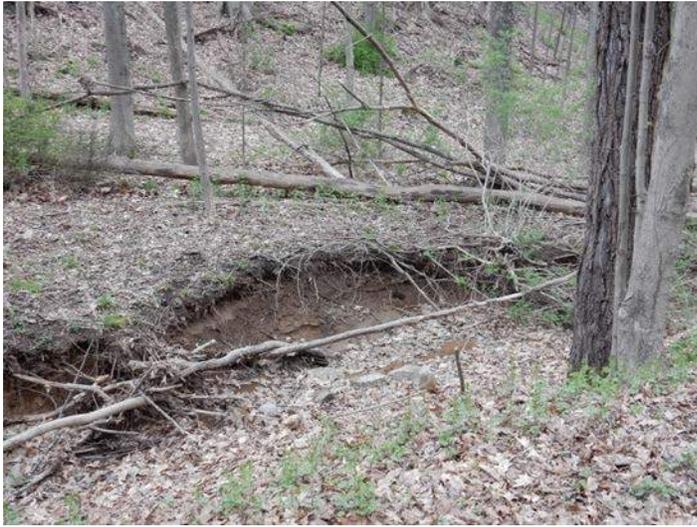
Photograph 1. Eroded banks along the UNT to Buffalo Run

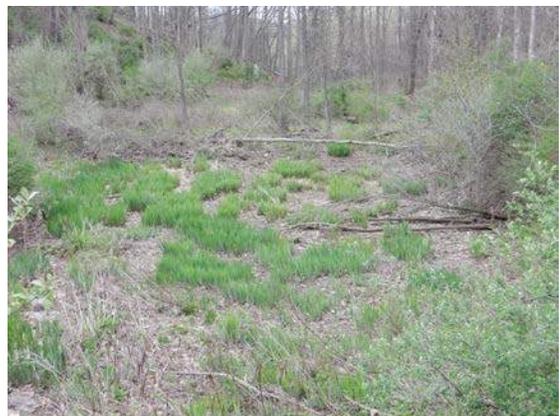
Photograph 2. Adjacent area that detains stormwater

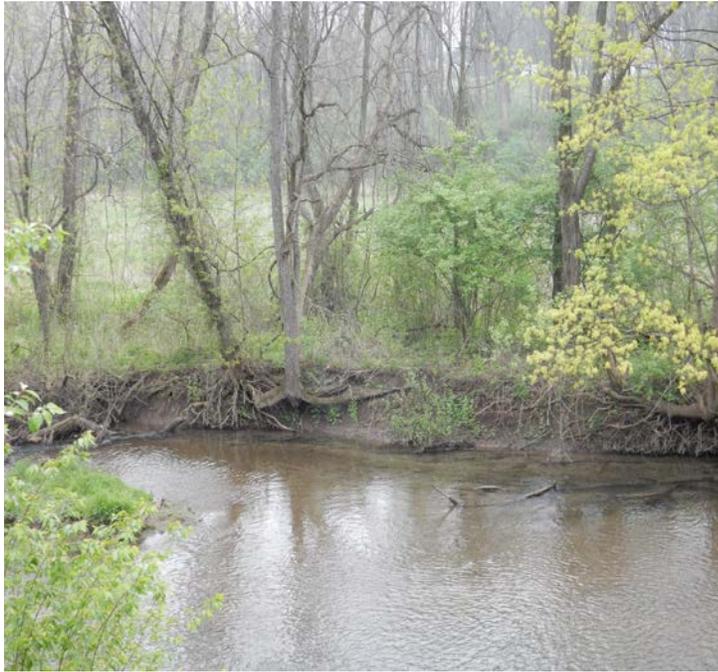
Photograph 1. Eroded section of Spring Creek adjacent to Spring Creek Estates

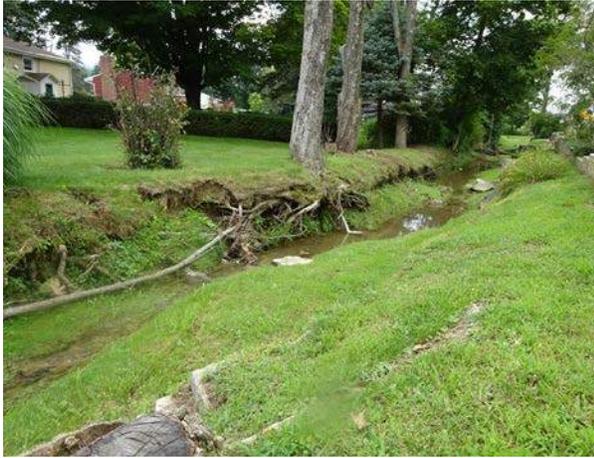
Photograph 1. UNT Beaver Branch Downstream of Wyoming in the Piney Ridge Subdivision

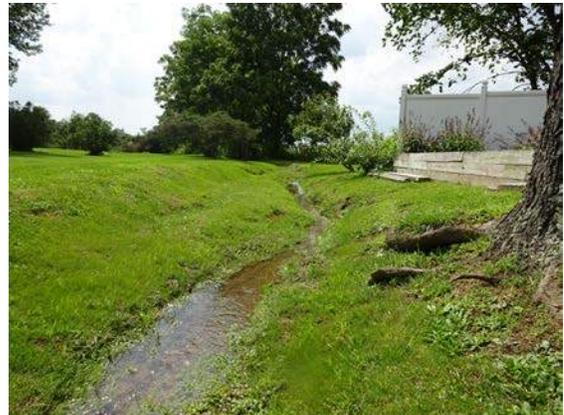
Photograph 2. Sediment deposition in channel

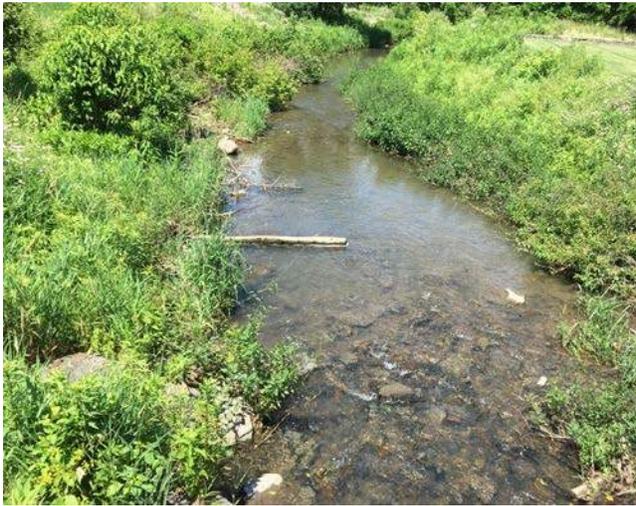
Photograph 1. Stream reach downstream of Military Museum dam (looking downstream)

Active bank erosion and lack of floodplain connectivity are evidenced in **Photographs 1** through **3**. This project would be a continuation of the restoration project previously constructed immediately downstream.

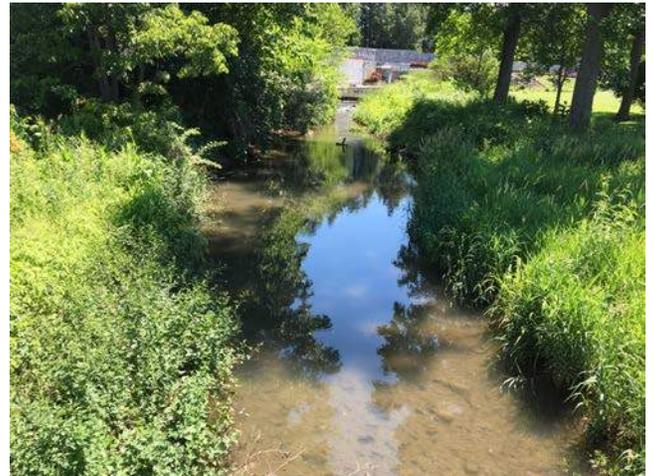
Photograph 2. Incised steep cut banks with little floodplain connectivity (looking upstream)

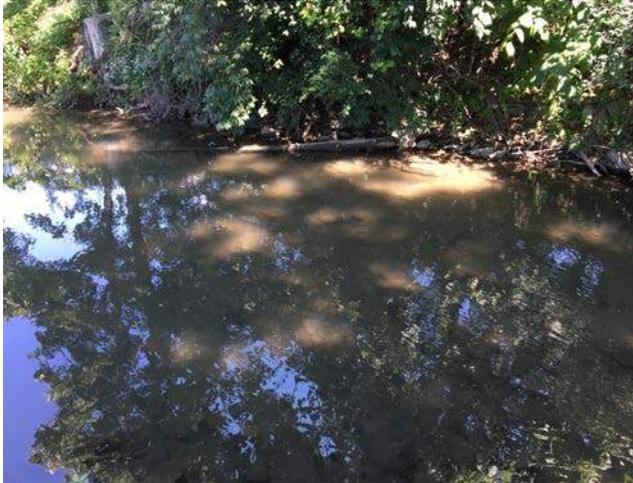
Photograph 3. Steep cut incised channel bank

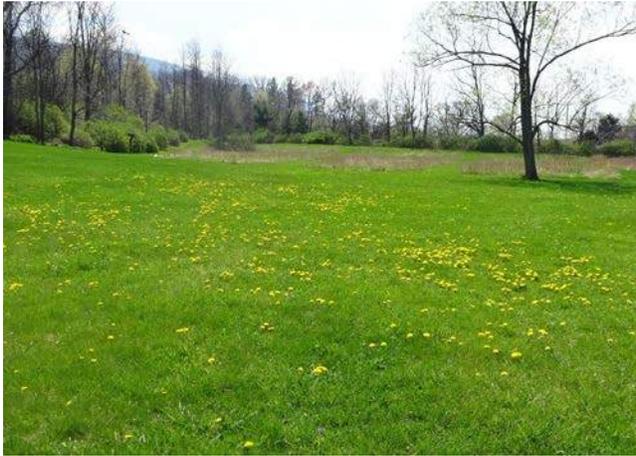
Photograph 1. Willowbrook Basin (BMP A7)

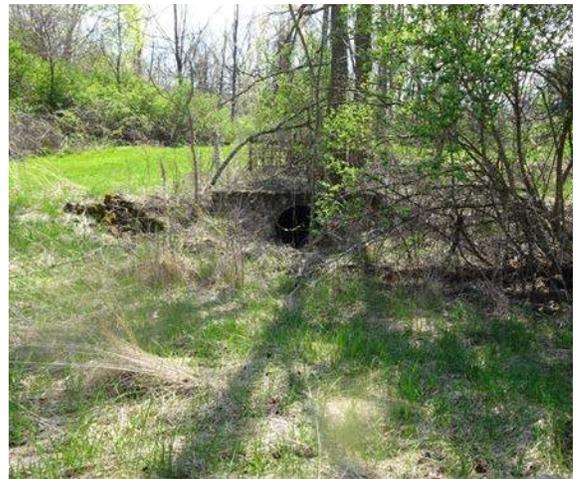
Photograph 2. Outlet structure for Willowbrook Basin (BMP A7)

As illustrated in **Photograph 2**, the basin outlet structure consists of a 24-in. primary outlet pipe with a 2 ft. by 4 ft. horizontal overflow orifice with trash rack. The total drainage area tributary to the basin is approximately 149 acres which includes 44 acres within Willowbrook Estates, runoff from an upstream partially developed subdivision with a separate stormwater facility, and agricultural lands.

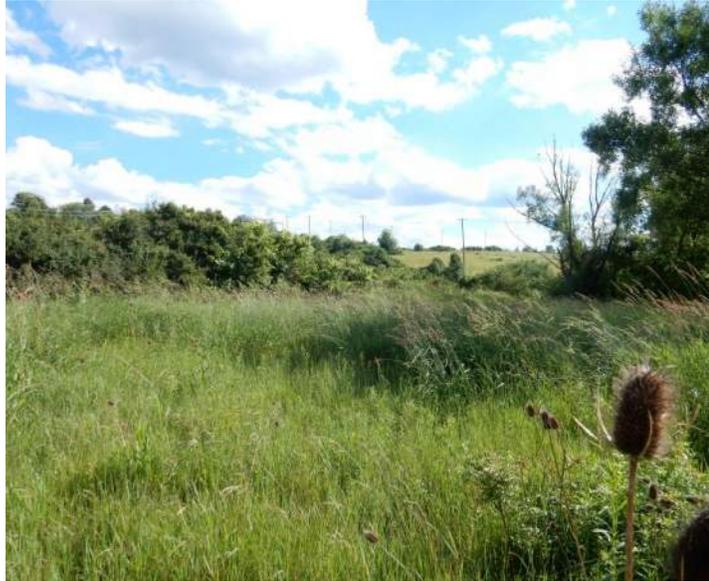
Photograph 1. Penn Hills basin

This project involves retrofitting a 1.38-acre stormwater management basin in Penn Hills to include a runoff reduction function. The existing basin, illustrated in **Photograph 1**, was originally constructed in the mid 1980's to provide peak runoff control from 70 acres of the subdivision. Approximately 17% of the drainage area (12 acres) is impervious. The basin is currently vegetated with meadow grasses and wildflowers and consists predominantly of Hagerstown and Opequon Soils. These soils (Hydrologic Soil Group B) are well drained and have good infiltration characteristics.
